## Airworthiness Alert

### Jabiru Aircraft- 4<sup>th</sup> August 2010

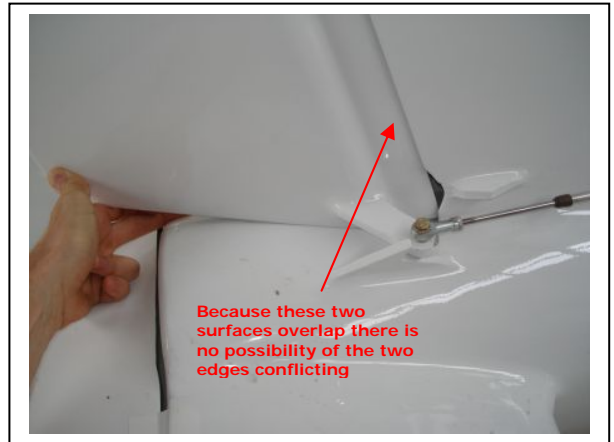
**This is an acceptable rudder fit; there is no possibility of the rudder's leading edge fouling the fin's trailing edge.**

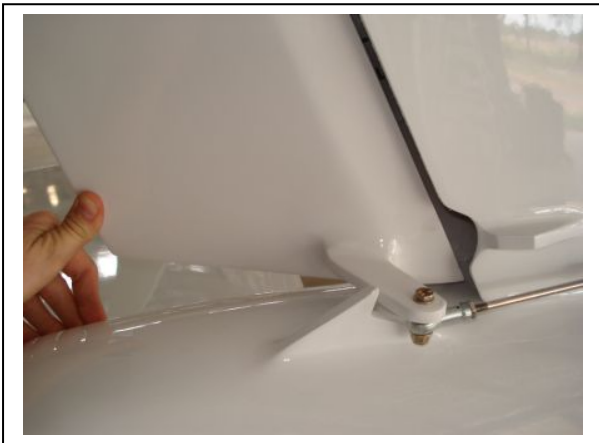
**This is an example of an unacceptable rudder fit, under some circumstances the leading edge of the rudder could jam against the trailing edge of the fin.**

Essentially, this is a simple inspection, but, because of the seriousness of the possible consequences of a control surface jam, this inspection must be signed off by an LAA inspector.

Before you undertake this inspection you will need a copy of the Jabiru Service Bulletin JSB 019-1 (29<sup>th</sup> February 2008) which can be downloaded [here](#).
