TAKE TIME TO CHECK

EV97 Eurostar: Material quality issues

Dyn Aero MCR-01: Flap bracket failure

SAFETY SPOT

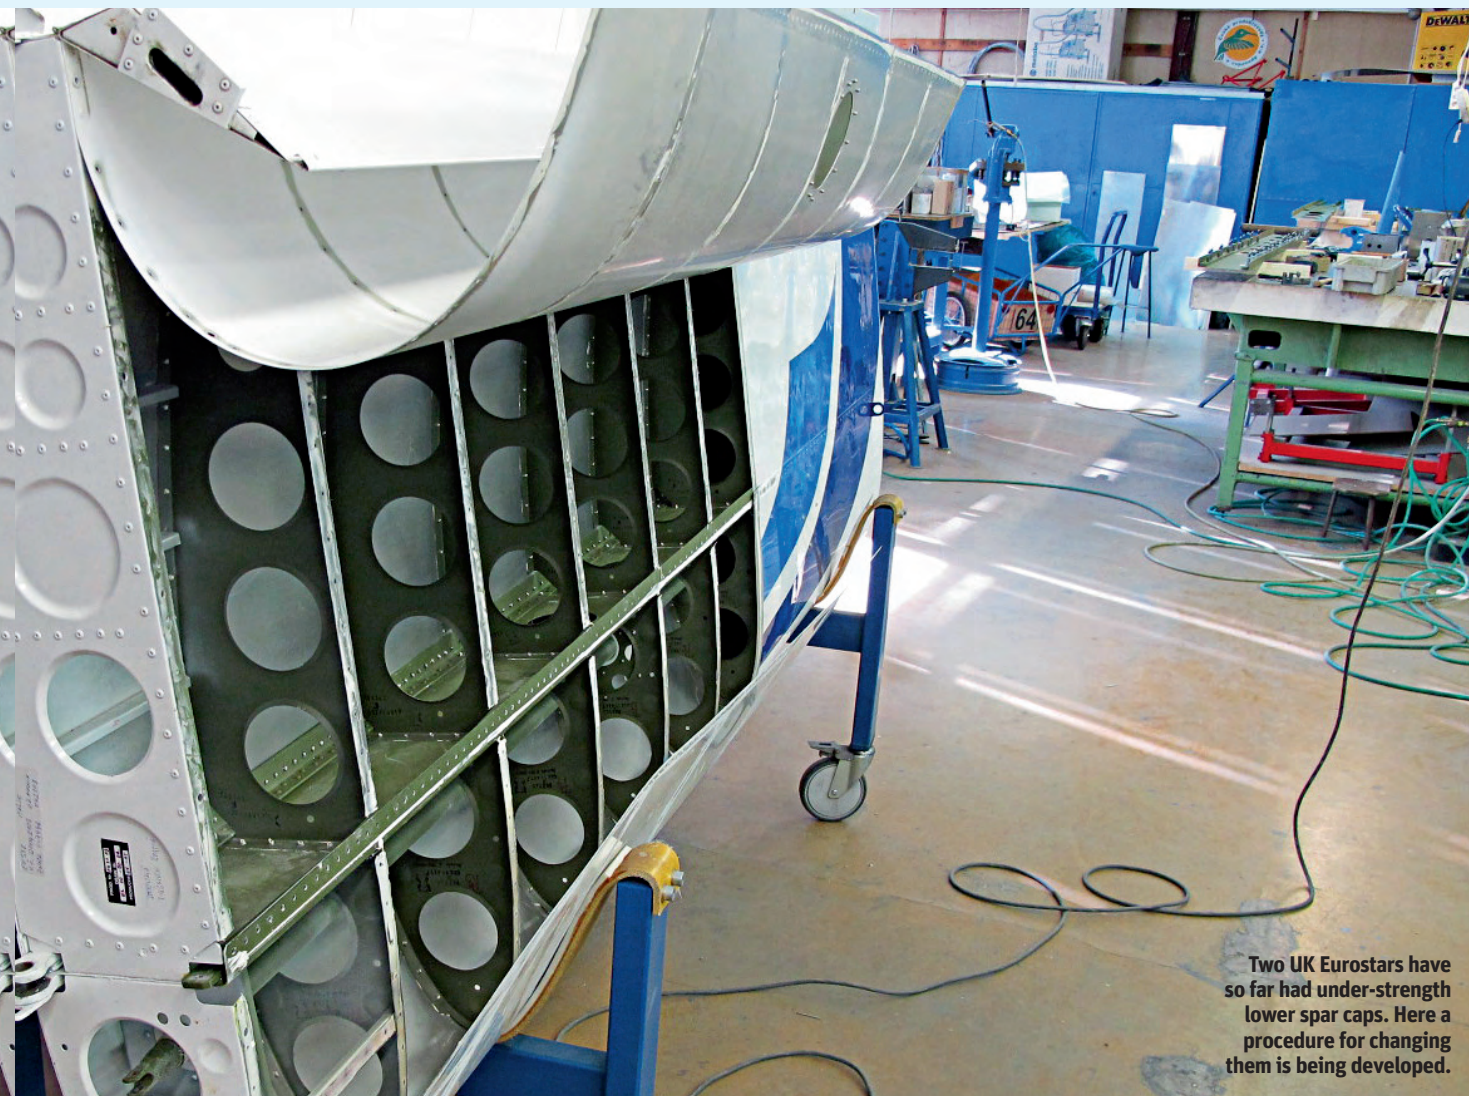
Two UK Eurostars have so far had under-strength lower spar caps. Here a procedure for changing them is being developed.

If a spar cap fails the test then all is not lost but the effected spar caps will have to be changed. To accomplish this the bottom skins need to be 'opened up' which is a fairly specialised job as you can imagine. I have just got off the telephone from Nigel Beale, boss of Cosmik, and he told me the MPD is imminent and that, in the next couple of weeks, specialist engineers are coming over from Evektor to train up UK personnel to be able to replace under-strength spar caps. Nigel explained that Cosmik will be picking up the tab for this work provided the wings are brought down to his facility near Banbury. You cannot beat that for service.

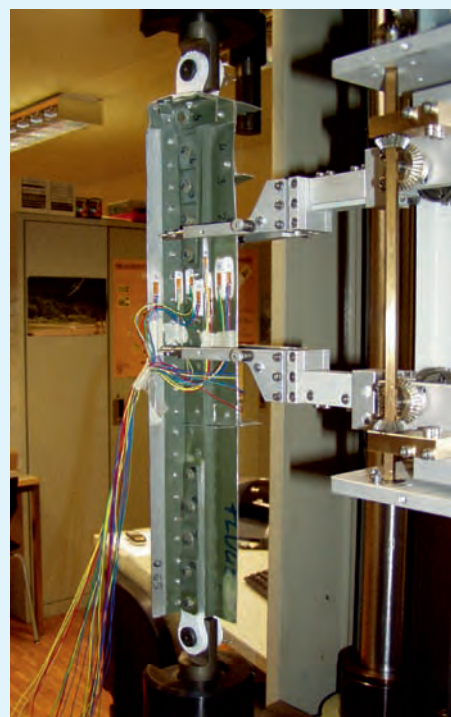
Elaborate set-up required to test the strength of the EV-97 Eurostar wing spar by the Swiss AAI8.

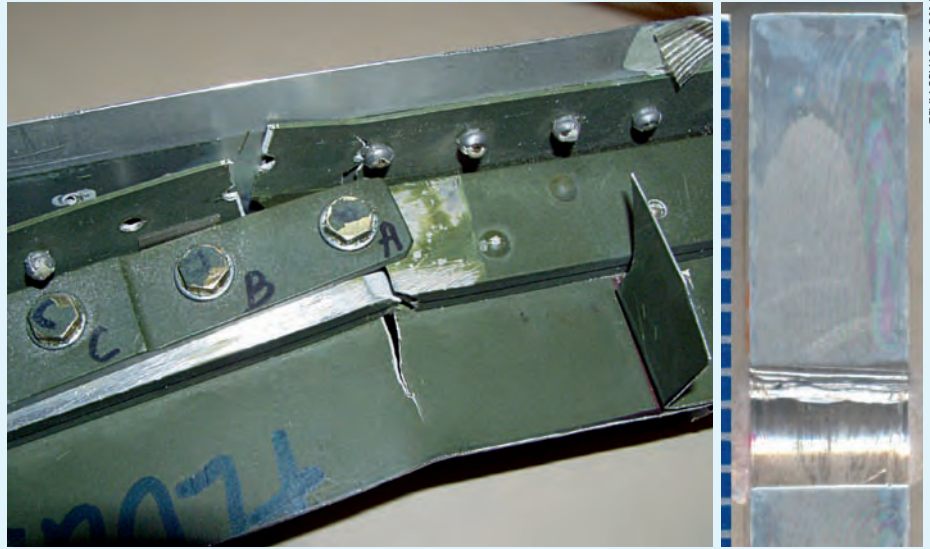
Whilst he was there he was able to establish that a continuous process is never used and therefore the unusual grain structure found must have another cause. In fact the engineers at the mill could not account for the reduction in strength of some of the extrusion tested at the Swiss facility and, to date no reason for this reduction in strength has been established.

Left: resulting failure identifies the assembly's weak point. Note 45° failure after overload tension. Right: sectioned extrusion from EV-97 lower spar cap – note finger-like projection and huge variability in visual texture of the material. Each of the divisions on the left is 0.1in.

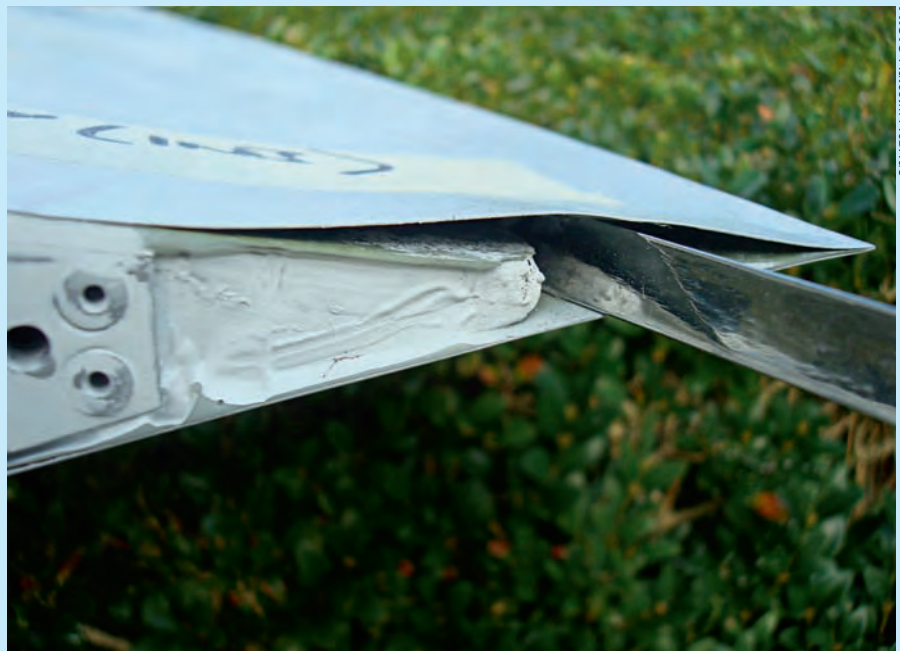
Debonding discovered by Mike Smart during his renewal inspection.

The reason why Mike asked for the flapperon to be removed was because he was concerned that the flapperon's skin appeared to be becoming detached from the rib; everything looked pretty normal apart from this. Once the flapperon had been removed the extent of the problems with

the end of the flapperon that the skin has separated from the rib. Initially, when Mike inspected the flap, this separation only extended a few inches from the trailing edge. It was decided to remove all the paint from the flapperon, both to fully inspect, but also to provide a good key for re-painting. Unfortunately, and there is a lesson here, the effect of sanding off the paint further caused a lot of vibration, damaging the remaining bond between the skin and the rib, effectively writing off this flapperon.

If I had to take a guess I would imagine this corrosion is what we call electrolytic corrosion. The ribs are made from carbon fibre which is electrically active and notoriously difficult to get metals to bond to, which I suspect, is one of the reasons why Dyn Aero have gone over to carbon skins where the carbon-carbon joint will present no difficulties and should be very strong. Once moisture gets between the bonded surfaces, corrosion starts and creates a path along which corrosion progresses. I am sure

The owner 'bit the bullet' and bought, at a cost of about £800, a couple of new carbon flapperons. I benefited from this as I was able to get my hands on the old flapperons and take a few pictures.

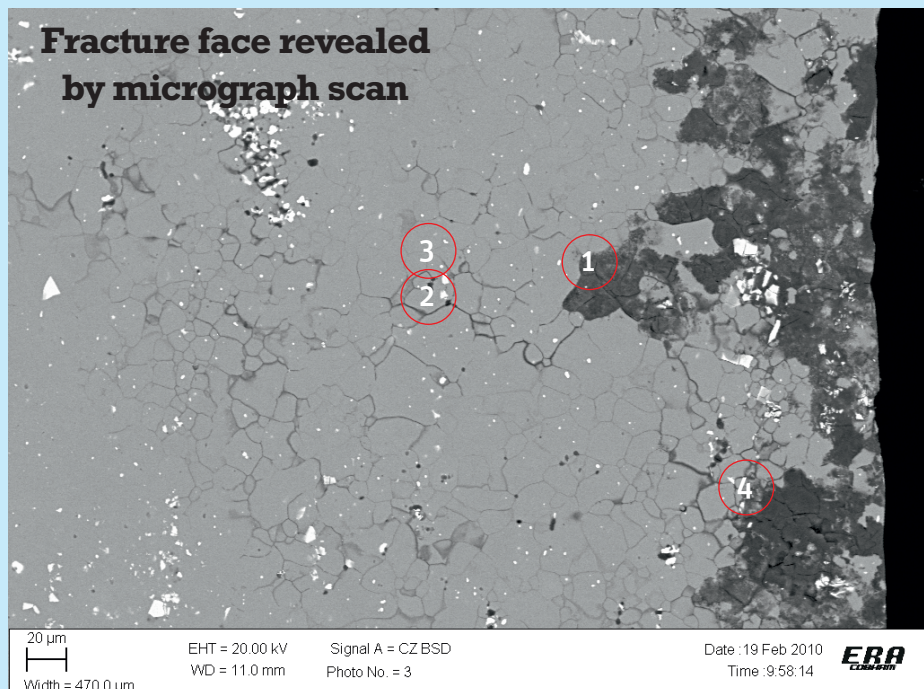
This is what's known as a scanning electron micrograph (SEM) taken by scientists at ERA. To put the size this image represents into context, the whole width of the picture represents a little less than 0.5mm. Modern technology allows us to identify the elements present in the sample by using a technique called Energy Dispersive X-ray analysis (EDX).

SEM-EDX of the intergranular cracks and pitting showed the oxide formation and evidence of sulphur and chlorine. Both these environmental contaminants could enhance the rate of corrosion. Note the table below which gives you the actual numbers and corresponds to the areas circled above.

AREA	O	Al	S	Cl	Ca	Mn	Fe	Cu	Total
1	60.7	33.4	0.7	0.8				4.4	100.0
2	29.5	67.6		0.6				2.4	100.0
3	3.8	89.7				0.9	1.4	4.1	100.0
4	66.2	32.9			0.9				100.0

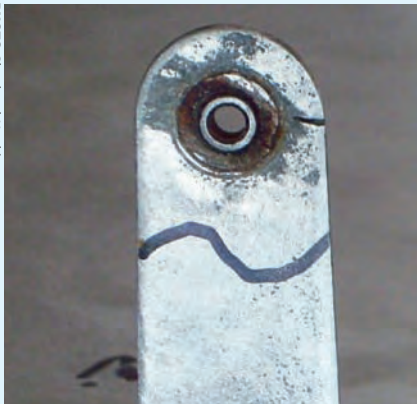
Failed flap bracket – crack at three o'clock.

Once the flapperon had been removed Mike was quite shocked to see one of the supporting brackets had actually failed. He sawed off the brackets and sent them to us here at HQ to have a closer look.

I have to say I am quite worried by this failure. The flapperon on this type is supported by three brackets; with one having failed the other two bearings continued their support. On later models, where a more conventional flap and aileron arrangement is used, there are only two brackets per control surface and an in flight failure of one of these could lead to the loss of the aircraft.

LAA Engineering is in discussions with Dyn Aero and the UK agent, Lyndhurst Touchdown Services, about what needs to be done to ensure this failure cannot happen again. One thing we'll do as soon as possible is to make changes to the maintenance schedule requiring annual removal of these flight control surfaces. Good Spot Mike.

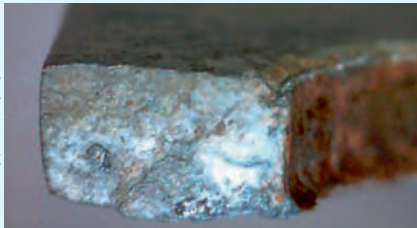
Fracture face of the MCR-01 flap bracket. Note corrosion (white stuff), fatigue beach marks (left lower corner), and the typical 'cup and cone' (cone showing, lower centre).

We sent the parts away for a metallurgical examination and it is looking very likely that our old friend 'stress corrosion' is back in town. It's been popping up quite regularly recently and, if you want to know a little more about its modus operandi, take some time to read Francis's article. You will see the reasons for this particular failure I'm sure.

I hope you agree with me the reason for the failure of this part could be laid at a number of doors. It's never a great idea to have a steel bearing in close proximity to highly corrodible aluminium structure without appropriate electrical insulation, but for me the big fall down here is the flapperon hadn't been off for ages and the problems of corrosion weren't spotted sooner.

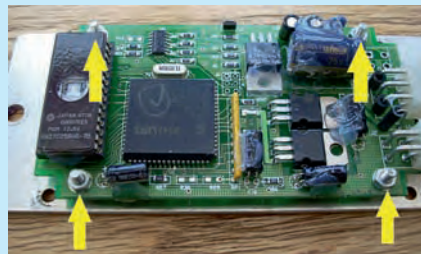
ignition control box and removing it he was quite surprised to hear a rattling from within. What Neil found was that the nuts that hold the printed circuit board down had become loose and a couple of them were 'floating around' in the control box.

Neil suspects the nuts were intermittently shorting out the controller, hence the misfire. The Ellison isn't in the frame this time. We're going to produce an Airworthiness Information Leaflet (AIL) requiring a drop of threadlock on these nuts... we wouldn't want Neil's engine to stop again during aerobatics now would we?
