THE THREE BIG GHOSTS

Coming back to haunt those involved in the care of an aircraft are cracks, corrosion and wear

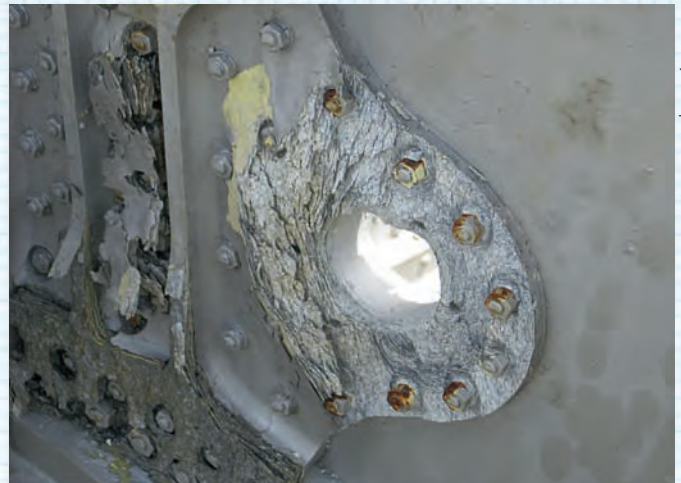
What a brilliant picture of exfoliative corrosion; as the material is rolled during its manufacture, the grains are forced into layers. Corrosion products force these layers apart – the results can be easily seen in this example. Notice also that the aluminium plate is held in place by ferrous bolts and nuts so the initiation of corrosion here could have been the electrical current generated by the dissimilar metals. Thanks, John, for taking the trouble to send this picture in.

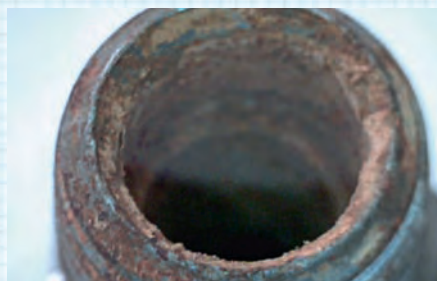
When Dave tried to remove the fuel outlet fittings he noticed that they were both glued in. Eventually, he managed to get them out and, well, you can see the issue for yourself in the accompanying pictures – one of the fittings was virtually completely blocked by some epoxy-like substance of unknown origin. I wonder when the last fuel flow check was done? Dave reckoned that the flow from this tank might just have kept up with the engine's usage!

Here's the inlet for the fuel tank fitting off the Ran's S4 discussed in the text. All fuel system components must be kept in 'tip-top' condition for obvious reasons.

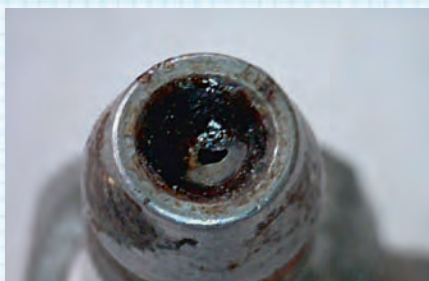
You can see that this outlet is nearly completely blocked by some unknown substance – it looks like the residue from the glue that was used to cement the fitting into the tank.

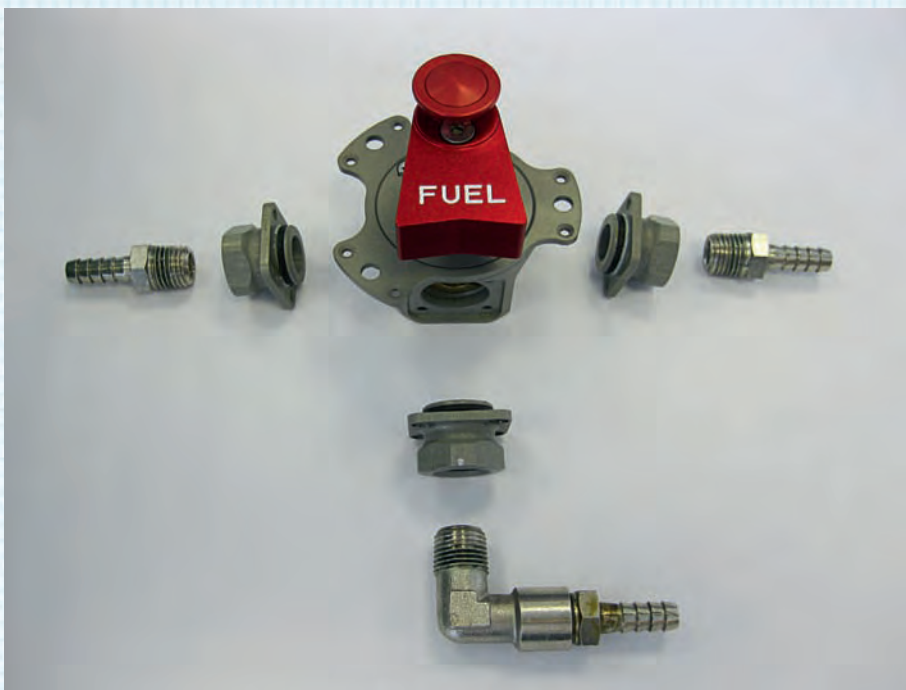
During this replacement, the fittings, which are made from steel, were removed from the fuel selector assembly, which is made from L168 aluminium. The manufacturers of the fuel valve, Andair, had gone to great trouble to prevent this type of corrosion by anodising the body of their unit but, because the male fittings are not really standard aircraft parts, this problem has arisen.

Here is a picture of the Andair Fuel Selector, and beautifully made it is too. Normally a fuel selector will have a number of selections so that the pilot can manage his/her fuel usage. Normal selections are OFF, where no fuel can pass; LEFT, where only fuel from the left-hand tank is used; RIGHT, where only fuel from the right-hand tank is used; BOTH, where left and right tanks are used together. In this case, the body of the unit is L168 aluminium chromic anodised, ie high spec. The commercial steel fittings look to have been originally designed for use in compressed air applications.

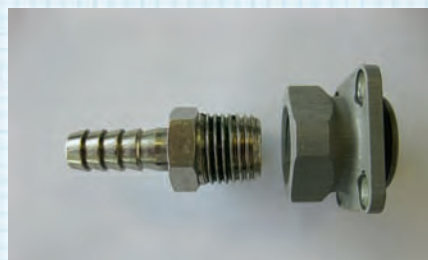
In this picture, the 'Taper' on this NPT can clearly be seen. Out of interest, the taper rate is 3/4in per foot, which is a taper angle of about 2° so quite a lot of force can be generated (regular readers will remember the Rotax oil filter incident).

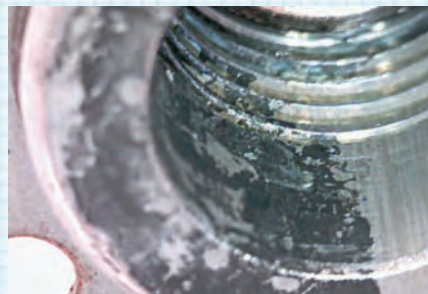
Here's a close-up of the corrosion within the fitting of this fuel valve. It's not a brilliant picture as it doesn't give justice to the internal damage found. There's a huge chunk of material missing roughly in the centre of the shot.

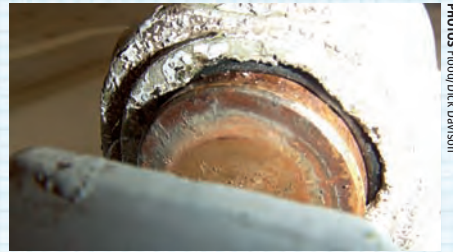
This is a case of corrosion whose probable origin lies in the difference in electrical potential created when different metals are brought together in close contact. This so called galvanic effect is primarily the same mechanism used to generate electricity in a battery. The problem is that at least one of the metals involved is sacrificed.

A closer look shows this brake unit was only a few applications away from failure.

I'm not sure who to credit this chart to, Cedric never said where he got it from, but it broadly fits the tables we use here and looks nicer! If possible, it's always better to insulate one material from another. Various methods are employed in industry including the use of high resistance scrims and proprietary pastes – like Duralac.

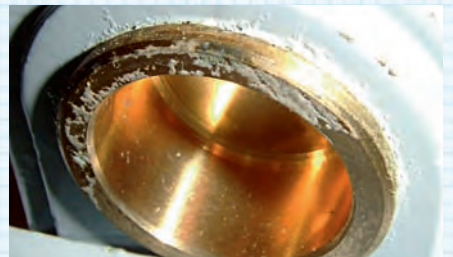
This is worrying. There were signs of corrosion on this replacement part before it had even been fitted. Several Eurostars operate under an LAA Permit; this is the first time I've seen this.

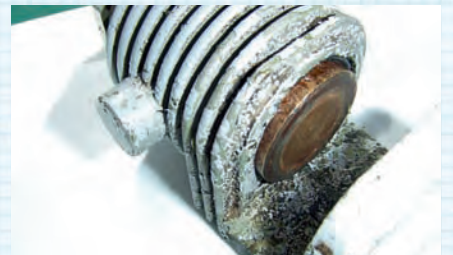
You can see Cedric's problem: the inner edge of the brake calliper has disintegrated, exposing the 'O' ring surface. This brake unit is only four years old, and may have been missed without complete disassembly. It is essential that calendar life of components is taken into account in your maintenance schedule.

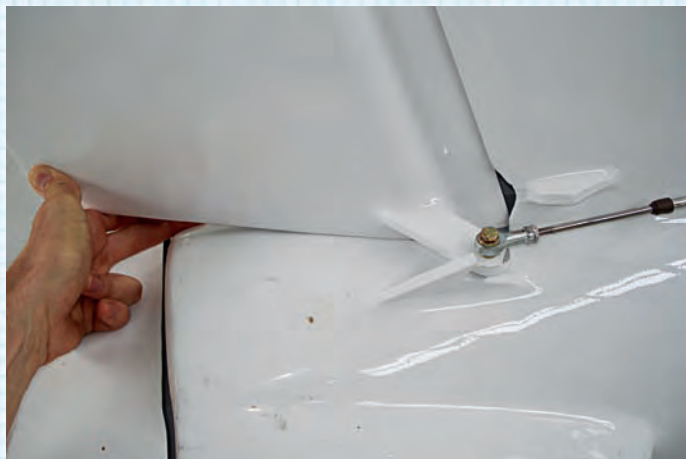
This is a photographic example that shows an acceptable rudder fit. No matter how much the fin/rudder assembly may move about, there is absolutely no way that the leading edge of the rudder can foul against the trailing edge of the fin.

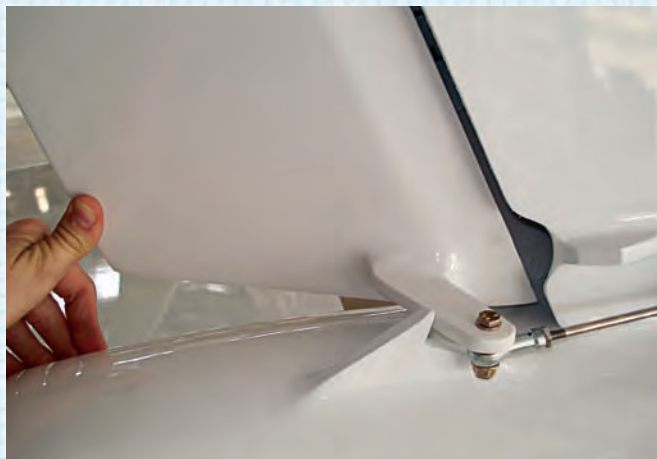
While demonstrating sideslips, full rudder was applied. This had the effect of applying a very large force to the fin that distorted the structure slightly in the area of the hinge allowing the clearance to close up. There was a sufficient clearance in one sense but, because there was no overlap, the edges were able to come into contact and jam.

Here's one that is likely to jam; note the overlap. The LAA will shortly be issuing an updated AIL offering advice to owners of Jabiru aircraft about this matter, but it is essential that pilots of all aircraft ensure that the control surfaces are free to move and that there is no possibility of a jam.

We're going to update our AIL to make the point more clearly. As I said earlier, if you have any suspicion that there is a possibility that a control surface could jam, then walk away from the aircraft and get the problem fixed before you fly it.

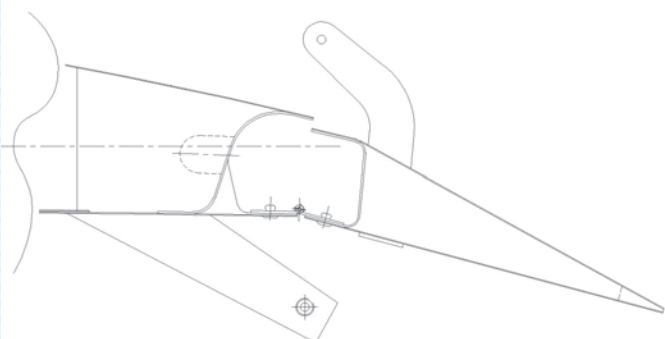
SAFE GAP EXAMPLE

There's confusion about what constitutes a 'safe gap' between the fin's skin and the leading edge of the rudder. It's not the faces of the adjoining components but their edges that matter. As flying surfaces take extra load they generally flex slightly, which must be taken into account during 'rigging'. While these sketches show an aileron, the rudder assembly is essentially the same.

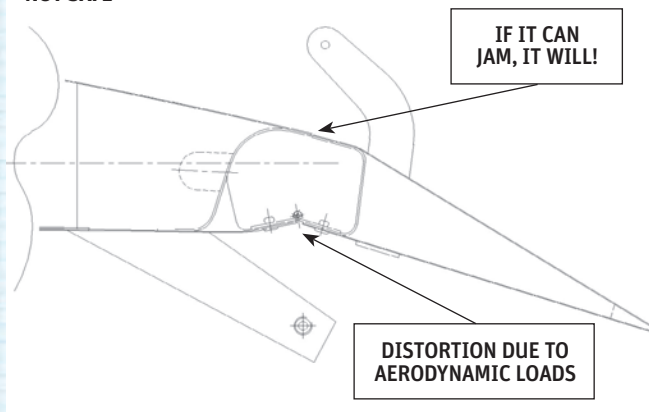
NOT SAFE

This illustration shows an aircraft with a problem. You can see that, as the fin/rudder assembly moves about during normal operation, it is possible for the leading edge of the rudder to jam against the trailing edge of the fin. Survivable probably in the case of a rudder, but not so with a jammed deflected aileron.

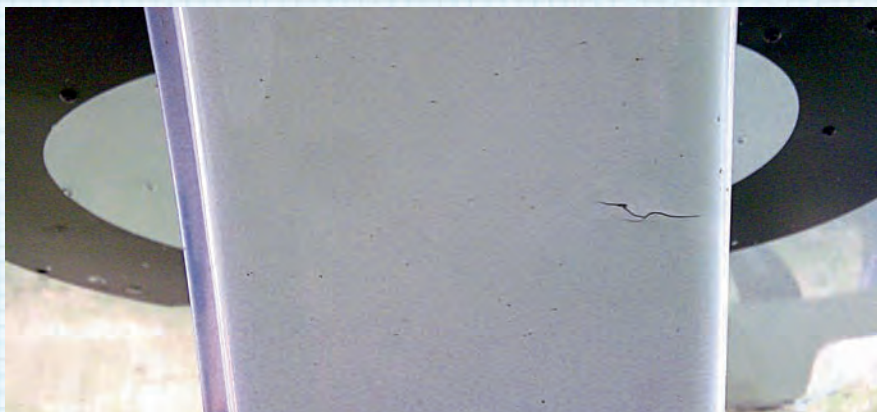
It's important to mention that in the UK we have not seen any undercarriage failures although several aircraft have developed cracks following heavy or sideways landings. Any crack will require a replacement undercarriage leg, but the important thing is to check your aircraft regularly.

A small crack in the paintwork may be just that but, on an aircraft, every bit of damage needs to be thoroughly checked out. Firstly, paint cracks are gaps in a material's protective coating that will allow water ingress and may lead to corrosion. Secondly, the cause of a paint crack may be that the underlying structure is damaged. Paint on an aircraft is not just about 'looking good'.

Most builders use a two-pack polyurethane paint, which is very flexible. If you can see a crack in the surface paint, it needs to be investigated. All the cracks I have seen so far have been on the inside of the leg, about two thirds of the way up and towards the front of the leg. If you find a break in the surface paint, gently rub back the surface with 320 wet and dry. The composite construction consists of a sandwich of carbon and glass. As you start to abrade the carbon, the black dust will be trapped in the crack and, where that crack runs through the white glass, any crack in the leg itself will be obvious. Take it easy because you don't want to ruin a sound leg because you got carried away with the wet and dry!

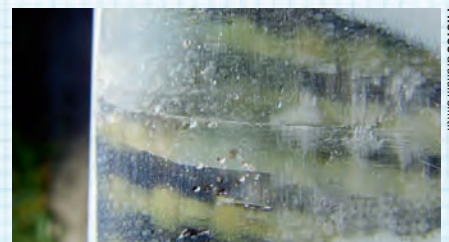
Here is what was found after cleaning off the damaged paintwork.
