EV-97 Eurostar - Overseas wing failure

SAFETY SPOT

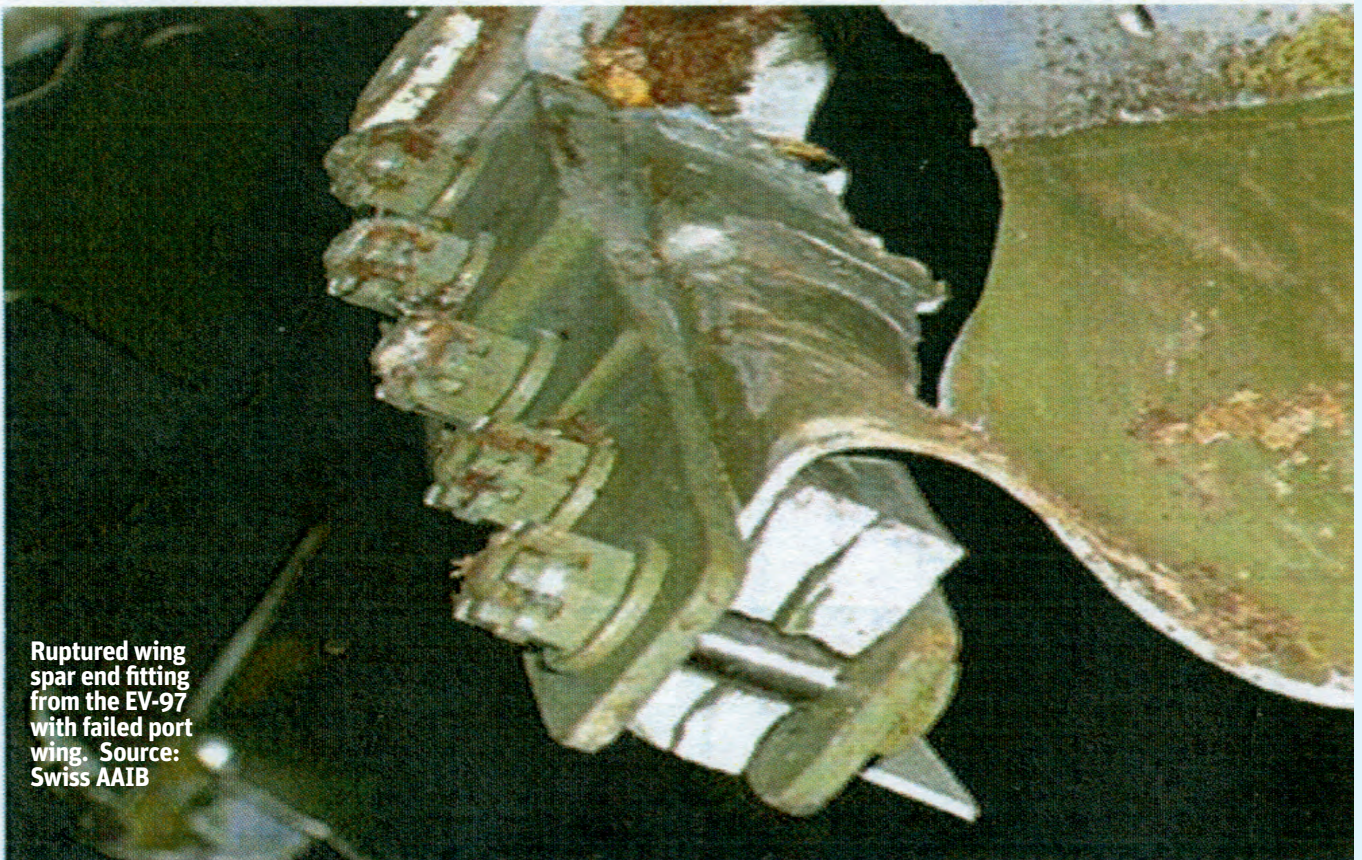
Ruptured wing spar end fitting from the EV-97 with failed port wing. Source: Swiss AAIB

In short, the Danish registered microlight aircraft failed to return to its departure airfield after a sightseeing flight. A search was initiated and the wreckage was eventually found. The accident has been attributed by the Swiss AAIB to a failure of the port mainplane, and it appears that the failure is a fairly straightforward overload failure (if there is such a thing as a straightforward failure!). Subsequent investigations showed that the aircraft's Maximum Operation Empty Mass for this machine should not exceed 210kg. (The Danish regulations consider this to be the Maximum Operational Empty Mass for two-seat microlights) which is a figure that would be impossible to achieve for an EV-97, the aircraft had a placarded empty mass of 285kg.

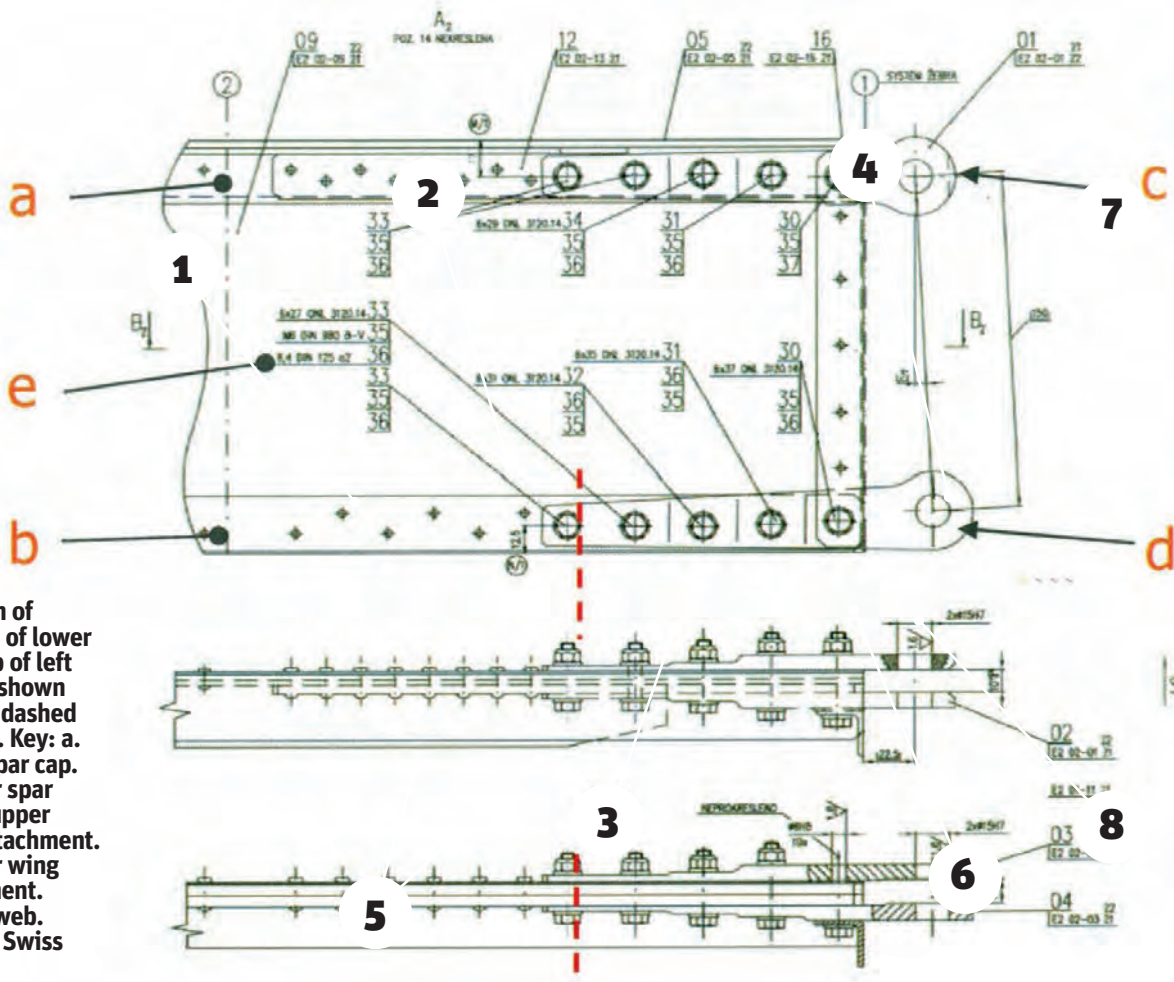
Location of fracture of lower spar cap of left wing is shown here by dashed red line. Key: a. upper spar cap. b. lower spar cap. c. upper wing attachment. d. lower wing attachment. e. spar web. Source: Swiss AAIB

Because the failure of the wing was easily identifiable it was possible to look closely at the construction and the materials used in the area of the failure and here is where things get interesting from an engineer's perspective. The testing of the constituents of the material used was AlCu4Mg1 and this relates to an aluminium alloy well understood by the aerospace industry, 2024. Nothing unusual about this. When this material was tested it was noticed that there was a huge spread of hardness values across the test pieces. This is unusual and, when the tensile strength was measured the test pieces were shown to be something over 25% down on expected values.

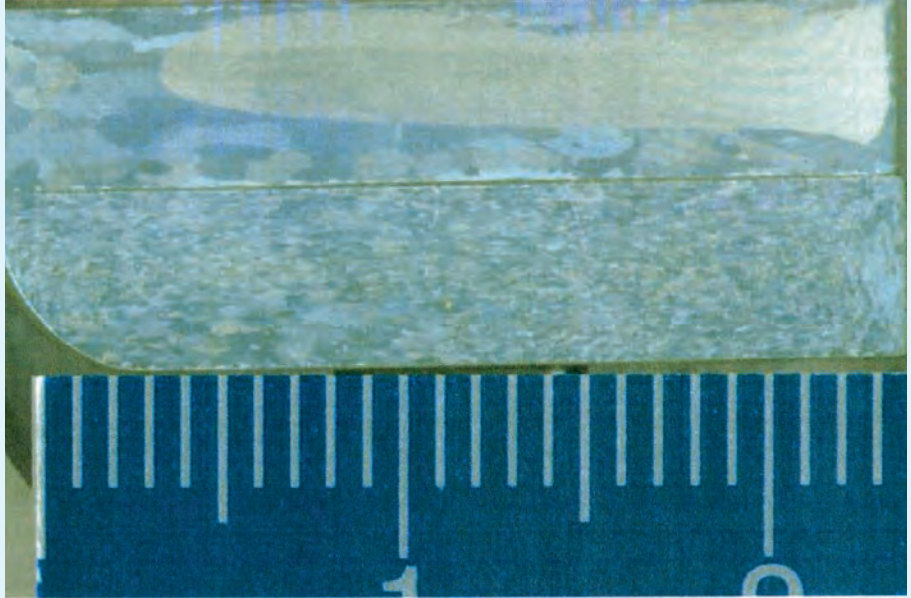
This is a picture of the lower spar cap of the left wing looking outwards (slightly magnified) showing considerable inhomogeneity within the materials matrix. Source: Swiss AAIB

It was found that the material exhibited some gross inhomogeneity at the microscopic level. There are a number of reasons why this may have occurred, some are mechanical, related directly to the extrusion process, and some may be directly connected to the heat treatment management process' during the manufacture of the originating billet or, possibly, post extrusion. Materials scientists are working to discover the full story behind this quality drop off. With regard to the mechanical problems that may have lead to the differences in grain structure the following may be relevant.

If you look at the microstructure at this point in the photograph from the Swiss report you can see a sort of intergranular tongue, which may show the transitional effects of this fusion. It has to be said here that this statement carries a huge health warning and, just because it looks like some kind of fusion process, it may represent nothing of the sort.

properties of a component which, as we have seen with other material problems over the years, must include its fatigue and corrosion properties. It would be normal practice to reject this transitional material, if that's what it is but in this case it looks like the mill producing the extrusion failed to do this and it slipped into the aircraft production chain. Naturally, investigations are taking place to establish the hows, whys and whats about this.

Meetings and discussions involving the CAA, Evekto, Cosmik, the BMAA and, naturally, the LAA are ongoing but it has been decided that, in order to address the possibility that aircraft are flying in the UK with reduced strength structural components, the Never Exceed Speed (Vne) and Manoeuvring speeds (Va) will be reduced. This will have the effect of reducing the flight envelope positive g limit from 4.0g to 3.0g which will restore the normal safety margins.

Evekto and Cosmik are working flat out to design a Non Destructive Test method to identify sub standard materials, should there be any, in the EV-97 fleet. Initially a Mandatory Permit Directive (MPD) will be raised by the CAA effecting the Operating Limit changes. When an appropriate (and acceptable) inspection mechanism becomes available the MPD will be amended to accommodate this. All in all though, this is not a very good Christmas present for EV-97 owners.
