# Who's in charge?

## Dyn Aero MCR-01: Corrosion update

## Ikarus C42: Throttle jamming

## Europa EFATO

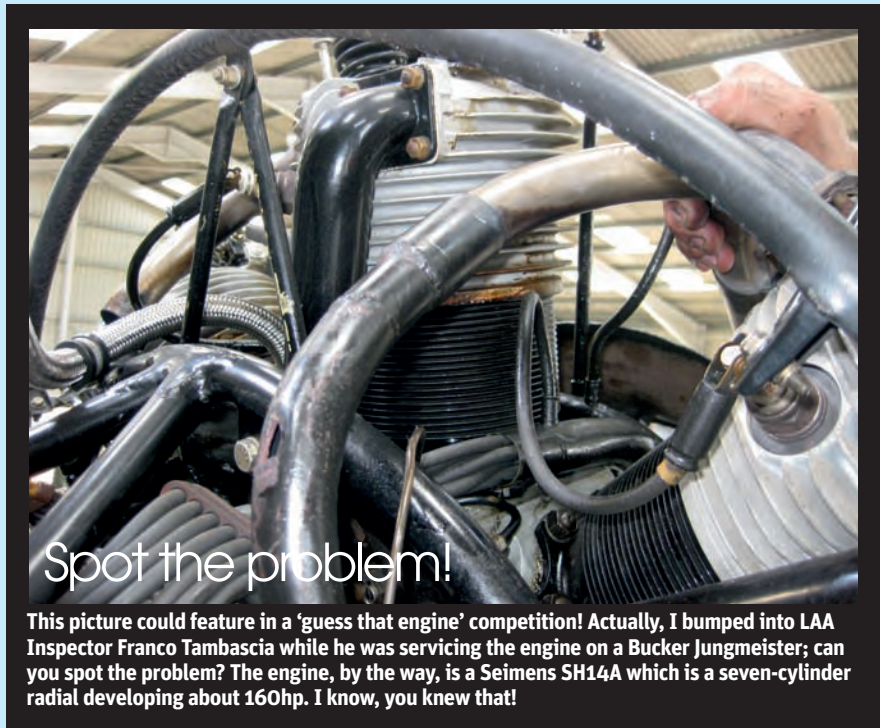
Spot the problem!

This picture could feature in a 'guess that engine' competition! Actually, I bumped into LAA Inspector Franco Tambascia while he was servicing the engine on a Bucker Jungmeister; can you spot the problem? The engine, by the way, is a Seimens SH14A which is a seven-cylinder radial developing about 160hp. I know, you knew that!

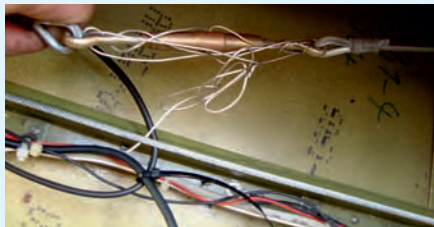
I am not sure that the guy who wirelocked this turnbuckle had quite got the idea.

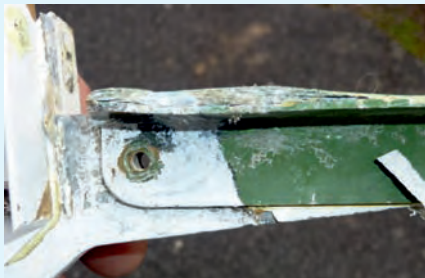
two examples of corrosion that should have never been allowed to get to this stage... where the bracket is essentially written off.

Notice the distinct line between corroded and non-corroded metal, due to weather exposure.

The featured pictures tell their own story and I will not labour the points made previously about the absolute need to completely inspect your aircraft frequently – get to know every corner of your machine and deal with any problems found immediately before they compromise structural integrity.

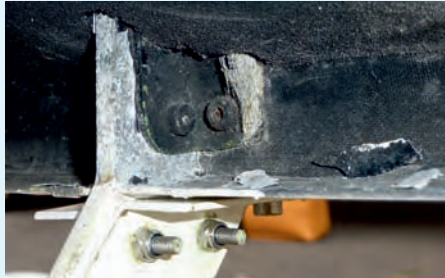
An example of exfoliation, which, when started, is very difficult to stop.

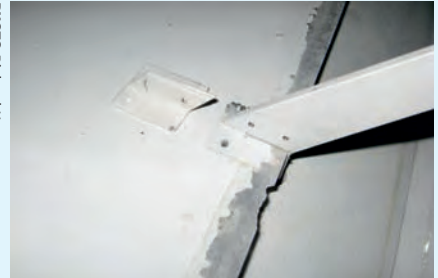
Water played a primary role in this corroded trailing edge, as the joint was covered by tape.

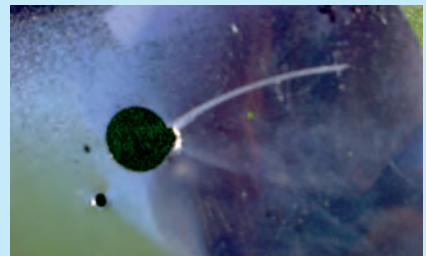
When they were safely back on the ground they had a look at the throttle mechanism to find out what might have gone wrong. It turned out that the head of a clevis pin had got stuck in a hole in the side panel which completely jammed the system. It's a straightforward oversight in design terms, easy to forgive as

the problem only occurs if the right-hand seat is occupied and the occupier inadvertently presses the panel in the wrong way.

Tell-tale scratch (and dent) left by the throttle cable attachment on an Ikarus C42 aircraft. The throttle is a primary aircraft control and a throttle jam could cause a serious accident.

Pioneer Aviation is about to issue a small modification which incorporates a spacer that prevents the side panel from impinging on the throttle mechanism. The throttle is a primary aircraft control and a failure here could have disastrous consequences; I certainly wouldn't have wanted this to happen to me with a 'fresh out of the packet' PPL and a nervous 'first timer' sat in the right-hand seat. For this reason, the LAA will be mandating this Service Bulletin by issuing an Airworthiness Information Leaflet.

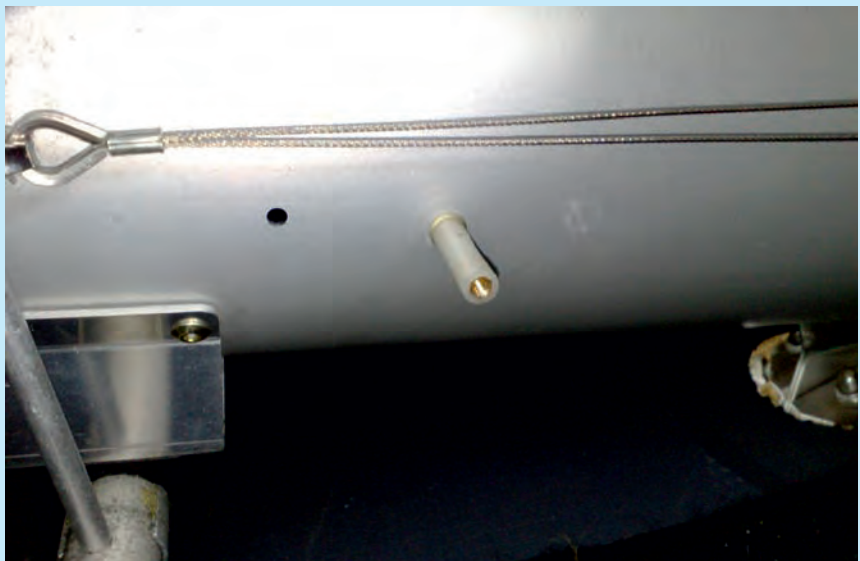
A simple mod devised to keep the side panel away from the throttle mechanism.

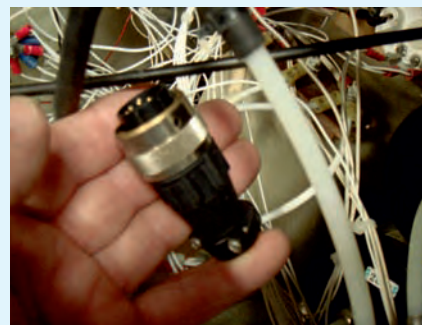
As is completely normal when I receive a field report like this I opened an Occurrence Report. The owner came back to us with his findings and, as you have probably guessed, he had disconnected the fuel pump's electrical connection so that he could remove the instrument module to enable the fitment of the new radio gear.

**Actual socket that came apart leaving LAA test pilot without an engine. We used to call this 'spaghetti' wiring when we were younger.**

of engine, as with so many others these days, no fuel pump, no run! I can almost hear your brain whirring, what about the other pump? Well, yes, you are absolutely right, because a positive fuel pressure is absolutely needed there must be two independent pumps producing it. For some reason the connector wasn't re-connected correctly when everything was re-assembled and this was missed during inspection; also missed, of course, was the fact that both fuel pump supplies went through the same connector block.

What has gone wrong is that there are shared components between the two systems and that independence has been compromised. Specifically, a single bulkhead connector plug carried current to the pump switches from both pumps. Disconnection or failure here will mean the failure of both pumps.

Aircraft designers are always trying to find ways to decrease the weight of their machines. Structure engineers are always looking for ways to share load paths and will always have one eye on redundancy. In this case an aircraft was very nearly lost for the sake of an extra ten pence connector, not very good economics really.
