SPREADING THE WORD

CASA 1-131E Series 1000 Jungmann - engine failure

Pulsar XP - fuel pump leak

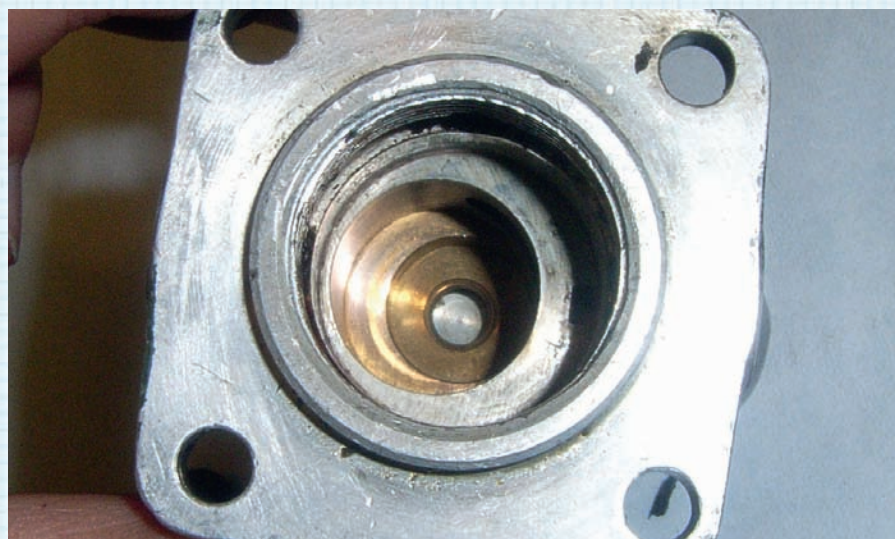
Just by looking at this housing it is not possible to see the wear that has inevitably accrued of the decades since it was manufactured. Manufacturing techniques employed half a century ago were very different to those available today and, consequently, this pump looks pretty simple to service. Don't be fooled, checking components like this often requires specialist knowledge and tooling; bench testing, a definite 'must do', invariably requires the use of a purpose built test rig.

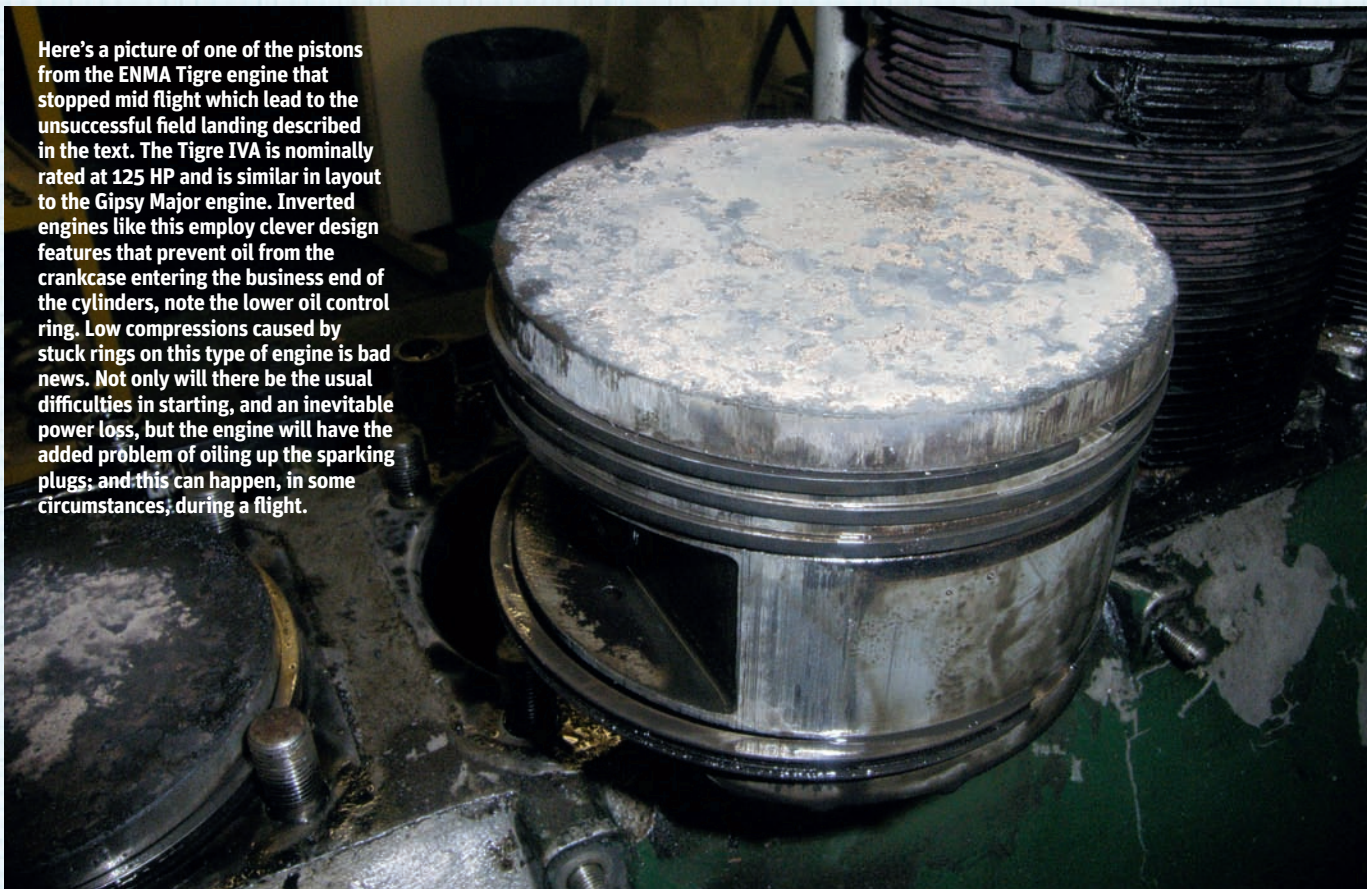
Here's a picture of one of the pistons from the ENMA Tigre engine that stopped mid flight which led to the unsuccessful field landing described in the text. The Tigre IVA is nominally rated at 125 HP and is similar in layout to the Gipsy Major engine. Inverted engines like this employ clever design features that prevent oil from the crankcase entering the business end of the cylinders, note the lower oil control ring. Low compressions caused by stuck rings on this type of engine is bad news. Not only will there be the usual difficulties in starting, and an inevitable power loss, but the engine will have the added problem of oiling up the sparking plugs; and this can happen, in some circumstances, during a flight.

The cylinder compressions were checked and were found to be low on cylinders 1, 3, and 4 and there was no, or at least almost no, compression on cylinder number 2. Further checks did not find any other faults except that the engine was "very oily" in the barrels. The

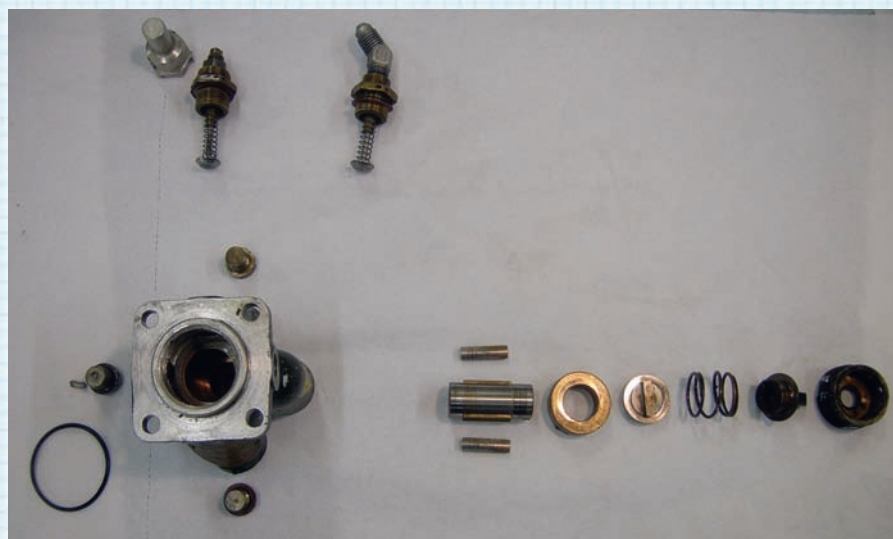
To return to the engine inspection. It will be noted by the reader that we have two separate problems here, the first being an unserviceable fuel pump and the second, a general low compression. During the engine strip inspection the fuel pump was removed from the engine. The pump's drive was intact and the pump rotated freely. When the pump was tested it was only able to produce 1.5 psi at full rpm, the book figure for this pump is 4.26 psi.

The pump, as you can see from the photo, is a fairly complicated device in its own right and requires specialist tools (and knowledge) to take apart. The fact that this pump produced a low pressure on the subsequent engine test, and the extent of the wear in the pump itself, points to the fact that this pump had been operating below par for some time.

You can see here how complicated this disassembled vane type fuel pump is. Vane pumps work by transferring the energy from the vane into the fuel, pressurising it. The method of operation is rather like a backwards water wheel, perhaps a paddle steamer would be a better analogy. Output pressure is regulated by an adjustable spring type relief valve. For these pumps to operate well they need to be in good condition.

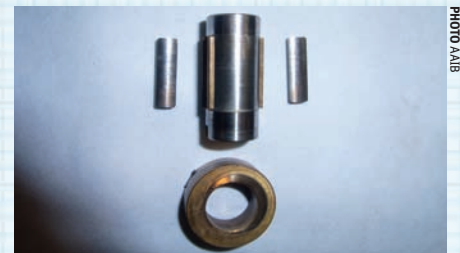
I also spoke to Mike's colleague at Vintech, another LAA'er of course, Paul Sharman. Paul has had a lot of experience with these vane type fuel pumps and explained that the problem of low pressure output can normally be traced to wear in the shaft's bushes and not the vanes themselves. This is because the vanes are normally well lubricated with fuel and the bronze bushings are less well served.

In this picture the shaft and bearing can clearly be seen. Normally the problem of a low output from a pump can be traced to wear or leakage due to wear. In the case of a 'vane type' pump the wear is not generally found where you would expect it, at the vane/cylinder interface. This is normally very well lubricated by the fuel, the problem, as in this case, is wear in the bearing which caused the vanes to run 'skew' in the cylinder. Turbulent flow is the result reducing pressure output.

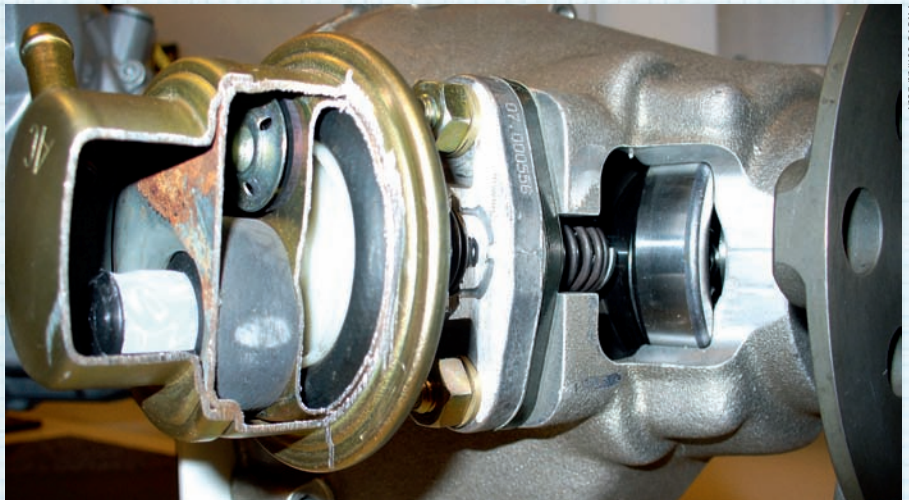
Later Rotax engines use an AC fuel pump but the 'workings' are essentially the same as the Pierburg featured in the text. This pump operates using the principle of positive displacement. A cam, on the gearbox output shaft forces a transfer shaft up through the body of the pump to the diaphragm which moves reducing the volume in the cylinder. A spring keeps the shaft pressed against the cam. There are two non return valves fitted, an inlet and an outlet. This sort of pump has proved very reliable but a leak in the diaphragm will stop it working completely as will the failure (perhaps through debris) of either valve. Wear in the cam/or shaft will reduce output and therefore delivery pressure. It's always a good idea to have a fuel pressure gauge, they are cheap and easy to install.

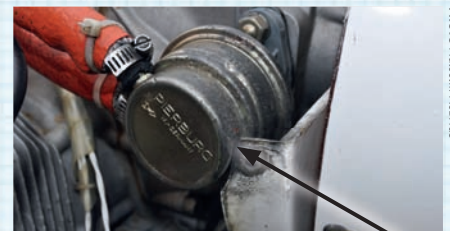
The enthusiastic chap, almost needless to say, was the Rotax aficionado, Conrad Beale. Well done to Conrad for spotting this fault which would have probably led to an in-flight event on David's flight home, perhaps an out field landing or a fire. The pictures tell their own story here so I won't go on about it except to say that it is often the case that the softer material will wear out the harder one. Here, the soft fibreglass wore straight through the steel casing of the fuel pump. I also ought to point out that Conrad was really

Here's a close up showing where the cowling was rubbing against the fuel pump. Often a soft material will wear straight through a hard material. This goes against the grain somehow. In this case of course the glass filaments in the glass fibre mat acted as a perfect abrasive.

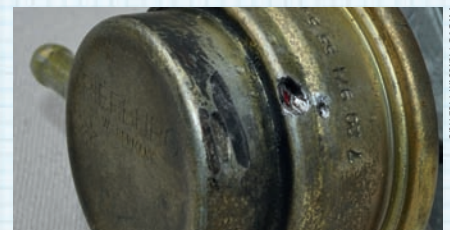
You can see the exposed diaphragm clearly in this picture. The pierced chamber is on the pressure side of the pump.

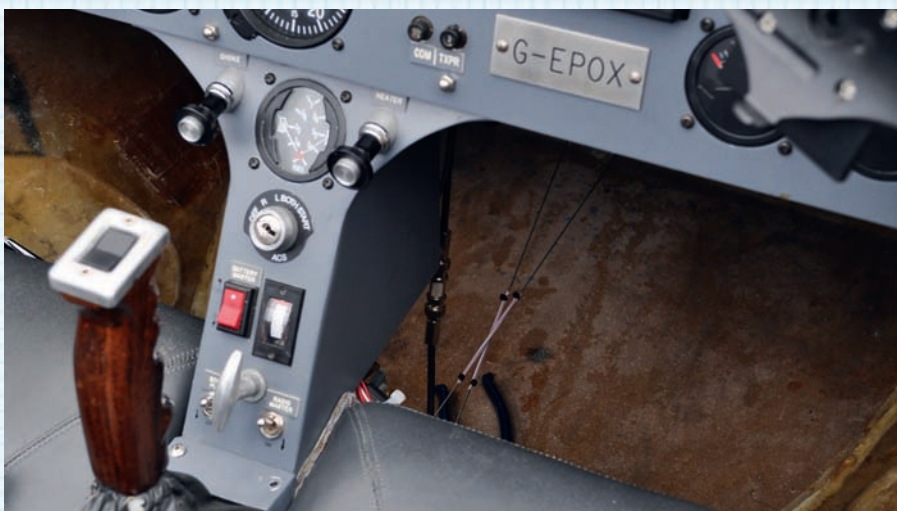
I asked Dave what he meant and he explained that the one built-in thing that everybody, or at least, nearly everybody missed was a pair of pliers lying on the floor by the central console. I took a quick picture and thought that it would be useful to remind Safety Spot readers about the dangers of leaving tools about!

Where's Wally? Can you see the offending tool? Most people didn't see it at the GASCo find a fault competition held during the Rally at Sywell.
