## GETTING GOING

## Van's RV6A: oil pipe failure

## EV-97: in-flight canopy failure

# Taylor Monoplane: cylinder head failure

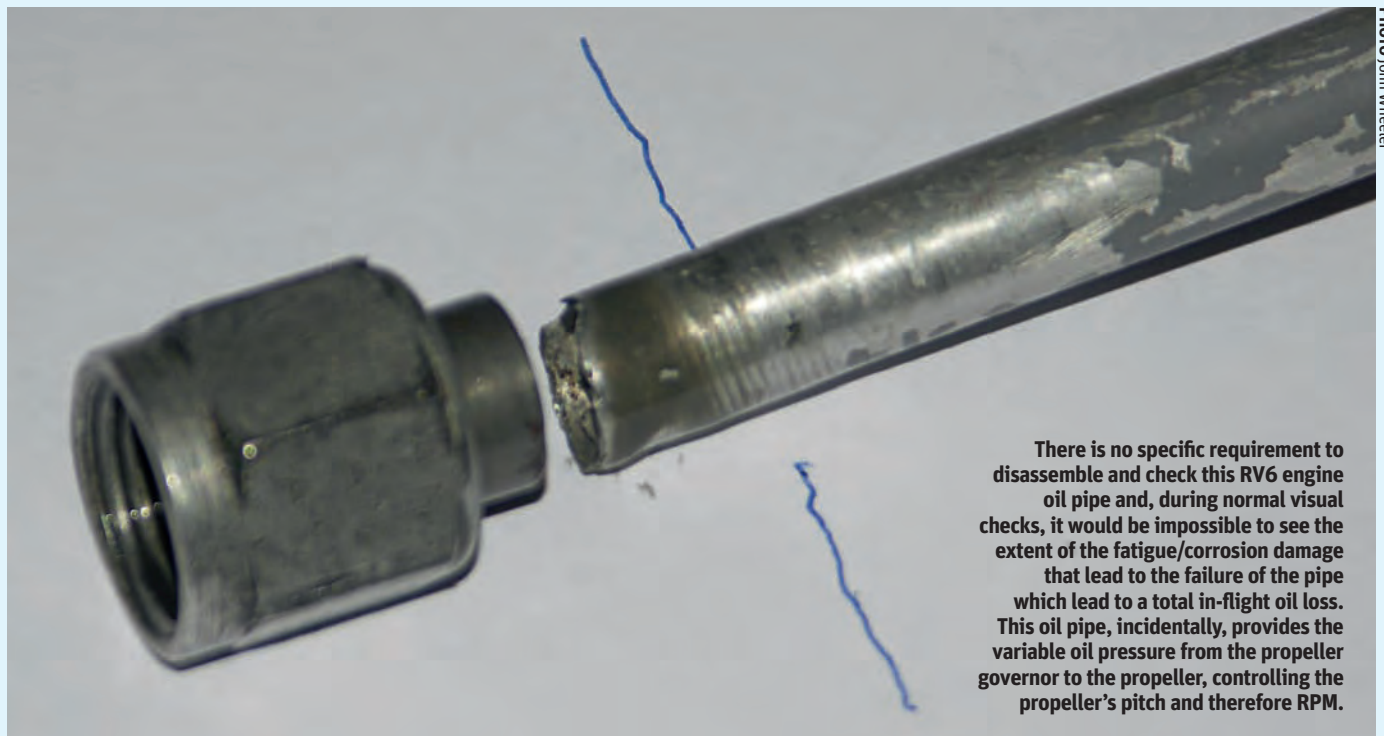
There is no specific requirement to disassemble and check this RV6 engine oil pipe and, during normal visual checks, it would be impossible to see the extent of the fatigue/corrosion damage that lead to the failure of the pipe which lead to a total in-flight oil loss. This oil pipe, incidentally, provides the variable oil pressure from the propeller governor to the propeller, controlling the propeller's pitch and therefore RPM.

control line from the prop governor had fractured immediately outboard of the fitting thus resulting in the loss of pressure to the prop and the sudden increase in rpm. This would account also for the total loss of engine oil."

This looks to me like a fatigue failure. The pipe is made of some kind of alloy, not sure what, and it's probably pretty old. The end fitting is a compression type and therefore the material is running at quite a high pre-stress and, fitted directly to the engine, will be in an area of vibration and subjected to continual changes in temperature.

In other words, even though the actual loadings taken by the pipe, generated principally by the oil pressure, are quite low, the material that makes up the pipe would be working quite hard. I think that I would be tempted to take these 'permanent' pipes to bits now and again to take a close look at the area around the flare. John did well to get the aircraft down in one piece after loosing all his oil, but things could have ended up very differently.

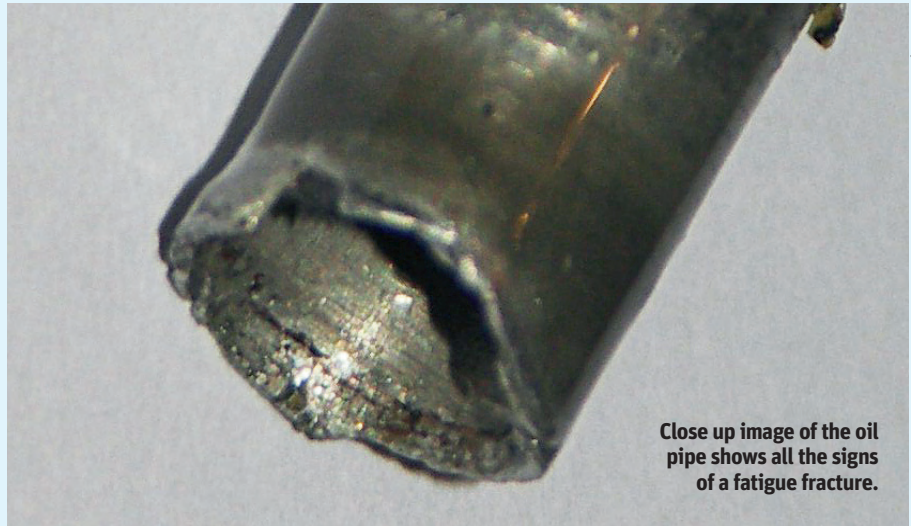
Close up image of the oil pipe shows all the signs of a fatigue fracture.

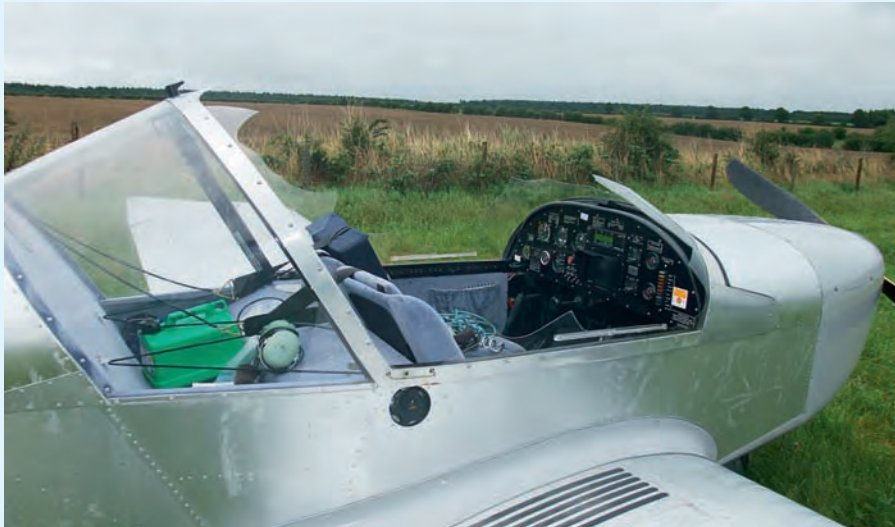
After consideration though, no evidence of meteorites were found and it looks like an unfortunate bird hit the canopy which shattered. In the general turbulence created when the canopy disintegrated, a tie-down, you know the sort of thing, a metal screw coupled to a short length of rope, flew out the cockpit but remained attached by the rope (temporarily) to the aircraft. This would (well, may) be the cause of the damage to the wing skins. I spoke to the AAIB about the incident and they confirmed that there was no evidence, or remains of, a bird. I wanted to take a look but the wing skins mysterious vanished... was it the men from the Ministry?

What could it have been that broke this EV-97 Canopy? Speculation continues as to the cause – and aliens haven't been completely ruled out.

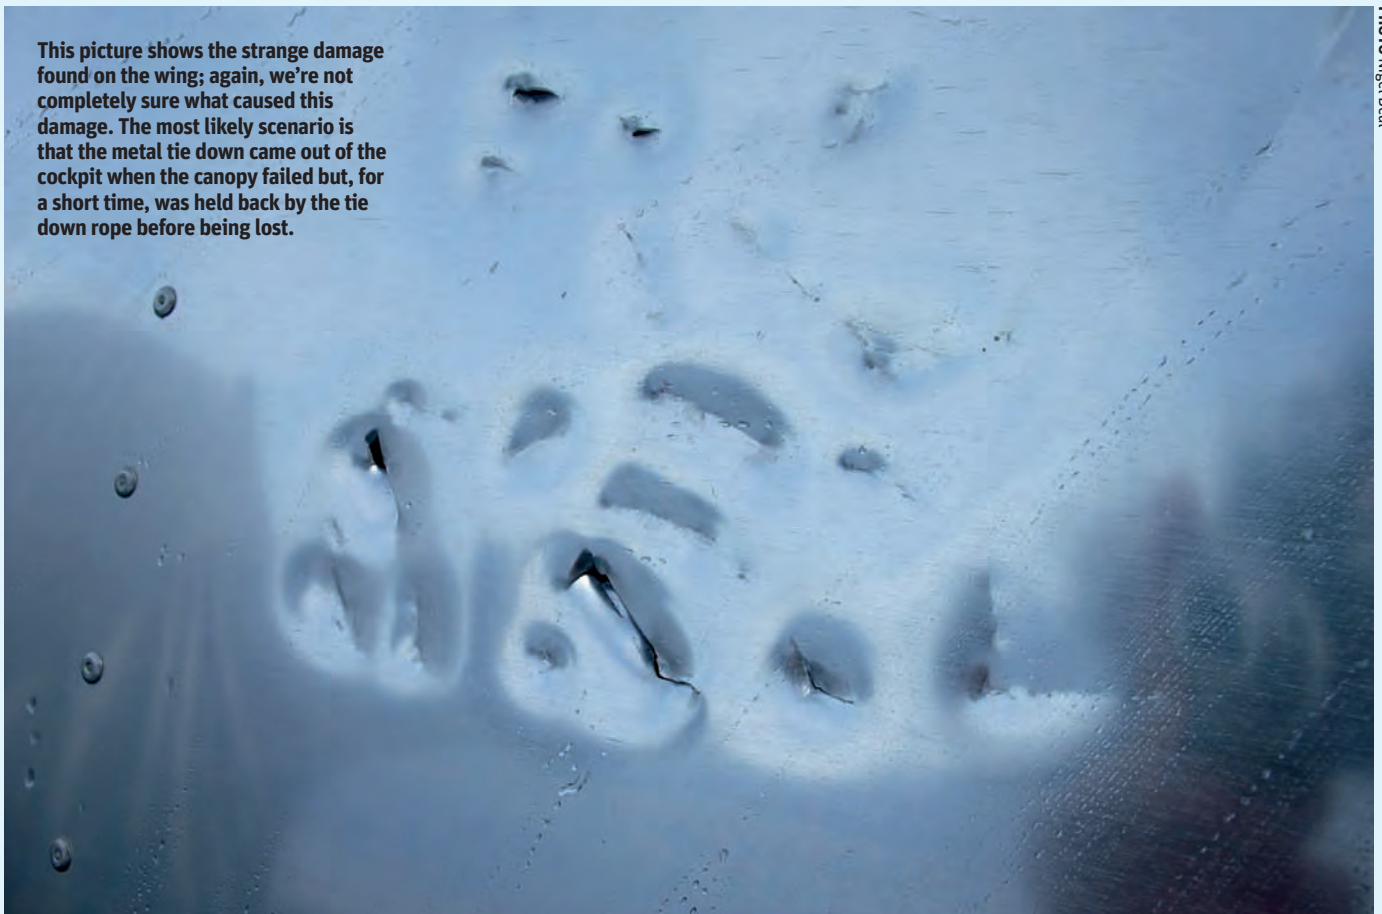
This picture shows the strange damage found on the wing; again, we're not completely sure what caused this damage. The most likely scenario is that the metal tie down came out of the cockpit when the canopy failed but, for a short time, was held back by the tie down rope before being lost.

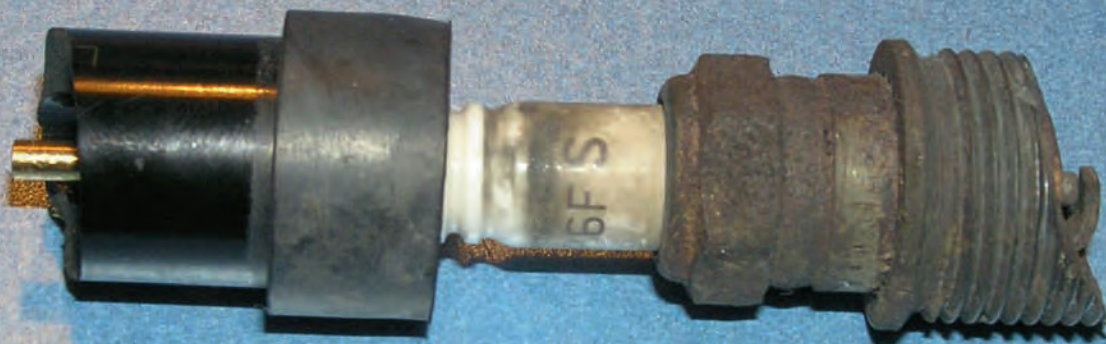
This is the plug that decided to leave the cylinder head on a 1600 VW fitted to Jeff's Taylor Monoplane. The full history of this unapproved modification was discovered only after some extensive detective work. All work done to an aircraft should be reported in the log books.

lower spark plug from number two cylinder had departed the engine. The plug, still attached to its steel insert, was found some distance from the aircraft. Bearing in mind that the engine, including its cylinder heads, was alleged to be new, I was very surprised to see the condition of the plug and that a steel insert had been used in an aluminium alloy head with no apparent means of mechanically locking the two together.”

You can see from the accompanying photographs what has happened. For some reason, a steel sleeve was manufactured to accept the extra spark plugs required for

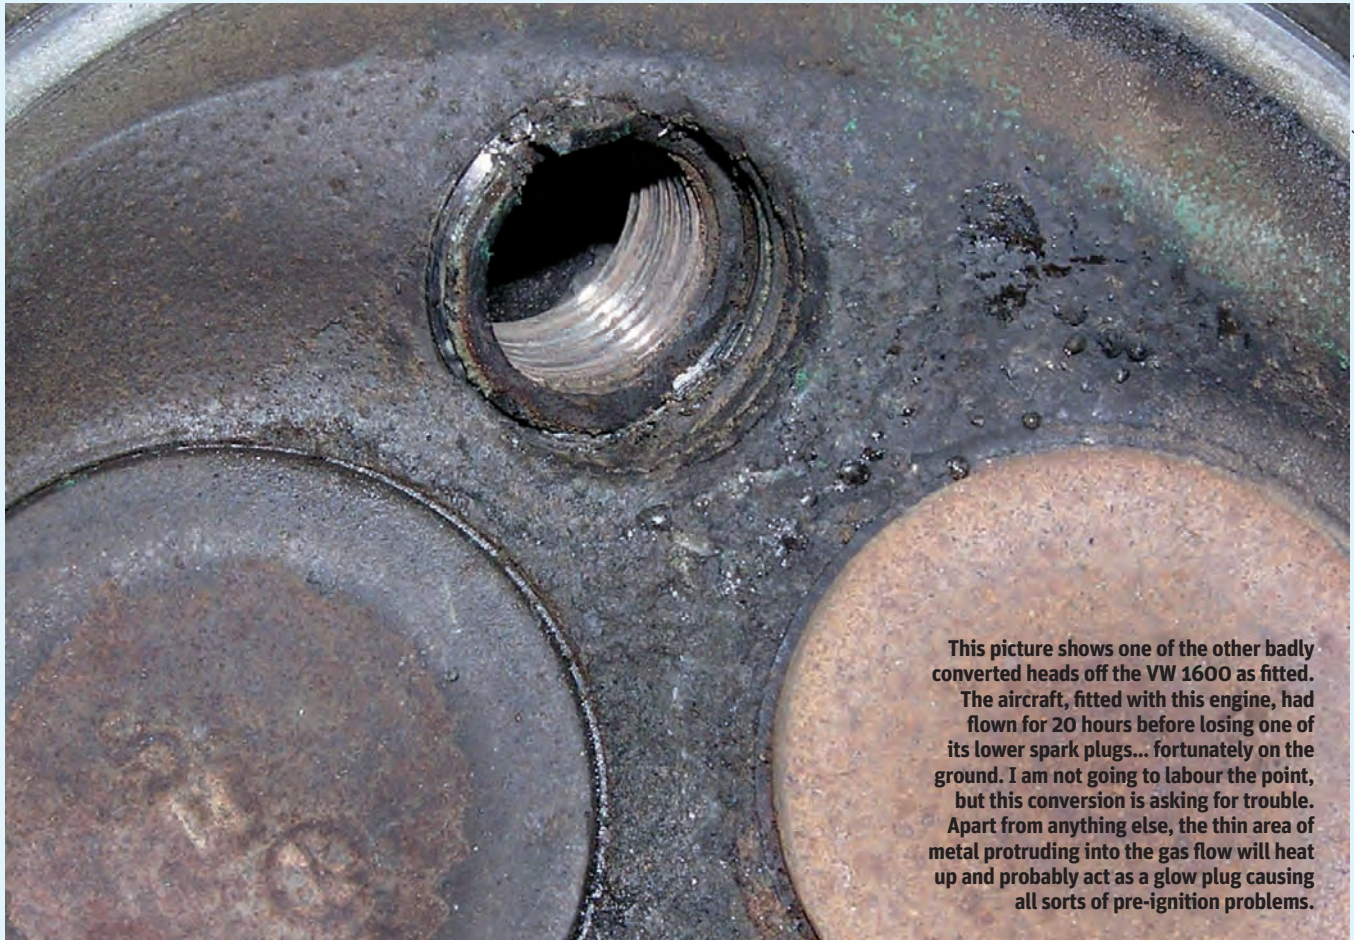
This picture shows one of the other badly converted heads off the VW 1600 as fitted. The aircraft, fitted with this engine, had flown for 20 hours before losing one of its lower spark plugs... fortunately on the ground. I am not going to labour the point, but this conversion is asking for trouble. Apart from anything else, the thin area of metal protruding into the gas flow will heat up and probably act as a glow plug causing all sorts of pre-ignition problems.
