LAA/AWA/13/07  
11<sup>th</sup> October 2013

## Rotax 912 and 914 (Series) Engines Checking of the Crankshaft Journal

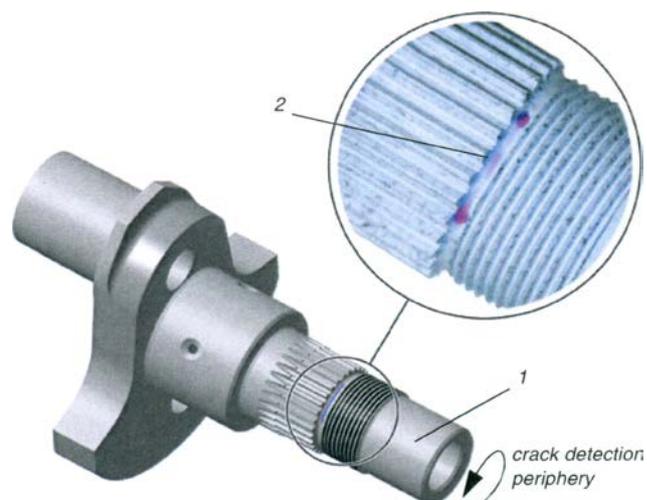
Fig. 1. Crankshaft Journal  
Rotax Aircraft Engines.

Fig. 1 (opposite) shows a sketch of the area of concern, item 1 shows the crankshaft journal itself, this bearing face sits securely in the gearbox housing. Item 2 shows a small crack in the radius between the splined power take off and the journal. It can be seen that drive to the propeller would not be lost if this crack progressed to a complete failure of the shaft as the gear is driven through the parallel spines although, naturally, some radial support would be lost in the crankshaft assembly should separation occur. Rotax engineers have determined that, in the event of complete failure, engine operational reliability is assured until the next maintenance check.
