LAA/AWA/13/08
5th November 2013

All Jabiru Series Aircraft

Main Undercarriage Bolts Inspection/Replacement/Mandatory Life

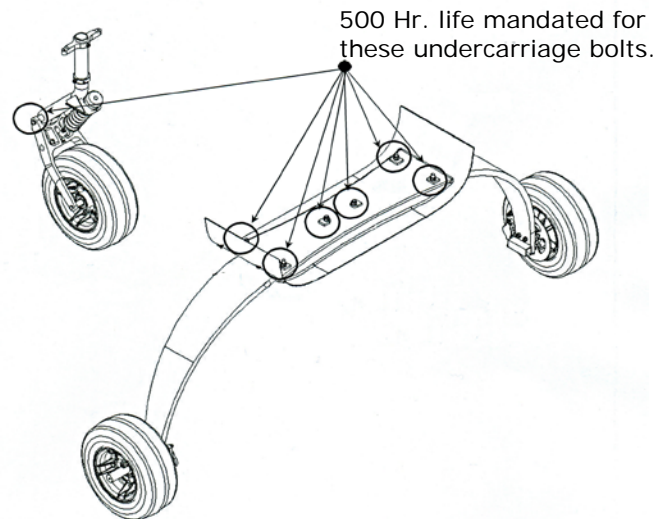
Fig. 1. General arrangement of the Jabiru Undercarriage

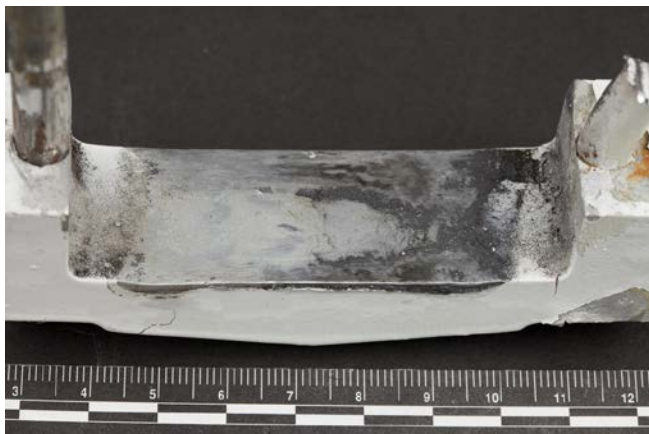
Fig. 2. Evidence of fretting due to loose U/C bolts

It has been found that the main undercarriage bolts on all Jabiru aircraft are prone to loosening; Operators must regularly check main undercarriage legs in service; this can be achieved by getting an assistant to lift the appropriate wing-tip and check that there is no fore/aft. movement in the leg.

LAA Engineering has recently issued an Airworthiness Information Leaflet (AIL) extending, to all Jabiru types, the requirement to replace any remaining 5/16" (AN5) main undercarriage attachment bolts with 3/8" (AN6) bolts and mandates a 500 hr. life for these bolts as per JSB 025-2 (7th May 2009).
