LAA/AWA/14/02  
3<sup>rd</sup> February 2014

## All Vans RV-6/6A, 7/7A, 8/8A Aircraft Operating under an LAA Permit to Fly

### Inspection for Cracks in Tailplane.

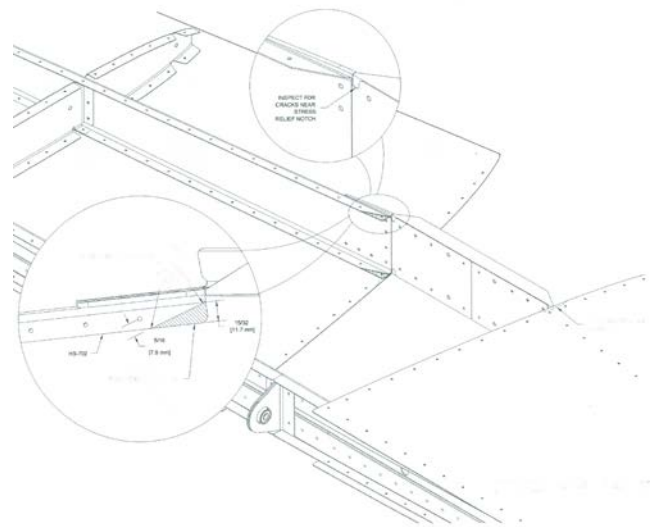
Fig 1. Sketch showing general inspection area.

This SB achieves two primary objectives; the first being an inspection of the tailplane structure. At the time of writing, LAA Highly Recommends that this inspection is carried out before next flight and, if a crack is found, the aircraft not flown and LAA Engineering is informed as soon as practically possible.

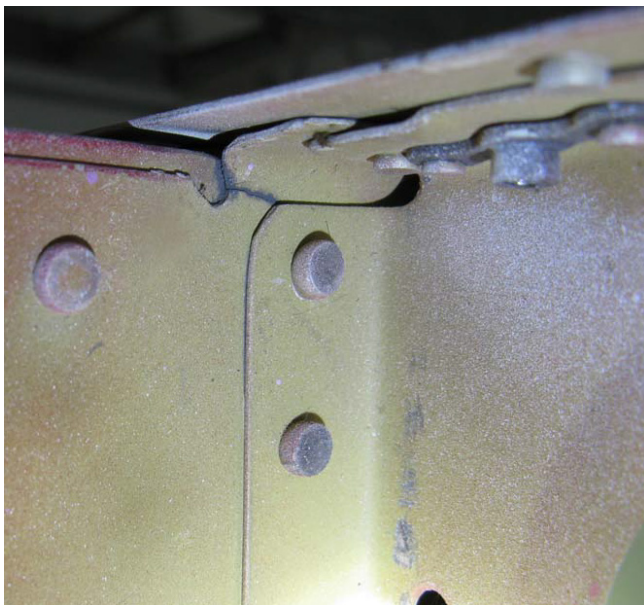
Cracks have been found in the forward spar of the tailplane emanating from the stress relief notch at the inboard end of the spar flanges.

Fig 2. Picture of crack in Forward Spar.

The second aim is to provide strengthening to this area; this is done by adding a number of doubler plates to the spar/rib attachment. This design change is currently under investigation and should not be installed until it has been authorised by LAA Engineering.
