All Vans RV-3, 4, 6/6A, 7/7A, 8/8A Aircraft Operating under an LAA Permit to Fly

Inspection for Cracks in Elevator Fwd. Spar.

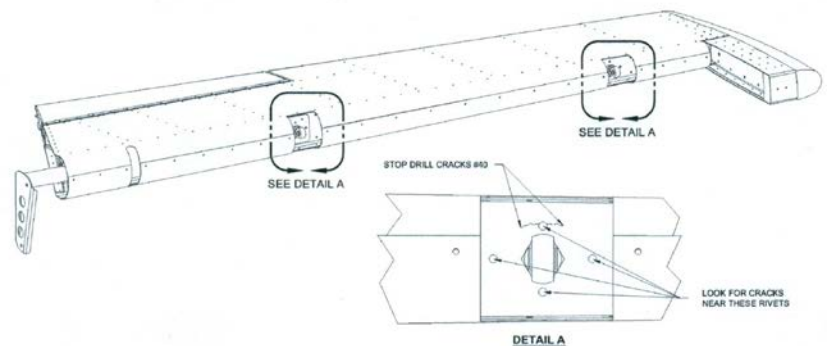
LAA Engineering have recently received notification that Vans Aircraft have published a Service Bulletin (SB 14-02-05) requiring 'before next flight' inspections of the elevators for cracking in the forward spar. Cracks have been reported in the elevator spar web near the elevator attachment points.

Fig 1. Vans Elevator showing area of concern

This SB aims to achieve two primary objectives; the first being an inspection of the elevator forward spar in the area of the elevator's attachment. The LAA Highly Recommends that this check is carried out before next flight and, if a crack is found, the aircraft not flown and LAA Engineering is informed as soon as practically possible.

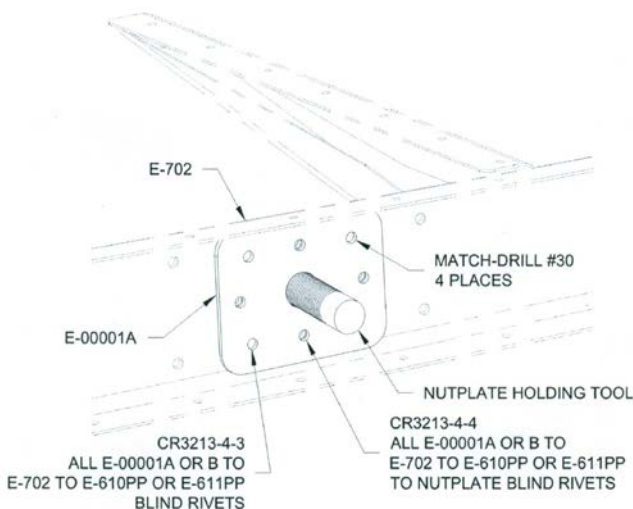
Fig 2. Doubler plate shown before riveting
(Note: Nutplate Holding tool is manufactured using a 3/8 x 24 Cap Head Bolt/Screw.)

The second aim is to provide strengthening to this area; this has been done by adding a doubler plate to the area surrounding the attachment fitting. This design change is currently under investigation and should not be installed until it has been authorised by LAA Engineering.
