SAFETY SPOT

Malcolm McBride
Airworthiness Engineer

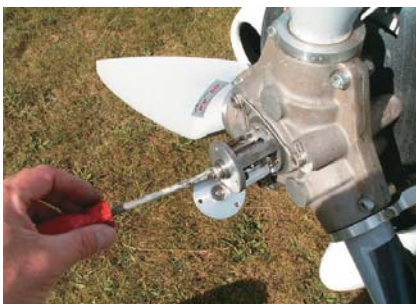
The location of the Leadscrew in the propeller hub

Let us cut to the chase with this, the reason for the propeller failure was that the lead screw that acts like a worm gear and drives the propeller pitch change mechanism failed. It failed through lack of lubrication. The reason why the propeller went to super fine pitch is that stops in the system (the fine pitch stops) were incorrectly set. Either one of these things on their own could

have caused an incident; both together, an accident. The reason that both these things were wrong is that propeller maintenance had not been carried out to the manufacturer's instructions. I wonder if this constitutes a shot in the foot as really this is only one thing!

The screw must be removed for cleaning, inspection and lubrication every 50 hours.

The propeller type in question is the Arplast PV50 and the LAA Engineering department is working with Jerry Davies of Lyndhurst Touchdown Services on a fix so the above situation cannot happen again. With regard to the Lack of lubrication, the LAA has produced an Airworthiness Information Leaflet which highlights the service intervals for the propeller. In effect the lead screw in this mechanism needs to be removed each 50 Hrs, cleaned, inspected and lubricated. Full instructions for doing this are available from Jerry. With regard to the lack of the fine pitch stop there is a fix available for this, also available from Jerry. Because both the inspection/lubrication and fine pitch stop setting requires the propeller mechanism to be disassembled there will need to be some inspector involvement and a Permit Maintenance Release will need to be signed before flight.

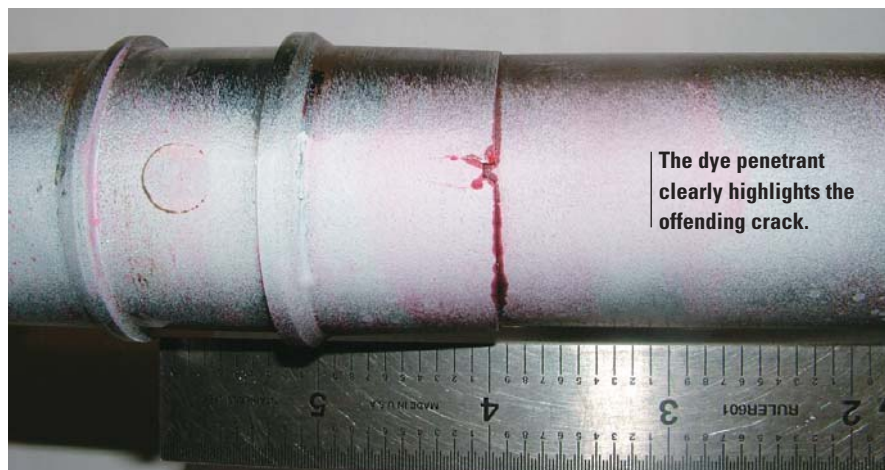
The dye penetrant clearly highlights the offending crack.
