ALL OF A FLUTTER

The latest in the ongoing saga of the Zenair wing flutter problems, and also the underlying problems of two failed undercarriages

Extra EA230 – undercarriage failure

Glasair 1RG – undercarriage failure

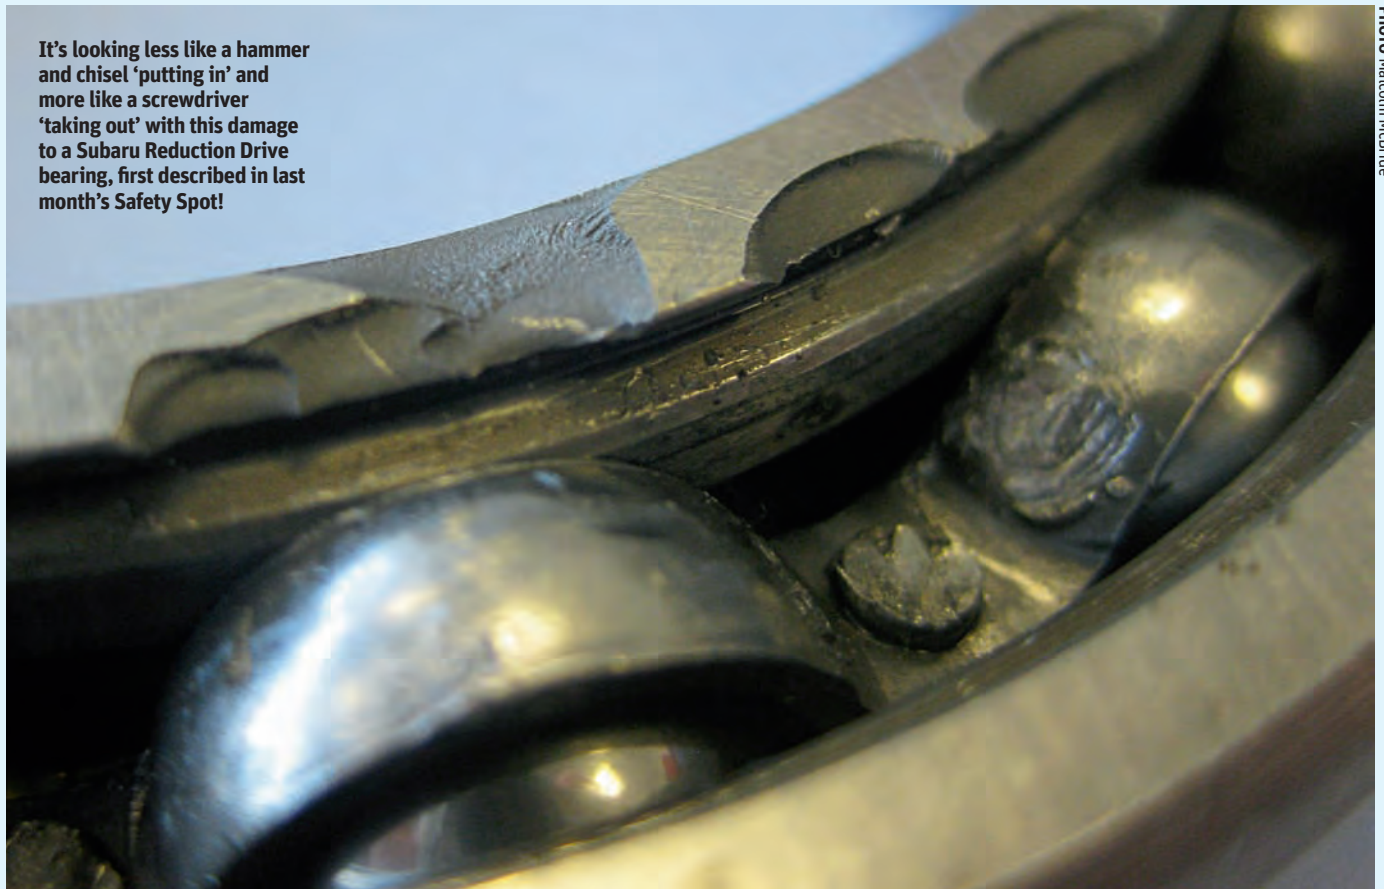
bearing face was the result of ungentlemanly behaviour, possibly with a hammer and a cold chisel. I have been assured that this was not the case by the builder of the machine, the surface damage to the bearing having been caused during the extraction process after the failure. I popped up to the LAA's Black Museum and took another look at the actual bearing; I can see how this damage would be caused trying to get the thing out. So, apologies to all concerned, I should have been more thorough with my checking process.

Speaking of checking; this particular Pietenpol is (from one or two accounts) a brilliant example and beautifully made, so I can understand why the builder took exception to my rather rude inference. What was the reason for the bearing failure? Well, we'll have to assume that lack of lubrication due to the fact that the bearing had been put in back to front. The installation manual is being updated by the technical chaps from the Pietenpol Owner's Club to stop this happening again.

It's looking less like a hammer and chisel 'putting in' and more like a screwdriver 'taking out' with this damage to a Subaru Reduction Drive bearing, first described in last month's Safety Spot!

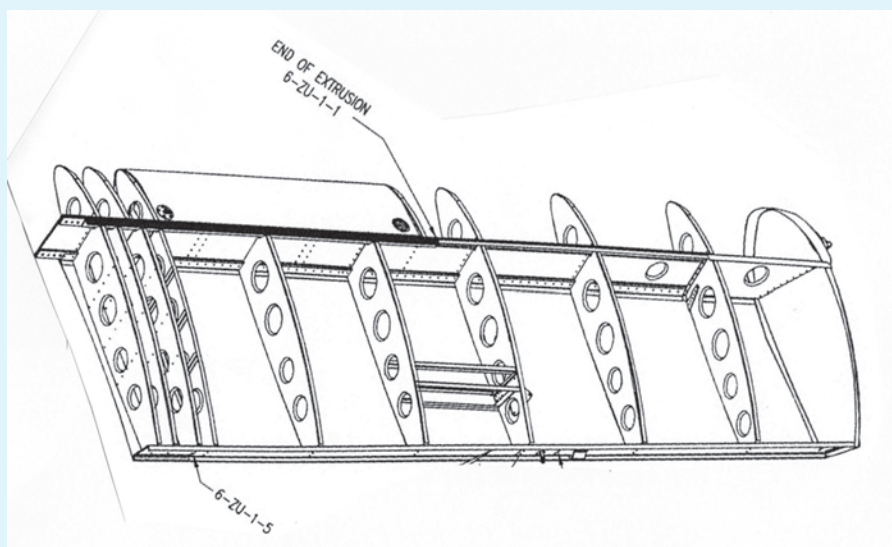
You can imagine my reaction when, after returning to work after a pleasant weekend, I was confronted with a Safety Alert/Directive requiring substantial modifications to CH601XL aircraft issued by the Zenair manufacturers AMD. Such is the worldwide nature of the sport aeroplane business. We weren't involved in the creation of this Directive which, at first sight, looked as if it would ground the UK fleet again.

Naturally, we're looking closely at the AMD modifications to see whether they actually improve the aircraft, but right now LAA machines must not be fitted with these modifications; they've not been approved. We're a bit worried about AMD's reasons for issuing this modification package so suddenly, and without consultation, but AMD's boss, Mathew Heintz, has assured us the test figures given to the LAA for UK certification purposes in the past (and recently) are 100% correct.

The modification diagram by AMD showing the additional modifications to kerb the flutter problem

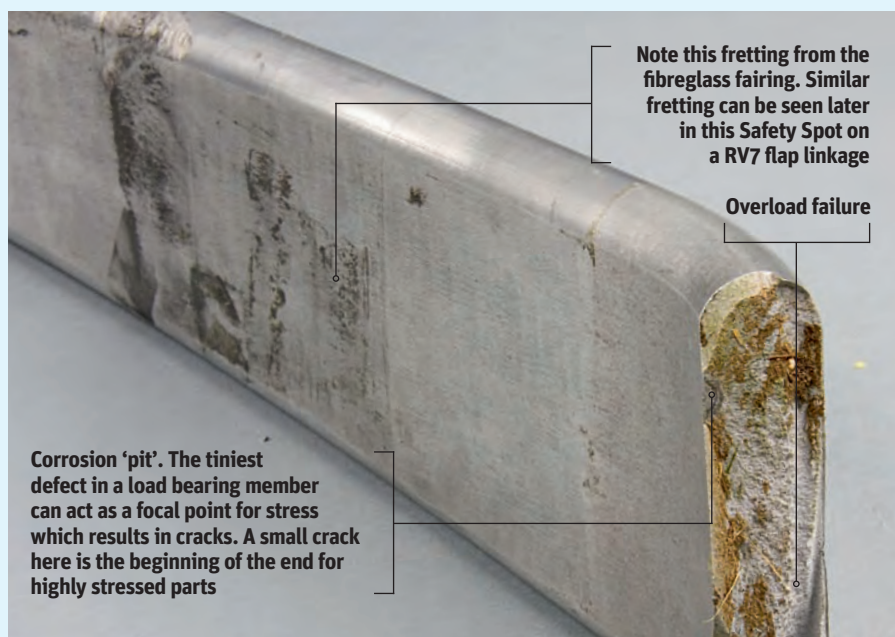
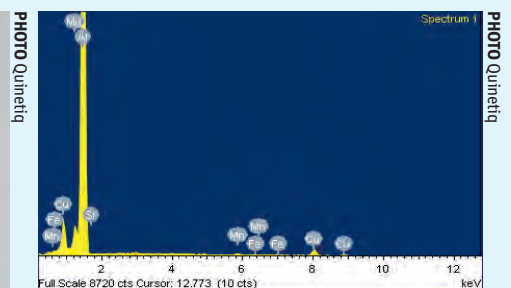
Using the technique of Energy Dispersive X-ray (EDX) analysis it is possible to work backwards and find out what material was used in the undercarriage's construction (it's one of the add-ons often fitted to electron microscopes). EDX works by energising atoms in the material being analysed and recording their energy response. Each element has a different response. By some clever maths the constituent of the material are revealed. In this example, the three biggies are aluminium (Al) which is off the scale, copper (Cu) a transition metal, magnesium (Mg) an alkali earth metal and another transition metal, manganese (Mn). It's the copper in this material that makes it very susceptible to corrosion cracking. This material, by the way, is 2024 aluminium alloy. Credit: Courtesy of Qinetiq.

This picture shows the broken undercarriage leg. I've marked the tiny corrosion pit that was the origin of the crack. As the crack grew the area of material left to resist the stress reduced increasing local stresses. This led to an eventual overload failure.

To cut straight to the chase as they say, this failure was the result of a fatigue crack which originated at a small corrosion pit on the inner surface of the bend radius at the top of the leg. It was virtually impossible to inspect this area during a normal pre-flight inspection. In fact to be inspected fully the undercarriage would need to be removed from the airframe. Close inspection of the other side (port side) showed evidence of a crack forming in, more or less, the same place. This is a really good example of the effects of fatigue on a system – the port and starboard legs were failing at the same time. A bit like my shoes incidentally, last week they both started to leak water on the same day – incredible!

This sort of failure – gradual, inevitable, but difficult to inspect against – could have been prevented if the leg had been removed and inspected from time to time. It demonstrates the need for pilots operating on a Permit to Fly to create and manage a sensible inspection programme tailored to suit the

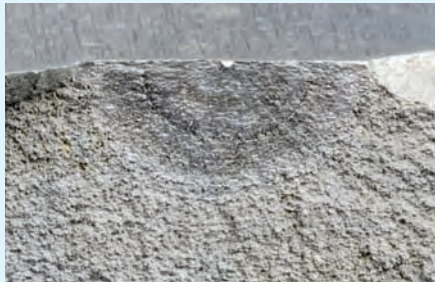
Closer look at the corrosion pit that wrecked the propeller of the Extra 230. The growth rings can clearly be seen in this optical picture.

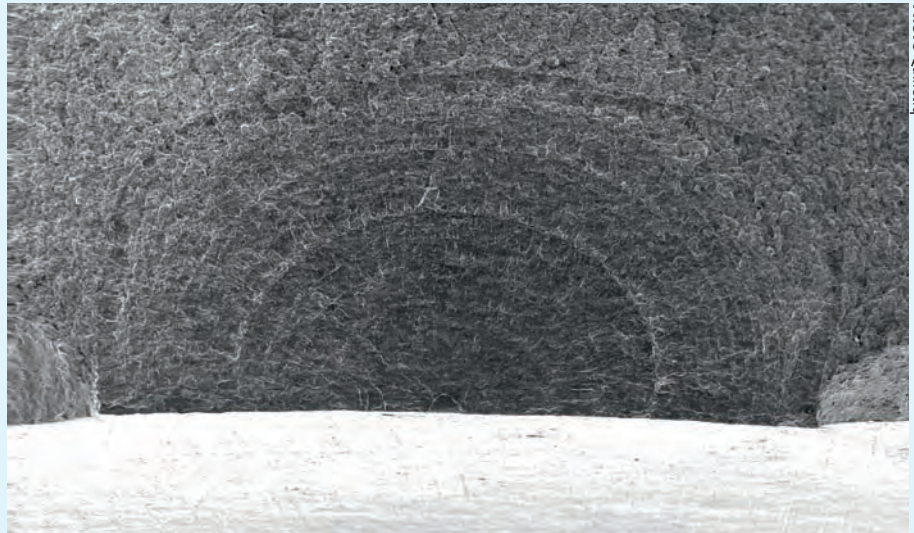
An electron microscope picture reveals the growth rings emanating from the corrosion pit. Corrosion pitting is dangerous because it is very difficult to spot. The high copper content of 2024, a common alloy used in aircraft manufacture, means the material is electrically quite active; it is postulated that corrosion pits are often caused by local cathodic sites in an otherwise normal surface.

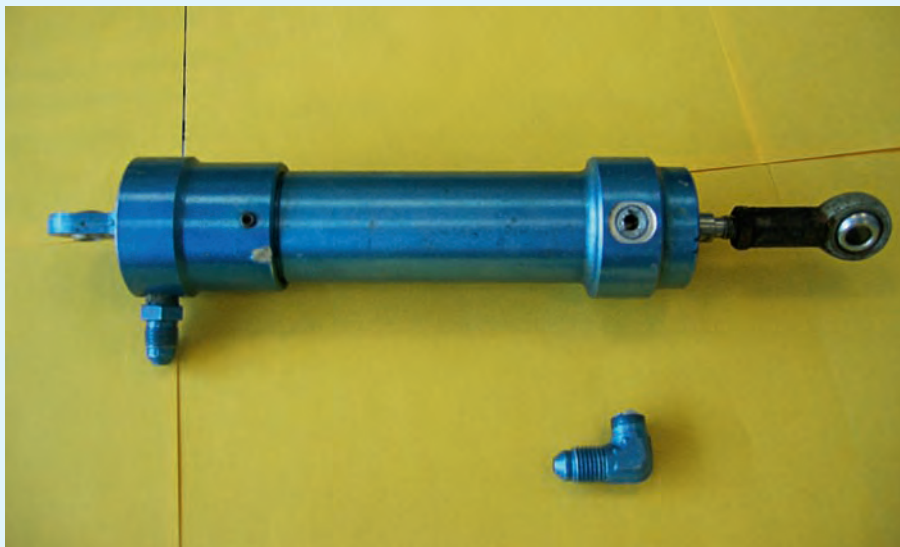
This hydraulic failed during the event. It couldn't have failed completely at the point of impact because it's on the up side of the jack and the pilot wouldn't have been able to raise the gear on this side.

It is very probable that this impact also weakened or partially fractured the AN fitting supplying hydraulic fluid to the 'up' side of the starboard undercarriage jack, initializing a failure sequence in this component, beginning with a small leak and ending in complete separation. It is likely that the bent undercarriage jammed fairly solidly into the wheel bay after retraction and, once the hydraulic fluid had been pumped out of the system as the motor ran, desperately trying to re-establish 'up' pressure, the stage was set. If you are really following this story then you should be wondering why the nose wheel didn't come down after system pressure was lost. Well, it was found that the gas pressure in this strut was too low to oppose the aerodynamic force generated by the leg itself.

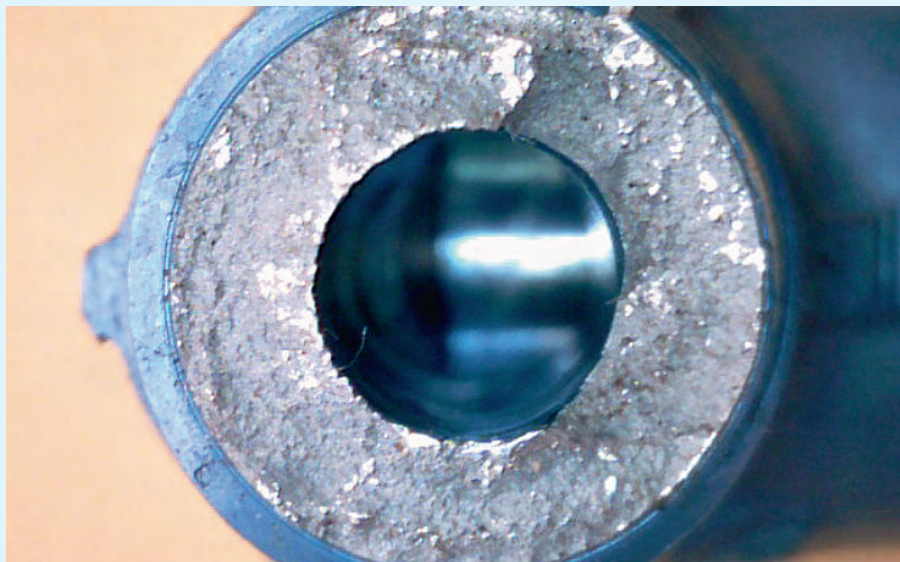
There's no evidence of a sequential failure in this close-up of the failed AN hydraulic fitting. A tapered thread is usually found on this type of fitting. It is easy to over stress whilst assembling the pipework.

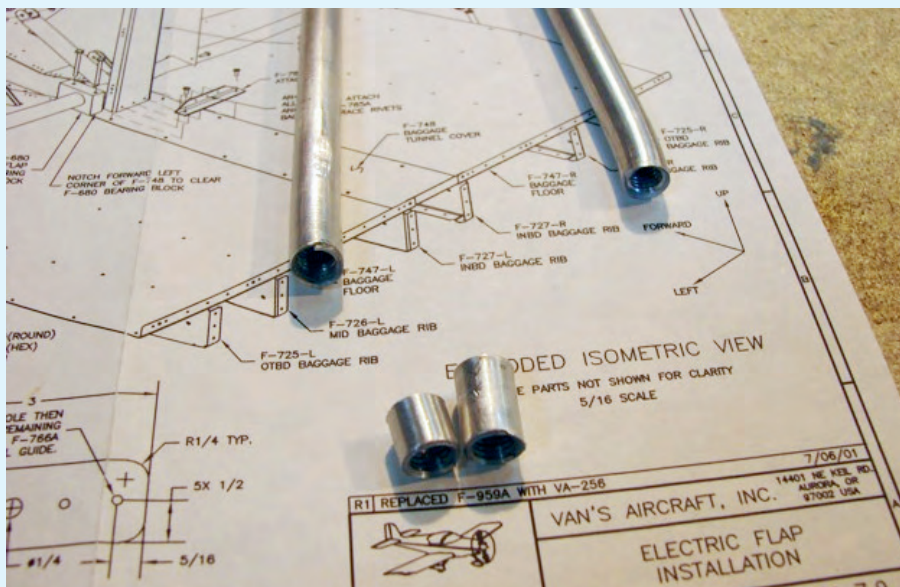
It's true that the failure of the tie-wrap probably overloaded this flap linkage and this is probably a fairly one-off event. I've not had other reports of flap linkage failure occurring to UK owners, although this has happened before in the US. Note the witness marks on the pictures. When Steve reassembled the flap drive he noted the hole in the fuselage was not big enough to afford proper clearance between the link and the fuselage - in the US this same lack of clearance may have contributed to a flap drive failure that ended up in a totalled RV6 back in 2001. Manuel checked his aircraft and found a similar situation. Remember, if a component is being placed regularly under a stress that it's not designed to take, it's almost bound to fail eventually. Now, where's that Saxophone? Oh, and where are my manners... Have a great Christmas!

The result of this double flap drive rod failure. In the workshop the flaps 'free fell' beyond their normal range and failed at the top of the internal threaded portion. Subsequent investigations revealed the cut-out made to accommodate the flap drive was not big enough, the chafing can clearly be seen.

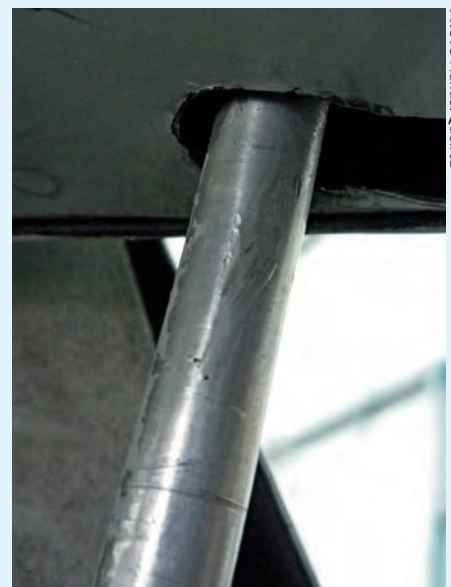
Manuel Queiroz found the clearance between the flap drive rod and the airframe was far too small and that his flap drive rod had been chafing.
