## Mystery of the Tippy sunglasses

# Spark plug failure

# Investigating on-going power loss

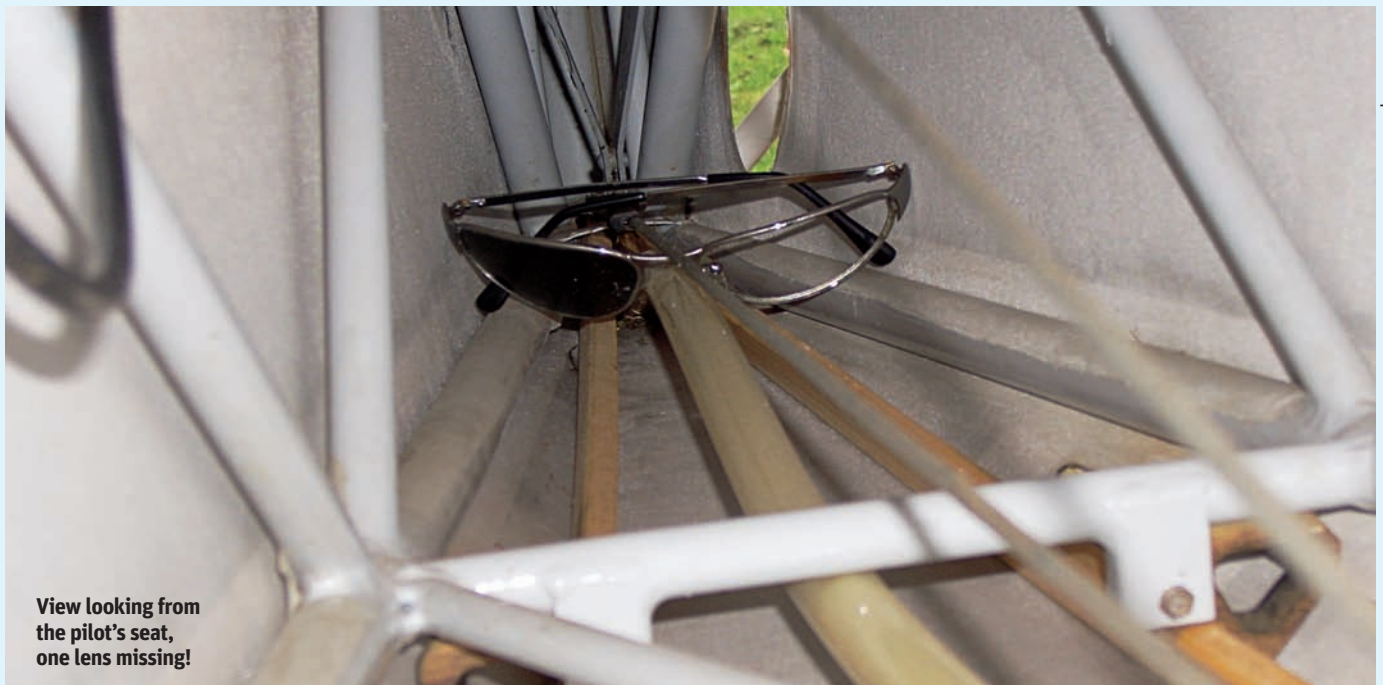
Neil's glasses were found balancing, like an acrobat, on an elevator control cable dangerously close to the elevator's 'mechanics'. Good spot Neil and thanks for sharing.

View looking from the pilot's seat, one lens missing!

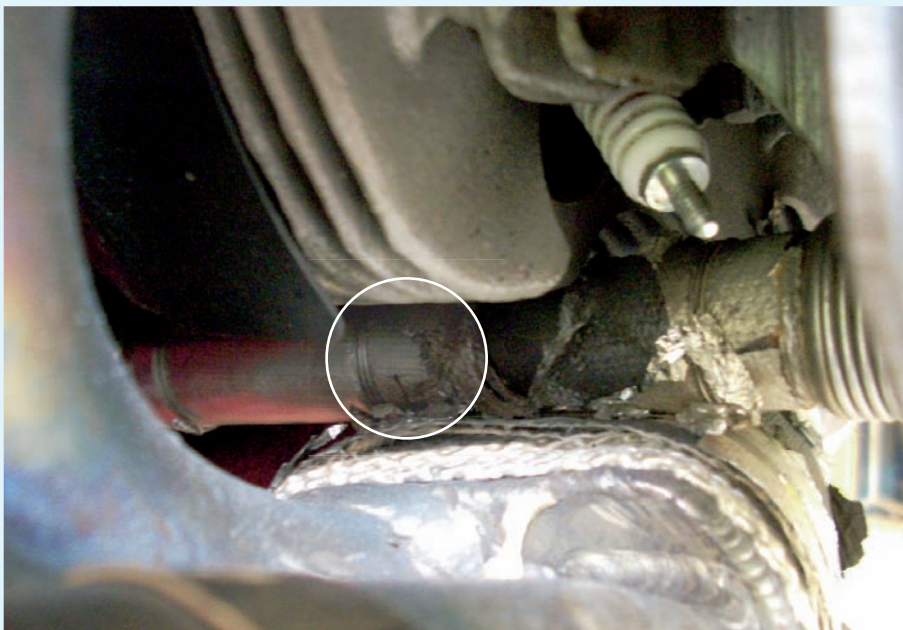
Neil allowed the engine to cool down a bit before removing the engine cowlings. He continues: "It would seem that the exhaust gases had leaked past the insulator and burned their way through the metal side of the body. The hot gases had then started to burn the cylinder head cooling fins and the pushrod tube just below it. (This would have then set fire to the leaking engine oil.) I had fitted a fire retardant/heat insulator cloth around the pushrod tubes to reduce heat soak into the

Gas flame can act like a blowtorch: Damage to push-rod tube shown above.

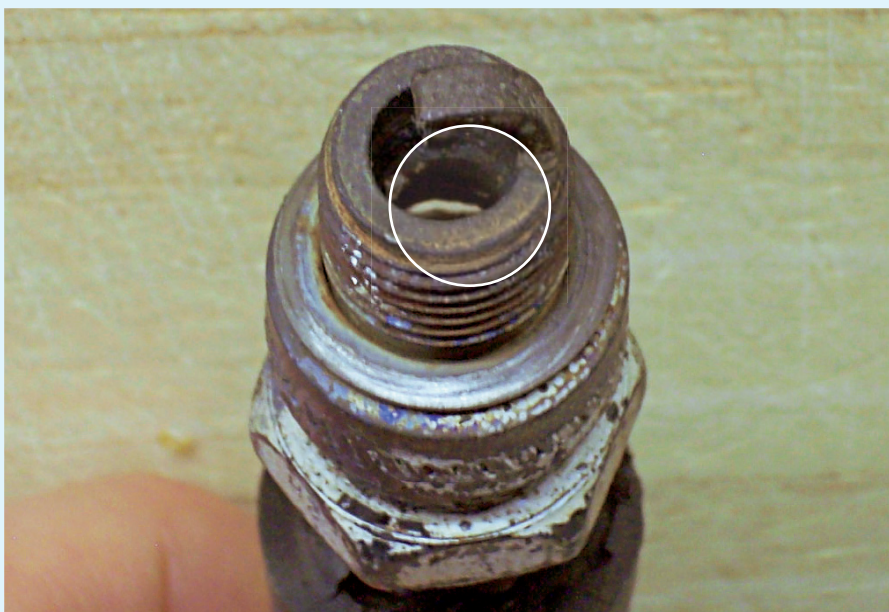
"Err... how did you say one should adjust the plug gap?": Centre electrode and insulator completely missing. The fact that there was no damage to cylinder bore or piston crown suggests that the debris of this failure exited the engine through the exhaust valve.

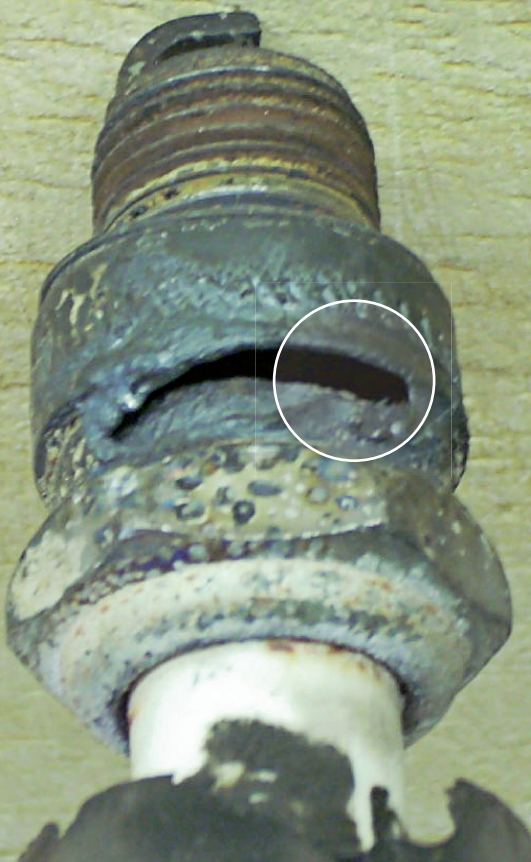
Neil sent us another plug from the set, which clearly shows witness marks where gas has been escaping between the metal body and the ceramic insulator and, after a pressure test, is clearly leaking.

These spark plugs had only been in service for 22 hours. I would definitely be interested if any of you out there reading this have any experience of this type of thing.

**The failed sparking plug. It probably didn't take long for the flame, at very high pressure, to burn through the plug body once the thermal runaway got started.**

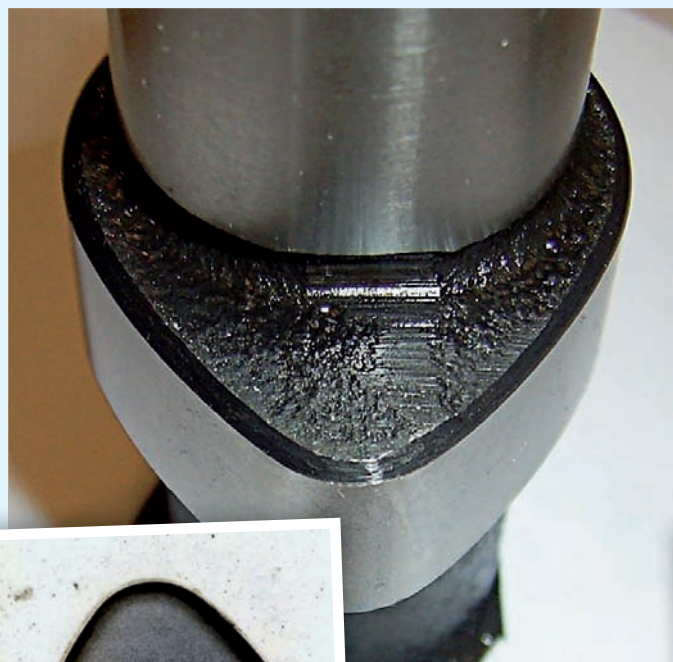
**GOOD CAM:** Note even chamfer around the edge of the cam lobe on this example of a new camshaft.

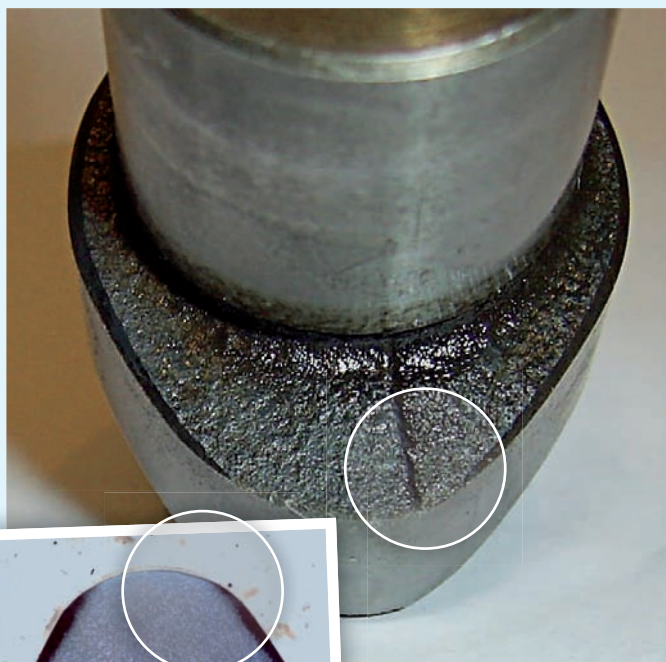
story descends into the kind of madness 'oft found in despair' but, eventually, Neil had a chat with an engine expert who suggested that the 'bottom end' should be inspected. The engine casings were duly split in half and the cause of the low power became very clear; the camshaft was worn out.

**BAD CAM:** 'Normal' wear point on a cam (highlighted above). Once the surface hardening has gone, wear will occur very quickly.

It will have been noticed, by the astute reader, that once the surface hardening on cams is damaged, cam wear will happen

I have recommended before that it is a good idea to run an engine every couple of weeks *UP TO TEMPERATURE* if you want to avoid internal corrosion. Lycoming Service Instruction L180B gives advice about longer-term storage of engines. You can download a copy off the web. Fair winds.
