SAFETY SPOT

Malcolm McBride
Airworthiness Engineer

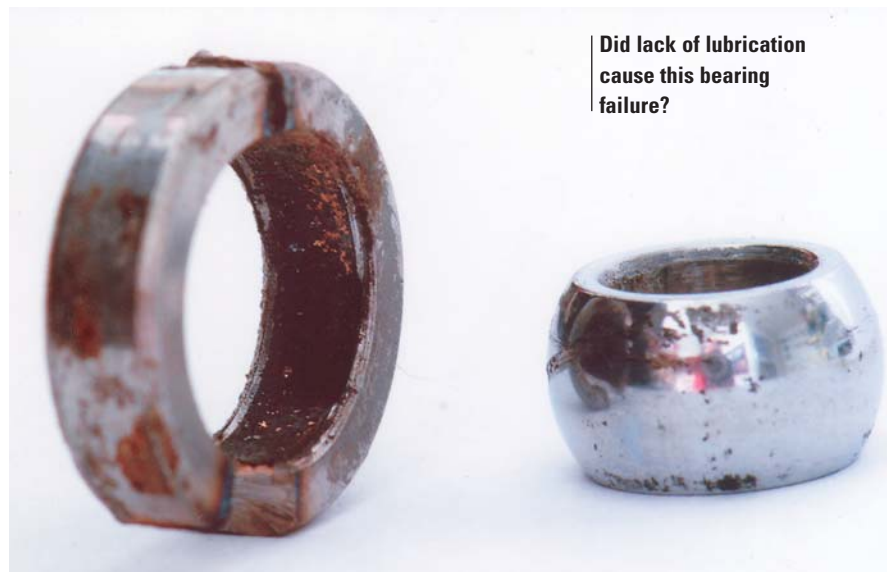
Did lack of lubrication cause this bearing failure?

One thing that was noted by the AAIB was the fact that there was little or no lubrication in the ball-end type spherical bearing and that the ball was nearly seized in its casing. This may or may not have been a contributory factor in the

bracket failure, this has yet to be decided but one thing is for sure, if a bearing seizes it stops being a bearing. The bearing may be introducing loads into the structure that the structure may not have been designed to take. Because the movement in the structure may only be slight it may be overlooked but, each time the control is operated, the structure, wherever it is, is being worked ... this can, after a time, change the material's structure often causing hardening, reducing ductility and leading to cracks. I can almost hear you thinking, "Calm down Lad!" Check out the picture of the

It's a good idea to get into the habit of checking drive rod-ends at each pre-flight – check that the rod-end bearing is free to rotate, hold the body of the rod-end and apply a small load to the control surface first up, then down – you are checking here for wear. Move the control surface through full deflection – what's the ball-end doing? Make sure that the body of the ball-end doesn't foul the control surface drive bracket and don't be scared to get the oil can out I know that there may be a chance of spoiling the lovely paint work with an oil streak but your aircraft is a machine and most machines treat oil as nectar from the Gods!

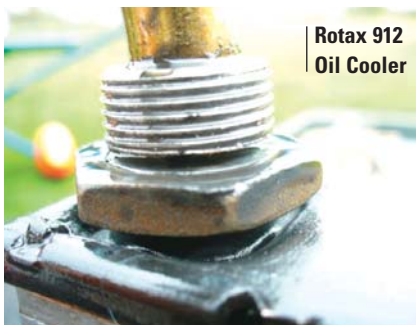
Rotax 912 Oil Cooler

While we are on the subject of cracking; Conrad Beale of Conair Sports sent me a great picture of an oil cooler from a Rotax 912 ULS that developed a small leak. The leak was noticed quickly and there was no drama, which is always good news. What happened here is that the nut holding the oil cooler to the engine mount bracket became loose; the owner tightened it up and, without further thought, went off to enjoy the delights of flight. Unfortunately, whilst the nut was loose vibration did its job and the bracket sawed through the oil cooler inlet. There is a lesson here somewhere!

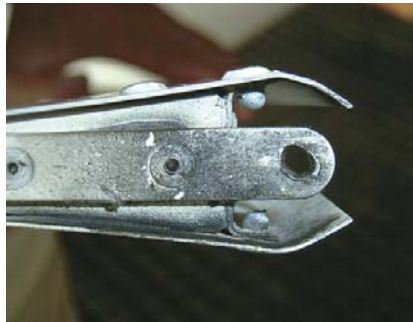
Trim Tab drive arm wear

Vibration is a massive wear 'inducer', take a look at the picture of the trim tab found by one of our inspectors, Tony Kay, last season. There are a couple of points that I want to mention about this; firstly this aircraft should never have been flying with this amount of wear in one of the control surfaces, the fact that it was only on a trim/anti-balance tab does not make it less important, it makes it more

important. Remember a trim tab is a small surface applying a load to a big surface, vibration in a tab will stimulate vibration in the principal control surface, this will lead to premature wear somewhere else on the airframe Note the use of the word will rather than my usual may! Under some circumstances it may (!) even stimulate a flutter condition, definitely not good.

Second point, take a close look at the design of this part, note that there is no bearing, essentially the connection is a hole through an aluminium alloy plate. This, by the way, is not a criticism; there are lots of good reasons for this type of design, cost and weight being two of the biggest, but don't forget, simple light structures/mechanisms require extra vigilance. The owner of this aircraft, who shall remain nameless (and the type ... type less!), was overheard moaning about the fact that he was suffering a lot of propeller vibration I hope that the renewal of the tab drive arm solved the problem.

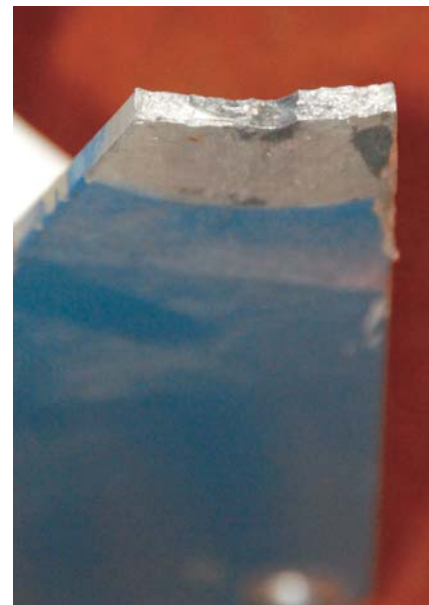
Shadow hang bracket

I promised earlier to talk about Shadow hang brackets so here goes; I ought to say firstly that I think the Shadow is a fantastic aircraft and that my hat comes off to David Cook the designer, for bringing such a device into the World. I wrote earlier about simple design standards and their relevance and I suppose this aircraft falls into the category of 'special and continual' inspections, do not wait for the annual, know your aircraft every last bit, keep an eye on wear and do not let it become excessive. Anyway, I digress. The bracket in the picture was sent in by another Inspector David Bremner, thanks David. He is rebuilding a Shadow that suffered a heavy landing and required the boom to be changed; he noted the broken bracket and put the break down to the heavy landing, quite naturally. David remembered that there is a PFA

Airworthiness Information Leaflet (PFA/MOD/161/001) requiring a thorough check of this bracket at each Permit Renewal and took a closer look at it.

The above discussion does not address the work hardening issue with this bracket and, in all truthfulness, I cannot say that we've actually cracked the problem. If you've ever flown a Shadow you will know that cross-wind landings put a fairly large, i.e. noticeable, twisting moment through the airframe; David Cook told me that he was able to turn with a sort of 'lurching' manoeuvre through 360 degrees without using bank. To reduce this fuselage twist CFM introduced a mod which stabilised these two front hang brackets, it consisted of a plywood gusset set between the two brackets. It is possible that movement in this bracket over the years has caused the work hardening; one thing for sure is that it is this bracket that holds the body of the aircraft to the fuselage boom and I would not want it to break when I was flying the aircraft. The aircraft that the broken bracket came from had not been fitted with the recommended gusset.

I shall be writing to all LAA Shadow operators reminding them of the annual requirement to check this bracket and requiring them to incorporate CFM metal fax Mod Number 9, which is the plywood gusset.

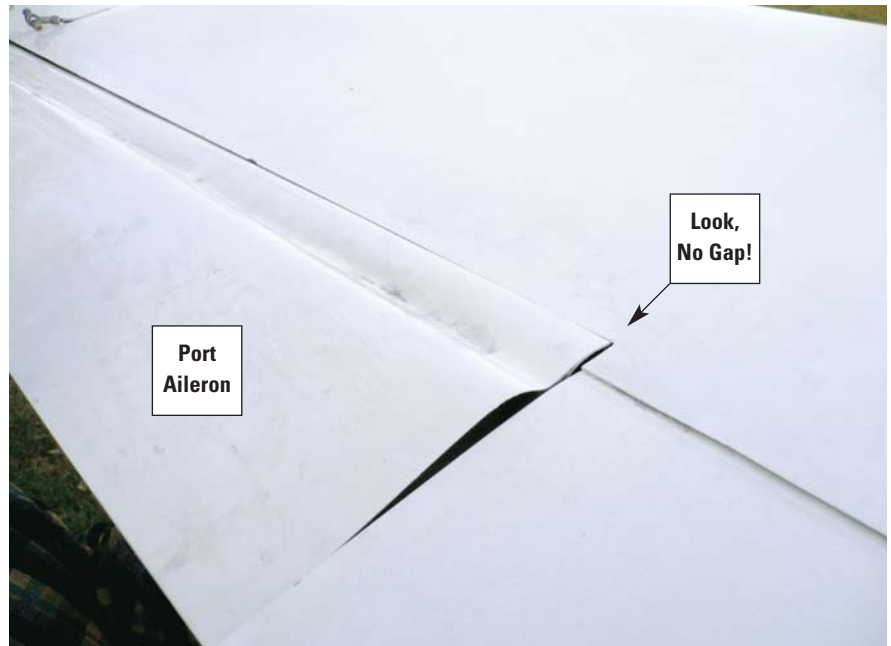
J400 Aileron Jam – a close thing

"The aircraft was returning after refuelling from Fenland Airfield at 1000 ft. During a co-ordinated 60 degree right hand turn, the control column jammed which resulted in the aircraft continuing to roll to the right. Full left rudder was applied and the power was reduced in (an) attempt to stabilize the roll. In (an) attempt to centralise the controls, a

On the ground, the inspector rechecked the gaps and clearances and found that by applying an up load to the aileron, and moving it through full deflection, the jam case could be simulated. Check out the photo. Kevin and Roger of ST Aviation and ST Aviation Services respectively have moved with creditable speed to alert all the relevant people and have issued a Service Letter advising all concerned about minimum distances between control surfaces and wings/tailplanes and fins. The LAA has created an Airworthiness Information Leaflet to alert all UK Permit holders. I think that this is a good example of 'never taking anything for granted' as discussed earlier; probably the aircraft and it's pilot were lucky to survive the incident and, most likely, the actual cause of the crash would never have been found. – *Fair Winds* ■
