LAA/AWA/19/17
12th June 2019

STEPHENS ACRO, LASER Z200/Z230, EXTRA EA 230 and EDGE 360 AIRCRAFT

INSPECTION OF FORWARD FUSELAGE LONGERONS

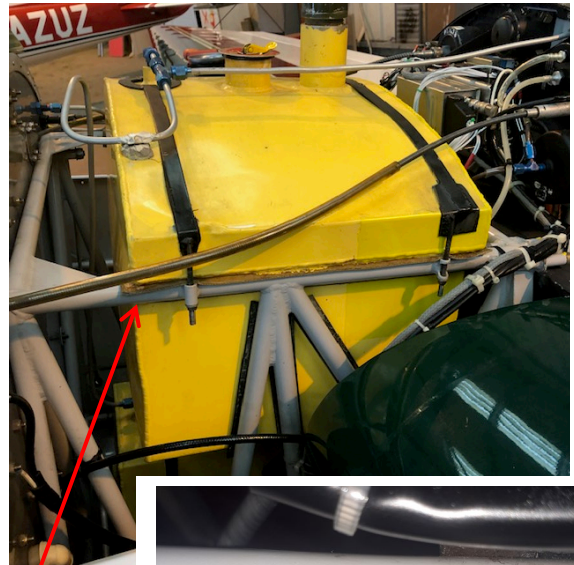
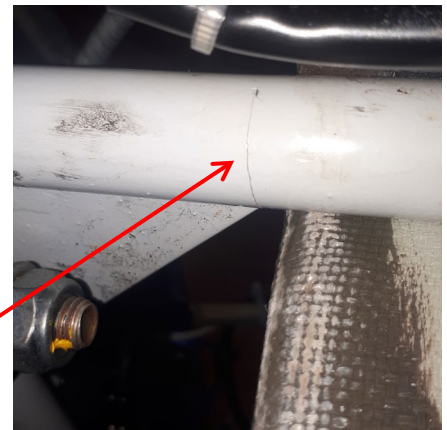
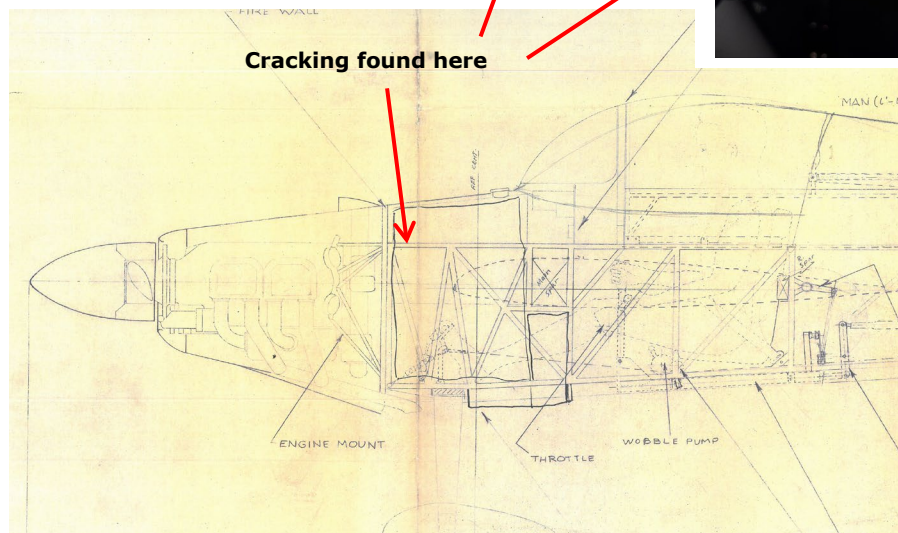
A recent report from a Norwegian Extra EA 230 owner gives an account of serious cracks found in the two forward upper longerons in the area between the fuel tank and the front cross member.

Worryingly, one crack extended almost completely around the full circumference of one longeron. Should this longeron give way whilst in flight, separation of the engine from the fuselage structure would be a very real possibility.

LAA Engineering has just issued two Airworthiness Information Leaflets (AIL) requiring owners of all Stephens Acro based fuselage designs to visually inspect both the top and bottom forward longerons (within five flying hours) to ensure that they remain in an airworthy condition.
