Schroth Harness

Issue of Service Information Letter

SIL SSP-007

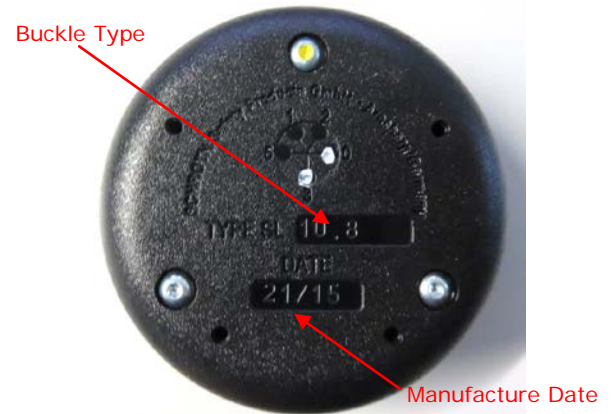
The issue relates to an inherent issue with some types of rotary buckle in that the latching mechanism can unlatch during aerobatic manoeuvres.

Fig. 1 The Schroth Harness Buckle

Because many LAA administered DH82a and some Bulldog aircraft will be affected by this Information Letter LAA Engineering has written to owners of both these types advising that they should follow the advice laid out by the harness manufacturers and, for some models, this means that aerobatics are not carried out on aircraft fitted with these harnesses.

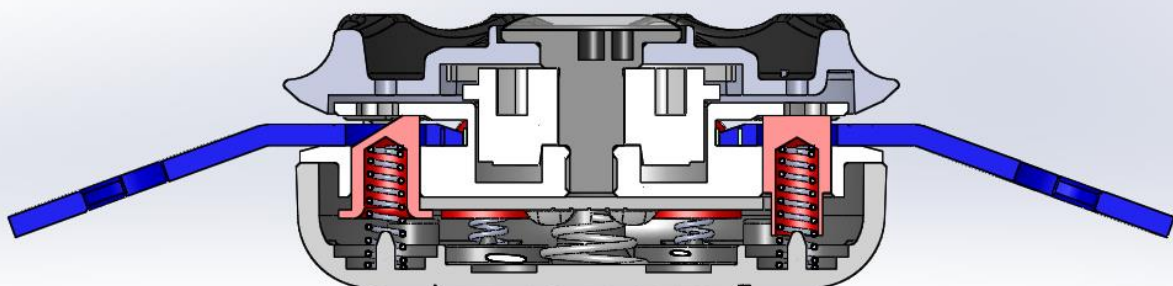
Fig. 2 Schematic of the Schroth Buckle Assembly
