CZAW SportCruiser

Nose Undercarriage

Withdrawal of PS Mk. I Noselegs & Changes to Inspection Requirements

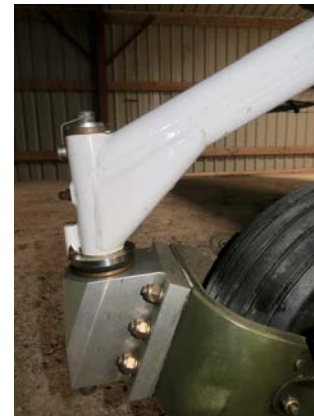
Fig 1. This picture shows a strengthened CZAW leg fitted with the Dover Spindle Mod; this undercarriage is fitted with a two 'leafed' fork, a three leafed alternative will be available shortly.

It has been agreed that both the Palmer/Sayyah leg strengthening mod and the Smith three leafed fork will not be mandated but will be available to owners as an LAA Standard Modification.

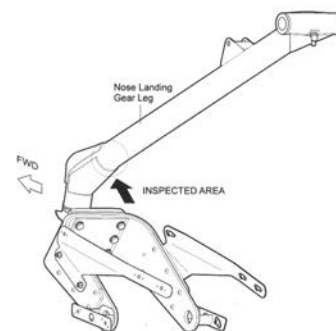
The recent failure featured a PS Mk. I leg and, after the aforesaid consultations, it has been decided that this type of leg must be withdrawn from service. Replacement options available include the PS Mk. II leg and the CZAW/Palmer/Sayyah leg. To give owner's time to source an approved leg it has been agreed that the PS Mk. I leg may remain in service for a further three months (from the date of issue of the mandating Airworthiness Information Leaflet) provided that the spat is removed and a careful inspection made before each flight; particular attention should be focussed on the condition of the welded joint between the leg and the spindle housing (see attached sketch).

Fig. 3. PS Mk. I nose undercarriage assemblies are to be withdrawn from service; as an interim safety measure whilst still in-service, the leg must be inspected before every flight – this sketch shows the most likely area of the first signs of failure.
