De Havilland DH82a Tiger Moth

Australian Accident Report

In-flight break-up

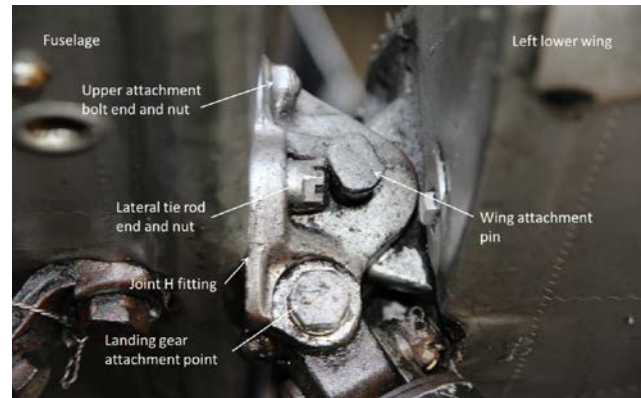
Early on in the investigation, it became clear that both the forward and aft. lateral tie rods had fractured through their threaded section at the left lower wing's attachment point. In the UK this failure generated the issue an Emergency CAA Airworthiness Directive (G-2014-0001-E) prohibiting aerobatics of all 'Moth' type aircraft until the provenance of their lateral tie rods had been established and found to be satisfactory both in terms of life left and correct part number.

Fig. 1 This picture shows the complicated arrangement of the DH 82a lower wing attachment, known as the Joint H fitting. A key element of the failure of the lateral tie rods may have been that the Joint H upper attachment fitting bolts were found to have been incorrect parts.

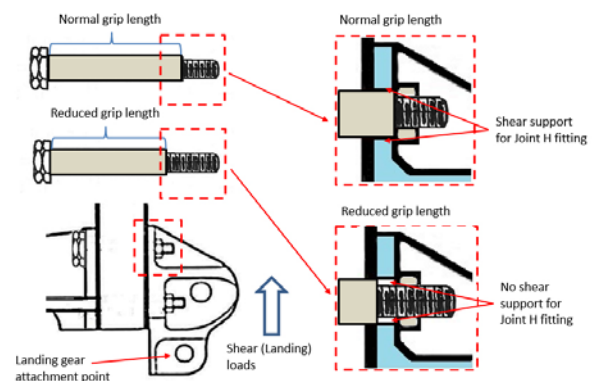
Fig. 2 This graphic, taken from the ATSB report, shows the importance of using the correct parts in critical assemblies. In the accident aircraft, it was found that the grip length in the incorrect bolt used was not sufficient to transfer shear forces correctly into the Joint H fitting.
