LAA/AWA/18/12
20th December 2018

TL 2000UK Sting Carbon & TL 2000UK Sting Carbon S4

Inspection of Horizontal Stabiliser Securing Pins

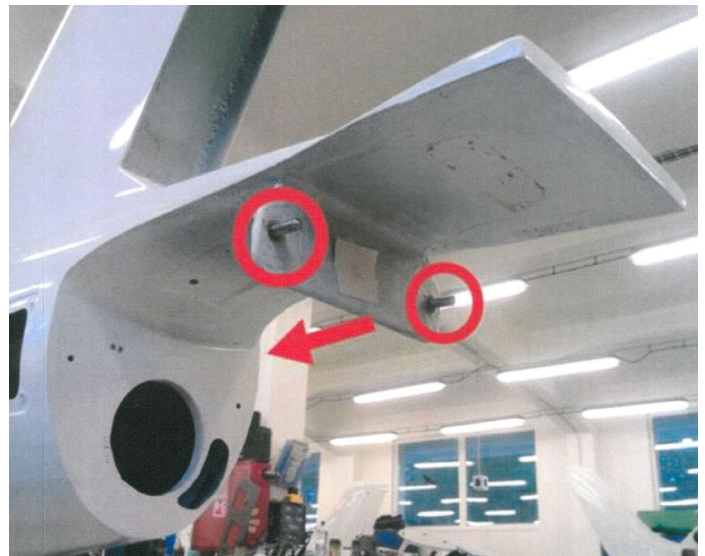
Fig. 1 This picture (above) shows the position of the two horizontal stabiliser's securing pins on the TL-Sting aircraft. Note that the stabiliser is finally secured using an attachment bolt at the forward end of the stabiliser. Inspectors should note that, because the bolt's head mates against the angled face of the stabiliser, a wedged-shaped washer is used – it is essential that this washer is fitted correctly.

After discussion with the UK agent for TL-Sting aircraft LAA Engineering has issued an Airworthiness Information Leaflet (AIL) (MOD/347/034 issue 1) mandating the annual removal of the horizontal stabiliser and the inspection/re-protection of the attachment pins on all TL-Sting marks. This task must be completed in accordance with the requirements of TL-Sting (UK) Ltd.'s Advisory Bulletin (#2018/001) and instructions given in the aircraft's current maintenance manual.

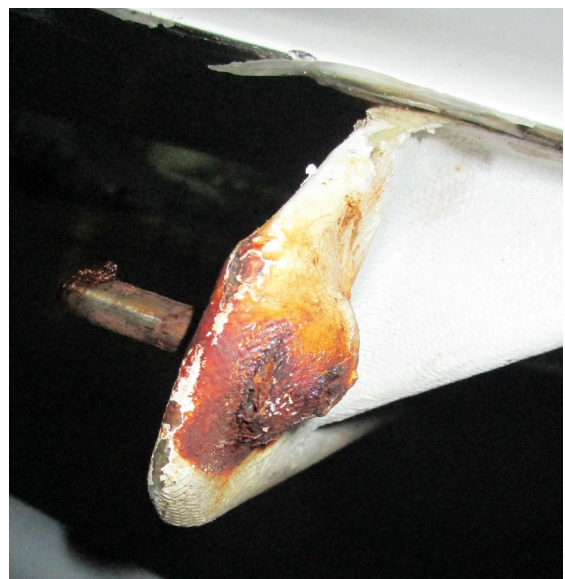
During an inspection an overseas TL-Sting aircraft was found to have suffered significant corrosion in the stabiliser's securing pins. Both because of the pins' critical function in securing the stabiliser to the fuselage and the method by which the pins are individually secured to the composite fuselage structure, any corrosion in the pin is unacceptable and, if found, in consultation with the aircraft's manufacturer, a repair solution must be embodied.

Fig. 2 The picture (right) shows a close-up of a badly corroded horizontal stabiliser attachment pin. Note that corrosion products have found their way into the attaching fibreglass seriously compromising the integrity of this connection.
