LAA/AWA/20/20  
3rd November 2020

## Wilksch WAM-120 Torque Check and Service Life of Flywheel Attachment Screws.

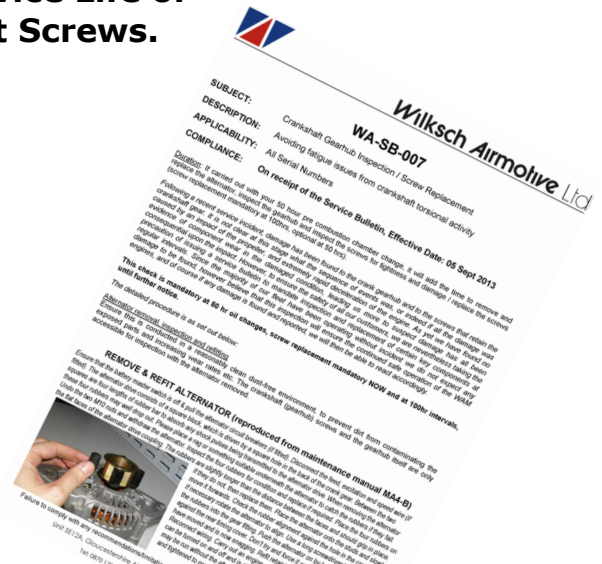
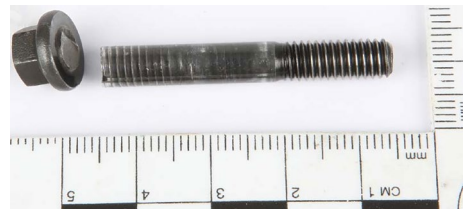
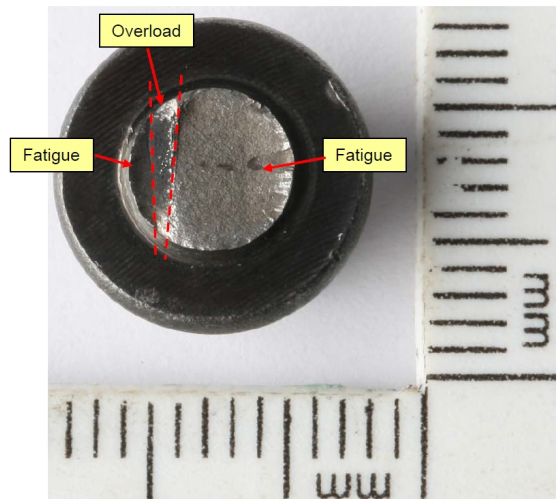
A recent in-flight engine failure of a Wilksch WAM-120 engine fitted to a Van's RV-9A has been found to have been caused by the sequential failure of all four of the screws attaching the gearhub to the crankshaft. Examination of the fracture faces of the embedded remains of two of these screws shows evidence of fatigue.

Investigations continue into the reason why these flywheel bolts suffer from fatigue cracking and subsequent failure. Current suspicion lays with an increase in local stress due to 'notch effect' between the flywheel and the bolt head; the design team is looking at ways to reduce this. For the time being, the safest way to remove the threat of a bolt failure, is to change these bolts in a timely manner.

LAA Engineering has issued an Airworthiness Information Leaflet (AIL) (MOD/ENG/WAM/001 Issue 1) mandating the fifty hour screw torque check and the one hundred hour screw life on the four gearhub to crankshaft screws, as directed by the Service Bulletin.
