LAA/AWA/18/08
27th September 2018

High Wing Piper Aircraft

Inspection of Rudder Hinge Assembly

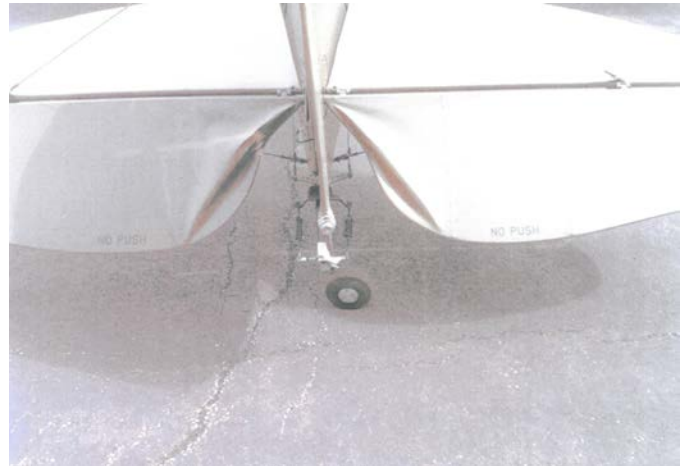
This complete failure of the top hinge assembly allowed the rudder to flail about violently, damaging the elevators and causing an overload failure of the bottom hinge; the rudder only remaining attached by the control cables.

Fig. 1 A pilot of a J3 Piper Cub, whilst flying in the area of Leeds East (Church Fenton) airfield, started to feel a vibration through his rudder pedals, this was shortly followed by a bang and the aircraft pitched nose down. The throttle was closed and, with heavy stick forces, the aircraft was recovered back to level flight. The aircraft landed safely soon after; the picture above shows the damage caused to the elevators after this partial loss of control incident.

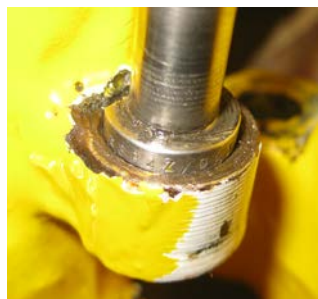
What appears to have happened is that the top hinge pin, along with the tubular bushes that are normally fixed in place within the hinge's knuckle, have become loose and fallen out.

Though this was the first record of a failure like this, the failure did highlight a previously un-spotted failure mode - note that the head of the hinge pin is smaller than the inside diameter of the knuckle but larger than the inside diameter of the bush (Fig. 2), so the only thing holding the hinge assembly together is the friction in the interference fit between the bush and the knuckle; lose this friction for any reason and the hinge can eventually fail.

Fig. 2 (Left) shows that, under some circumstances, the head of the hinge pin can be smaller than the inside diameter of the hinge knuckle, this means that the hinge pin is only retained in place by the interference fit of the bearing (not visible). Fig.3 (Right) shows a simple 'fix' which will prevent the assembly failing should the bearing become loose; note the thin washer under the head and between the knuckle and the securing split pin.
