Rotax 912i (Series) Engines

Checking of the Correct Positioning of Sealing Plug in Ignition Housing

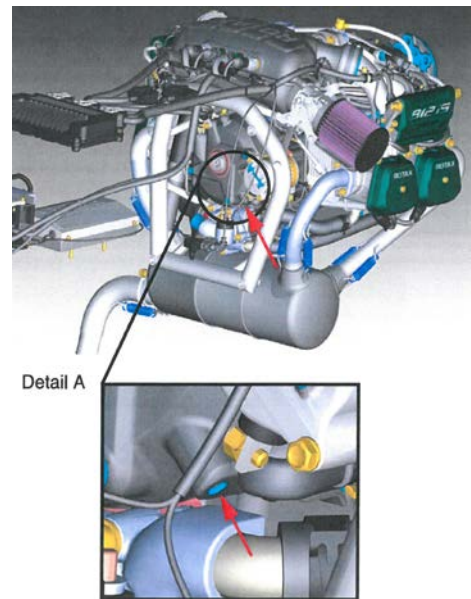
Fig. 1 This General Arrangement drawing shows the position of the ignition housing, Detail A shows the position of the sealing plug

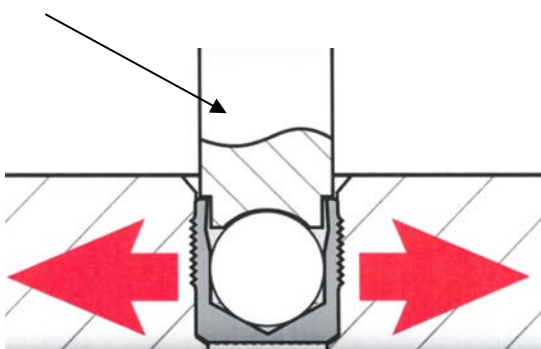
Ball Insertion Tool

Fig. 2 This sketch shows the correct position of the expansion ball in the oil sealing plug. Note that the ball expands the sealing plug firmly into the casting of the ignition housing.

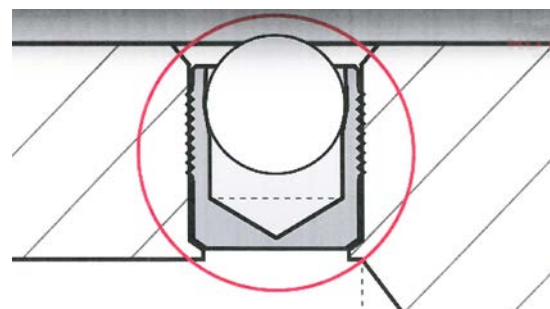
The problem appears to be that the oil sealing plug was not firmly seated during the assembly of the ignition housing and that this may lead to oil leaks or, in the worst case, the plug falling out which could lead to a total loss of oil and engine seizure.

Fig. 3 This sketch shows a ball that hasn't been driven firmly home into the oil sealing plug; this situation can be dangerous as it could leave the sealing plug loose in the casting.
