British Gliding Association
Aircraft Inspection

Number: 042/07/2004	Issue: 4
------------------------	-------------

Subject: Structural inspections

Applicability: Schleicher Ka 1, Ka 2, Ka 2B, Ka 3, Rhönlercher II (Ka 4), Ka 6 series, K7, K7 conversions, K8 series, K10, ASK 13 series, ASK 14, ASK 16, ASK 18 series and all variants of each type.
(This inspection is strongly recommended for the motor glider types listed above)

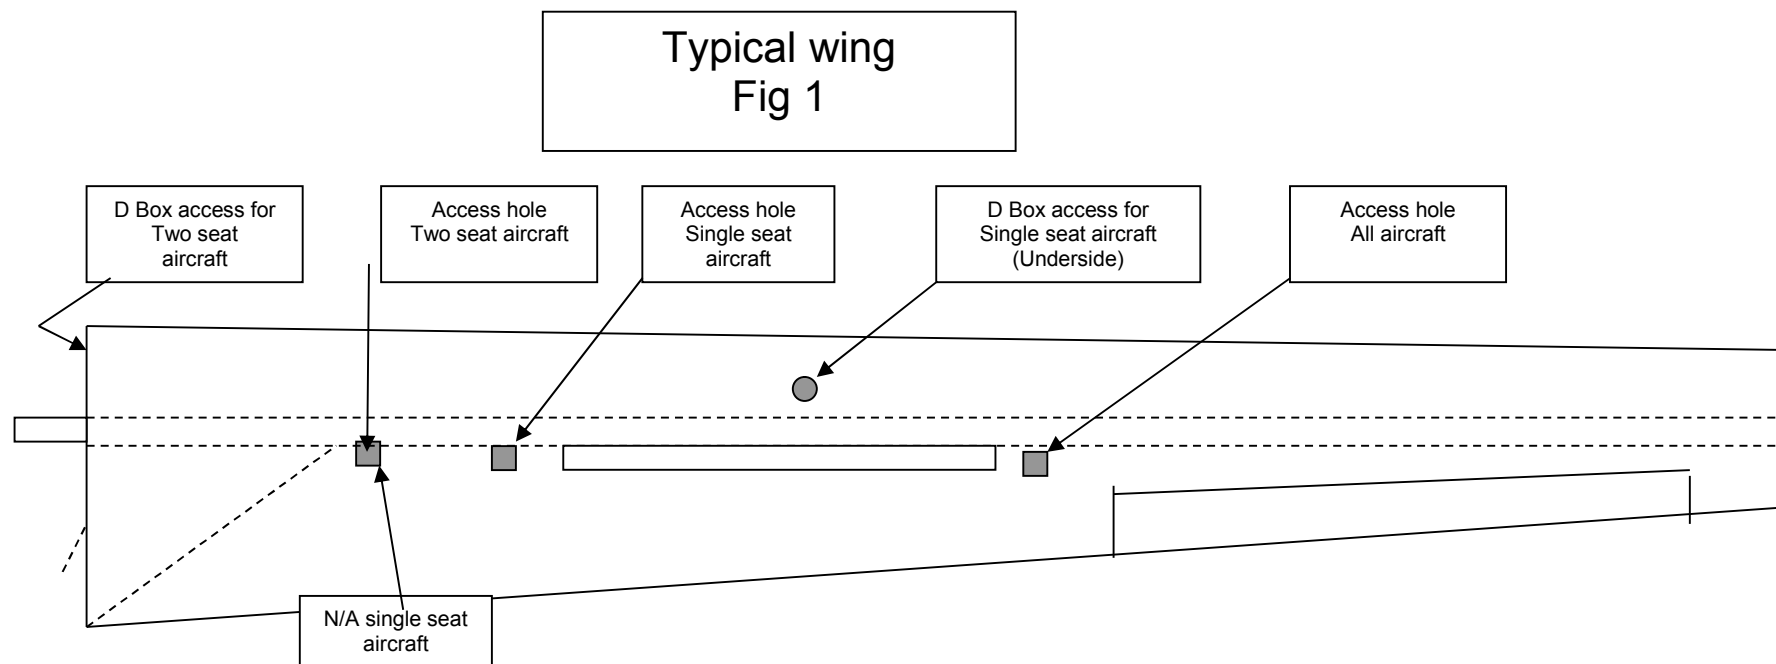
Single seat aircraft: Adjacent to the rear face of the main spar immediately inboard and outboard of the air brake box. See fig 1.

Two seat aircraft: Adjacent to the rear face of the main spar immediately outboard of the air brake box and at the drag spar intersection with the main spar. See fig 1.

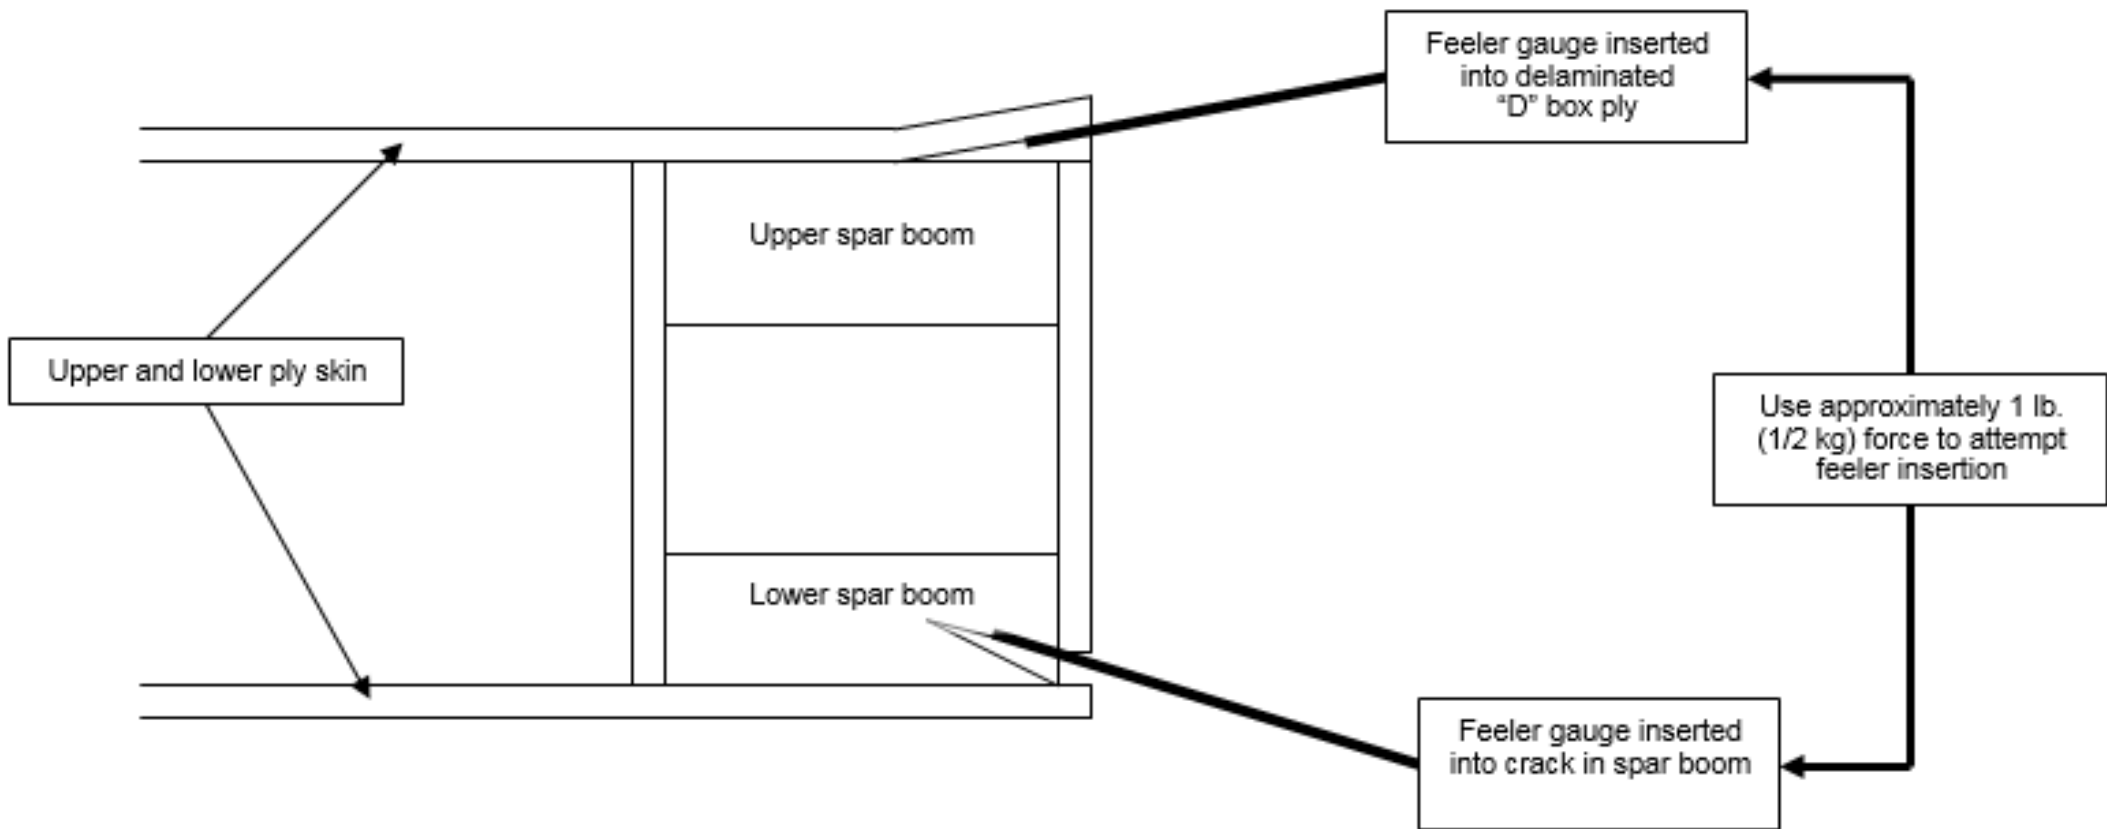
Figure 2 Typical spar section

Using a 005/010" (0.12/0.25mm) feeler gauge, try to insert into the glue joint parallel to the wing top surface. See fig 2.

Check for cracks running into the spar booms by trying to insert the feeler at 45° to the spar. Apply a force of approximately 1 lb. (1/2 Kg) See fig 2.

If the feeler gauge can be entered more than 3/16" (4mm) or any evidence of glue failure is observed the aircraft must not be flown. All the fabric must be removed and a complete aircraft structural survey carried out. An inspection report must be submitted to the CTO for further instructions.

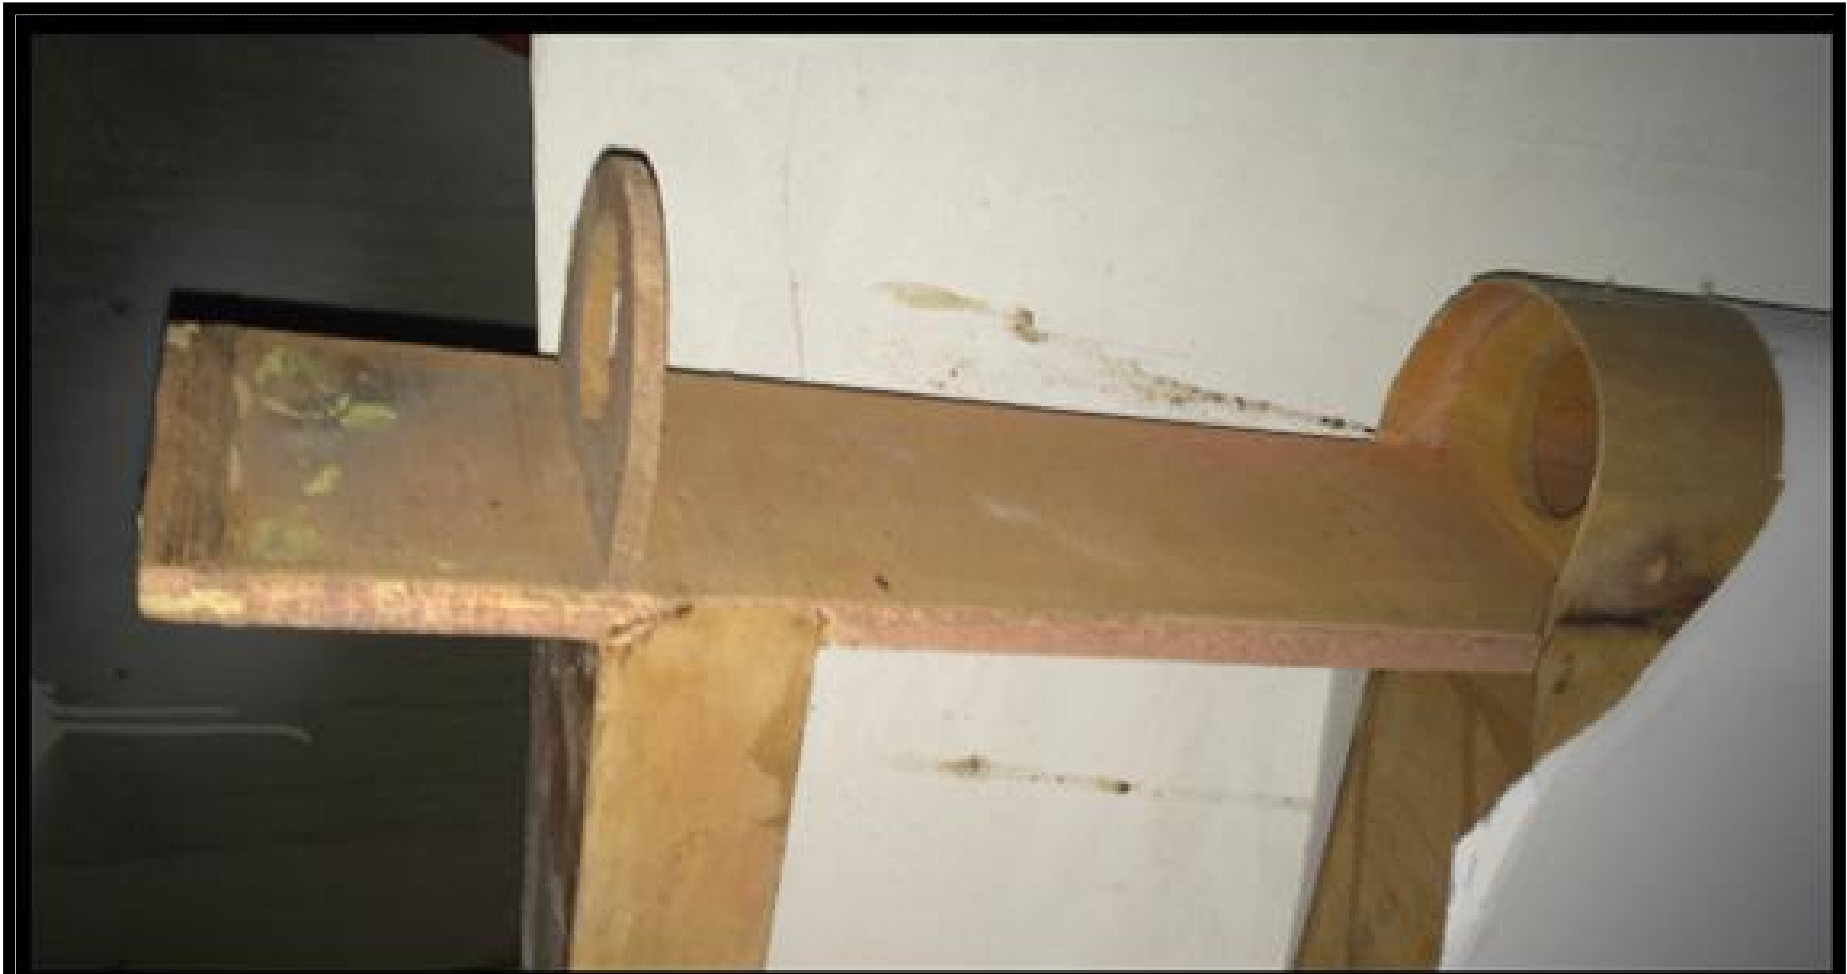
Figure 3

Typical elevator glue failure after root rib fell off and spar "D" was removed due to it not being bonded. Note the pink Kaurit glue in this instance

Check trailing edge is straight and solid. Apply pressure to every rib over its entire length to ensure there are no broken sticks. The root rib requires gentle but significant pressure trying to pull it out of the spar.

Using a feeler gauge (as in figure 2) check for any disbonding of the spar to D box skins on the root end of the spar where you have access (including inside the D box tunnel)

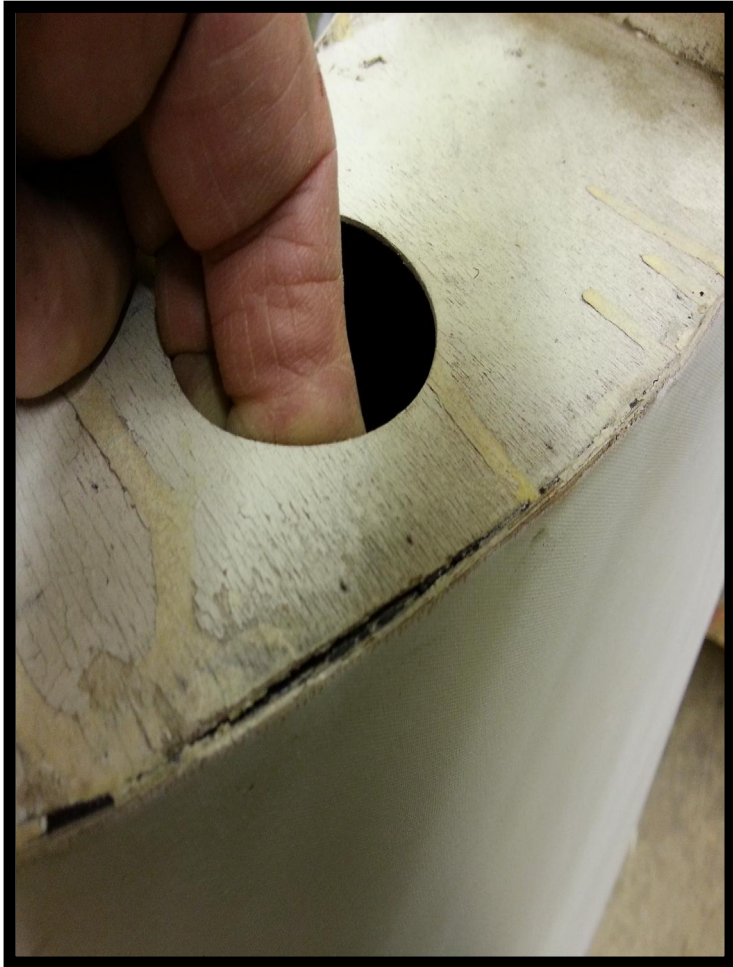
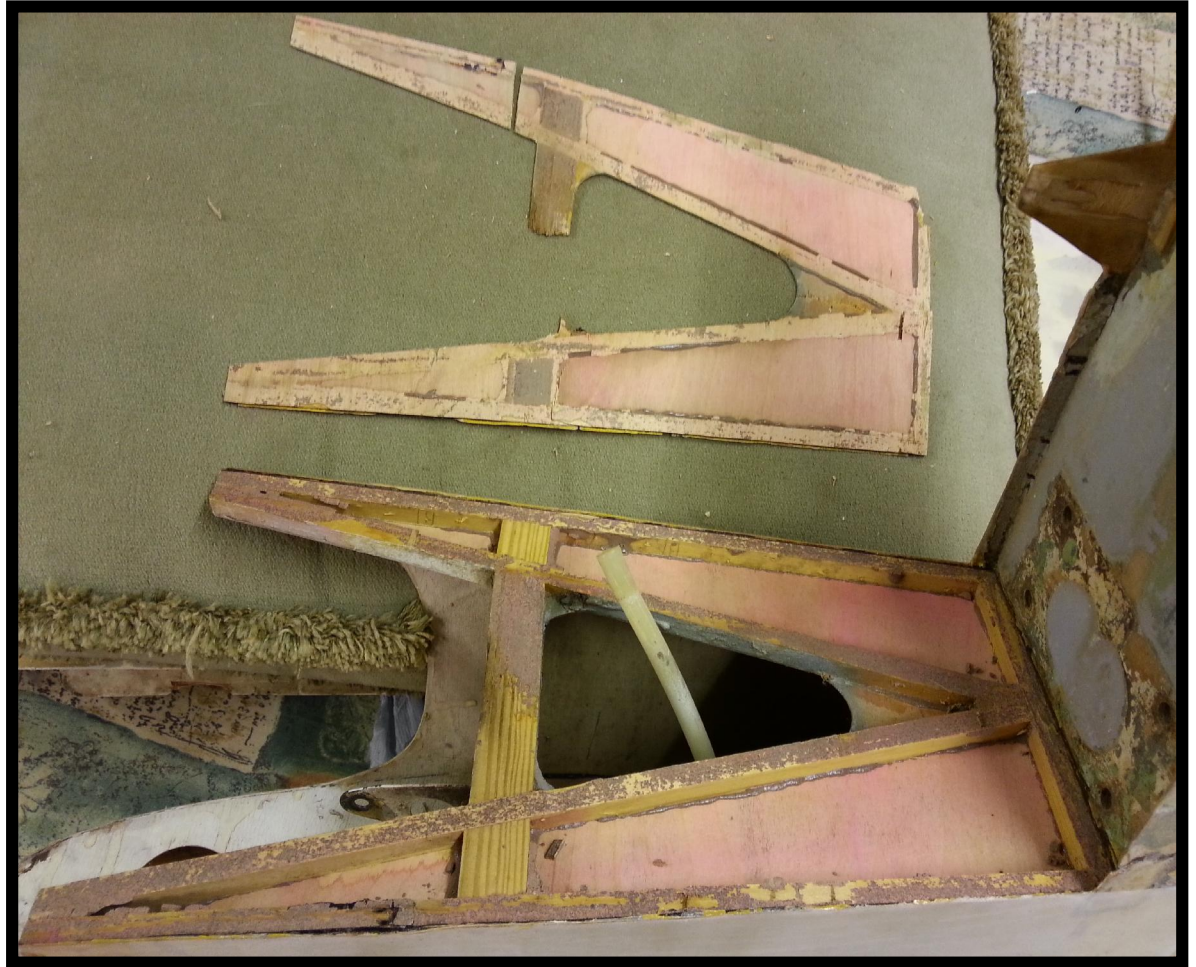
D Fin inspection. If performing the inspection during a fuselage recover then the fin is to be removed (except K6s where they are not bolted on) See figure 4 for images of glue failure found previously

Figure 4 Typical Sternpost and base rib glue failure

Remove the fin (does not require much fabric work) This must be done on all types apart from K6 and K14 types (Indicate on the form returned to the BGA when the fin was last removed) as checking in situ gives very poor access and pressure has to be applied to see if the glue joints still have the required high strength. Inspect base of fin rib and put some pressure on it pulling it away from the fin. Check the entire stern post both sides by applying gentle pressure to the plywood that bonds onto the stern post spar. Apply gentle but firm pressure to shear web plywood away from the spar caps to ensure there is no disbonding over the entire length. You are looking for any sign of disbonding or rotten wood (especially at base of fin). Apply significant pressure to the elevator drive mount to ensure that rib is completely bonded. Note, often the bolts that hold the fin onto the fuselage are rusty and should be replaced.
