LAA AWA/12/03
28th March 2012

Dragon Wings Rotors

Inspection of Hub Bar

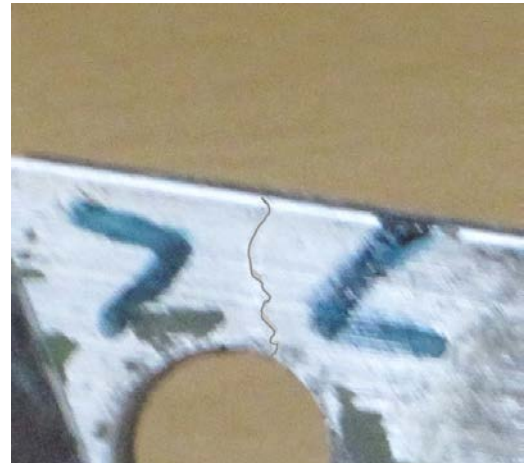
During a pre-flight inspection of a Montgomery-Bensen B8 Autogyro the inspecting pilot notice a hairline crack in the outside face of the Hub Bar.

During the investigation into this event a number of possible causes for this crack were suggested including, blade flap, over-tightening of the attachment bolt(s), incorrect tolerances during blade assembly, fatigue or incorrect assembly /disassembly methods of the blades from the rotor.

Fig. 1. Close-up of the Hub Bar crack

Unfortunately, it was not possible to obtain the cracked Hub Bar for inspection and so the actual cause of this crack will remain a mystery. After discussions with the manufacturer of this Hub Bar and LAA Inspectors with substantial experience with this rotor assembly, it was agreed that the most probable cause of the event was that, at some time in this Hub Bar's history, an incorrect assembly/disassembly procedure was used.

After discussion with the UK CAA the LAA has issued an Airworthiness Information Leaflet (AIL) requiring pilots of aircraft fitted with Dragon Wings Rotors to visually inspect the rotor head before each flight (LAA/MOD/GYRO/001 issue 1). In addition to this, the AIL requires a close inspection of the Hub Bar at each annual inspection; this annual inspection requires the removal of the blades from the Hub Bar.
