LAA/AWA/14/08
4th June 2014

Pioneer 200 and 200M Aircraft

Inspection for Water Damage to Fuselage Structure

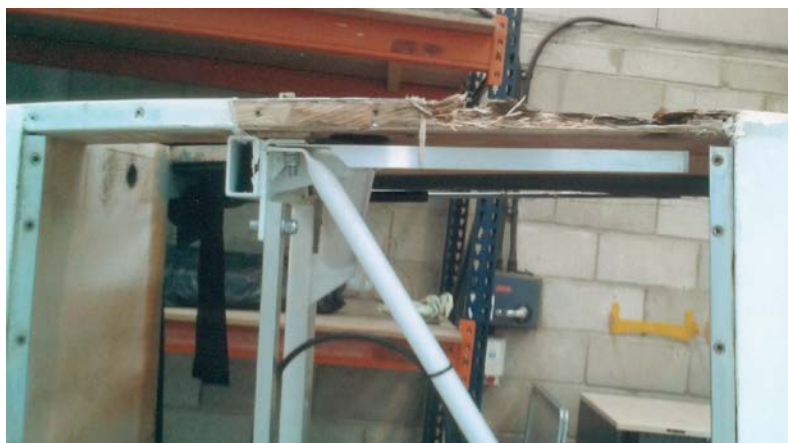
LAA Engineering has received a worrying report from a Pioneer 200 owner about some serious damage he has found in the primary structure of his aircraft; the damage has been caused by water which has leaked into the airframe via small gaps in the junction between the lower fuselage inspection panel and its supporting wooden structure.

Fig. 1. (Opposite) Shows the damage found to the port lower longeron when the lower fuselage inspection panel was removed. This picture was taken after the wings and tailplane had been removed and the aircraft laid on trestles on its side.

Because of this report LAA Engineering has published an Airworthiness Information Leaflet (AIL), LAA/MOD/334/003 issue 1, requiring all Pioneer 200 and Pioneer 200M owners to remove the lower fuselage inspection panel and inspect the aircraft's wooden primary structure before further flight. This AIL can be downloaded [HERE](#).

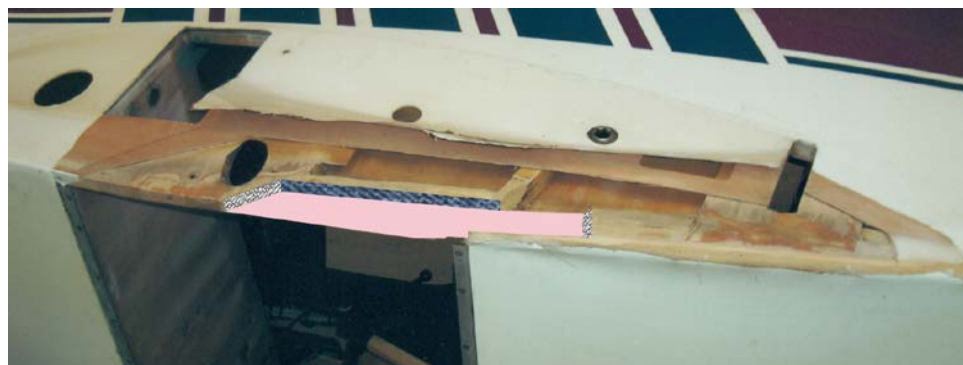
Fig. 2. This picture shows well the extent of the damage; in this picture the repair team has removed all the damaged wood revealing just how much of the structure was compromised.
