SportCruiser

Reduction of Published Vne

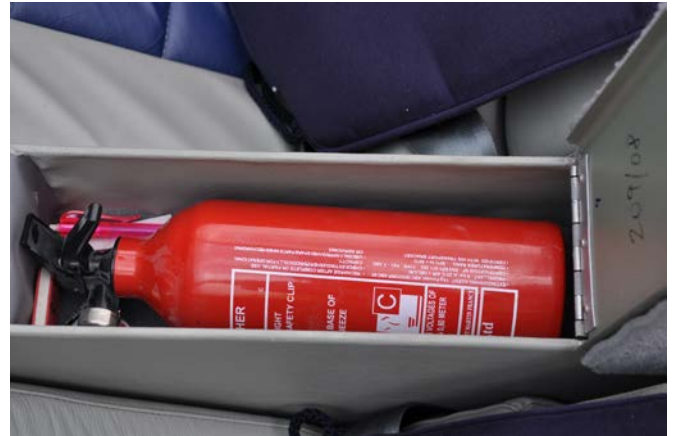
One of the features of this incident was that, during a period of negative 'g', an unrestrained fire extinguisher left the confines of the centre console and discharged its content into the cockpit. This, in itself, might have caused sufficient distraction to cause an accident but, as it happened, the extinguisher came to rest in the pilot's footwell, temporarily jamming the rudder; the pilot, whilst slightly injured, was able to regain control.

Fig. 1. It is essential that any article carried in the cockpit of an aircraft is properly restrained. A Fire extinguisher, if carried, must be affixed by an appropriate fixing to an appropriate structure.

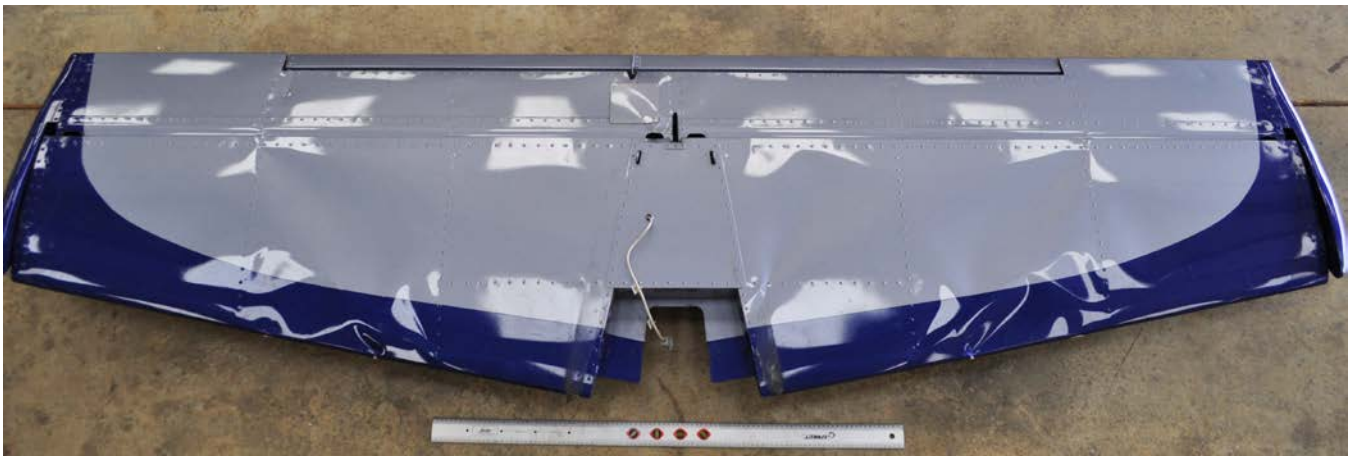
A recent incident involving a SportCruiser aircraft during a routine annual air test, which led to a symmetrical overload failure of the tailplane and a failure of the aircraft's canopy, is currently under investigation by LAA Engineering.

Fig 2. Shows the bottom surface of the SportCruiser's tailplane after suffering an in-flight structural failure.

Whilst investigations into this incident continue, LAA Engineering has reduced the Vne of all SportCruisers operating under an LAA administered Permit to Fly from 138 knots IAS to 120 knots IAS and has asked owners to placard their aircraft (and flight instruments) appropriately. Revised Operating Limitations have been issued for the type.
