Rotax 912 & 914 Series Engines Replacement of Flywheel Hub Washer

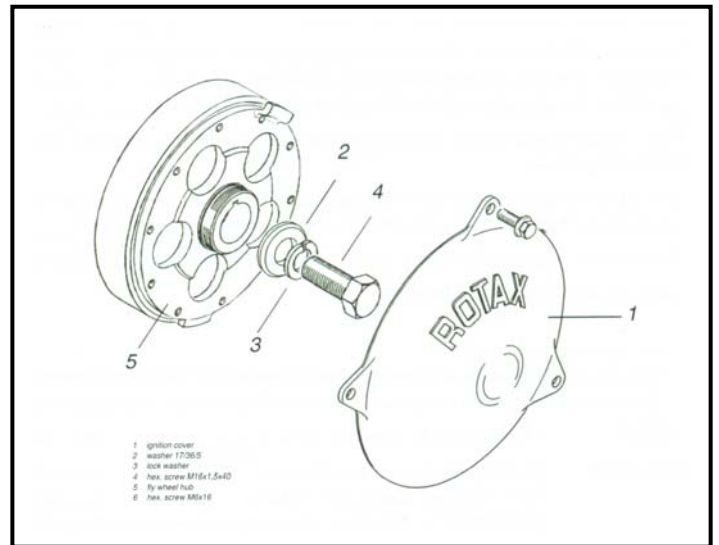
In response to an Emergency Airworthiness Directive issued by EASA on the 15th April 2011 (2011-0067-E) the UK CAA has just issued an Emergency Mandatory Permit Directive (EMPD 2011-003-E) which requires the replacement of a faulty washer (part No. 944072, item 2 on accompanying drawing) fitted to some recently assembled Rotax 912 & 914 engines.

The reason for this replacement is that it has been discovered that there was a deviation in the hardening process during the manufacture of a batch of these washers. This change in hardness could lead to cracking and failure which could lead to the loosening of the flywheel resulting in ignition failure or engine damage.
