# Airworthiness Alert - October 2009

## Jabiru Engines – Lean mixture due to incorrect Jetting

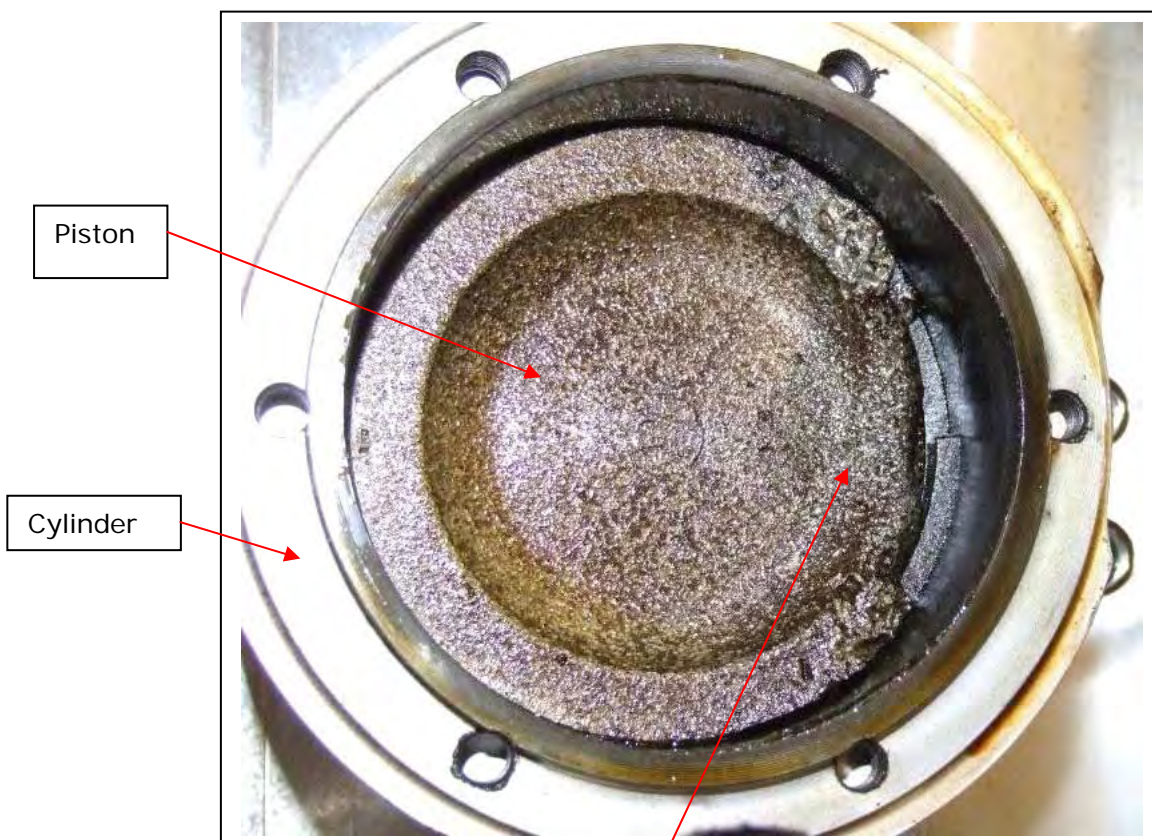
There is strong evidence that the engine had been incorrectly 'set-up' and that the engine was running very lean at mid range and high power settings. The subject aircraft was not fitted with an Exhaust Gas Temperature gauge and the Cylinder Head Gauge sense probes had been fitted incorrectly and were severely under-reading. The pilot was therefore unaware that the engine was overheating.

Note: Severe piston crown damage associated with multiple impacts from molten material from the piston's edge. This piston has melted right down to the rings allowing hot gasses through into the crankcase, hence the pilot's report of smoke/oil in the cockpit.

It is strongly advised that owners and/or operators of Jabiru engines read the Jabiru Service Bulletin relating to this issue; this document can be downloaded here: [JSB 018-2](#)
