LAA/AWA/14/06
9th May 2014

Tipsy Nipper – All Variants

Inspection of Mainplane Attachment Bolts

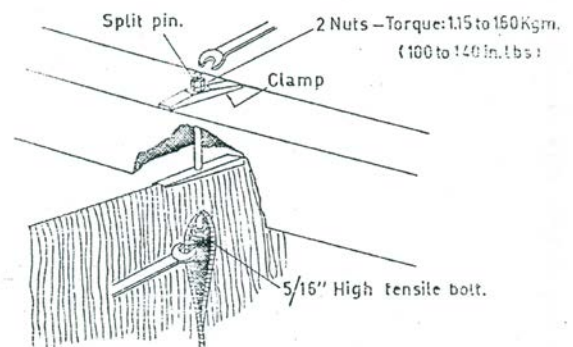
Fig. 1 Sketch of Nipper main wing bolt

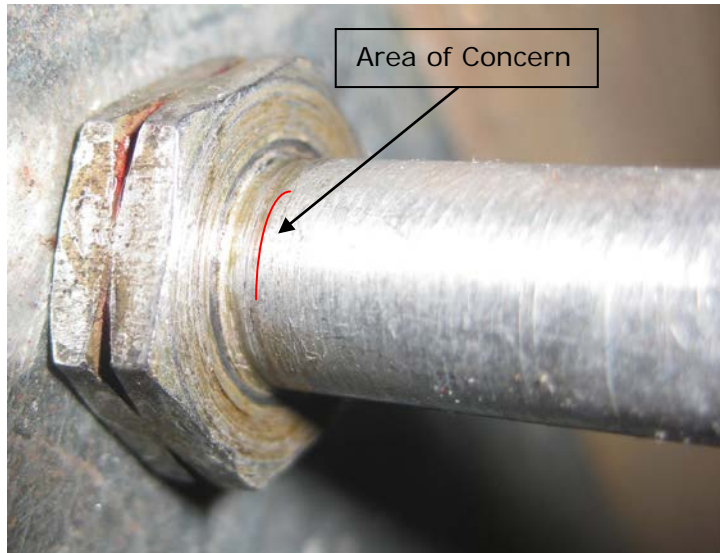
Because of this incident, an LAA member who owns a Tipsy Nipper, was inspired to remove and inspect the two main wing-to-fuselage attachment bolts on his aircraft; examination of these components revealed a serious crack in one of them (between the bolt's head and shaft).

Fig. 2 A Nipper bolt head showing area of concern

LAA Engineering has recently published an Airworthiness Information Leaflet (AIL) MOD/025/003 issue 1) prohibiting aerobatics until a Magnetic Particle Inspection (MPI) of both main wing attachment bolts (when fitted), demonstrating that the bolt is free from cracks, has been completed. In any event, this inspection must be completed within five flying hours. This MPI is not required on wing attachments that use tie rods.

The AIL requires owners to first establish whether bolts or tie rods are used to connect the wing to the fuselage; this inspection can be carried out by the owner alone. Should tie rods be fitted, a note to this effect must be made in the aircraft's airframe log book and the aircraft may resume normal service. If bolts are fitted then they will need to be removed and MPI Inspected (or replaced) before further aerobatic flight.
