LAA/AWA/14/14  
14<sup>th</sup> November 2014

## Rotax 9 Series Engines

### Sinking Carburettor Floats

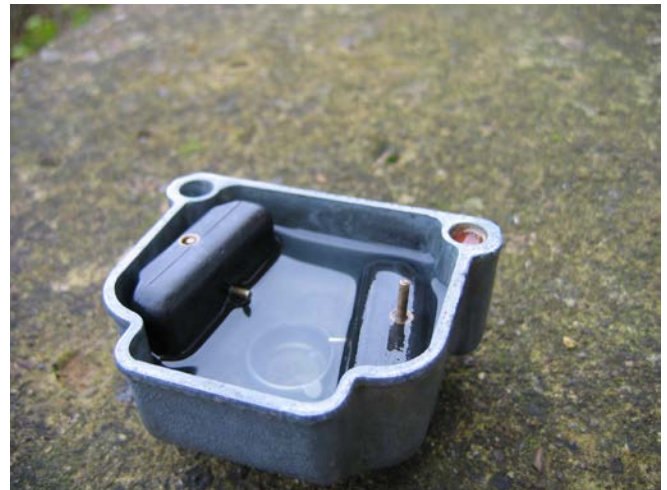
Fig. 1. This photo, taken in 2011, shows the difference in fuel absorption between the floats in a Bing carburettor (removed because the engine was running roughly). It's easy to check for problems here because the carburettor float bowl has been designed to be removed quickly (it's held on by a spring-clip).

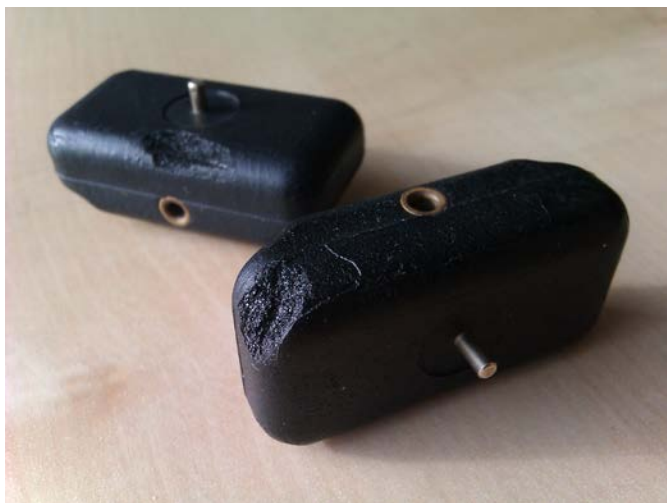
Fig. 2 The Tailored Maintenance Schedule (TMS) for your aircraft should include an inspection of the carburettor, this should be at least an 'Annual' check item. During this inspection it's certainly worth taking a close look at the floats: the first sign of problems of material failure in the example shown above was debris in the float bowl, although in this case the buoyancy of the floats wasn't noticeably affected.
