LAA/AWA/20/24
9th December 2020

Volkswagen Engines Removal of Mechanical Fuel Pumps Using Plastic Rocker Arms from Service

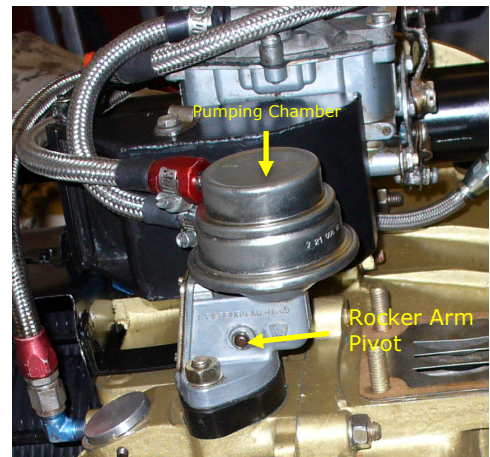
This picture (above) shows a fairly typical after-market automotive mechanical fuel pump. Note that the chamber containing the diaphragm and non-return valves is a sealed unit but, in this example, because a side panel may be removable to inspect the rocker arm itself, it may not be necessary to lift the pump itself. OEM pumps can be stripped into individual components.

Enquiries suggest that 'after-market' pumps using plastic rocker arms have a high failure rate and, for little extra cost, pumps based upon the original VW design, using steel rocker arms, are readily available. For this reason, mechanical fuel pumps using plastic rocker arms must not be used on VW derived aero-engines operating under an LAA administered Permit to Fly.

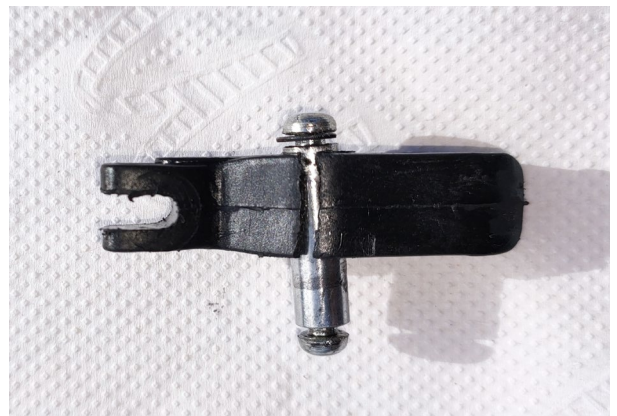
A recent engine failure affecting a Druine D.31 Turbulent aircraft led to an off-airfield forced landing, during which the aircraft was substantially damaged; fortunately, the pilot wasn't seriously hurt in the incident. After a detailed examination of the engine, the LAA Inspector discovered that the rocker arm, designed to transfer motive force from the engine's mechanical fuel pump operating pushrod to the fuel pump's diaphragm, had broken at its pivot, preventing the pump from operating.

The picture above shows the rocker arm from the failed fuel pump described in the text. Following the recent accident, plastic rocker arms are not considered suitable for use in an aero application.
