Service Bulletin SB 09/04

Pioneer 300 Undercarriage – Mandatory Modifications to System

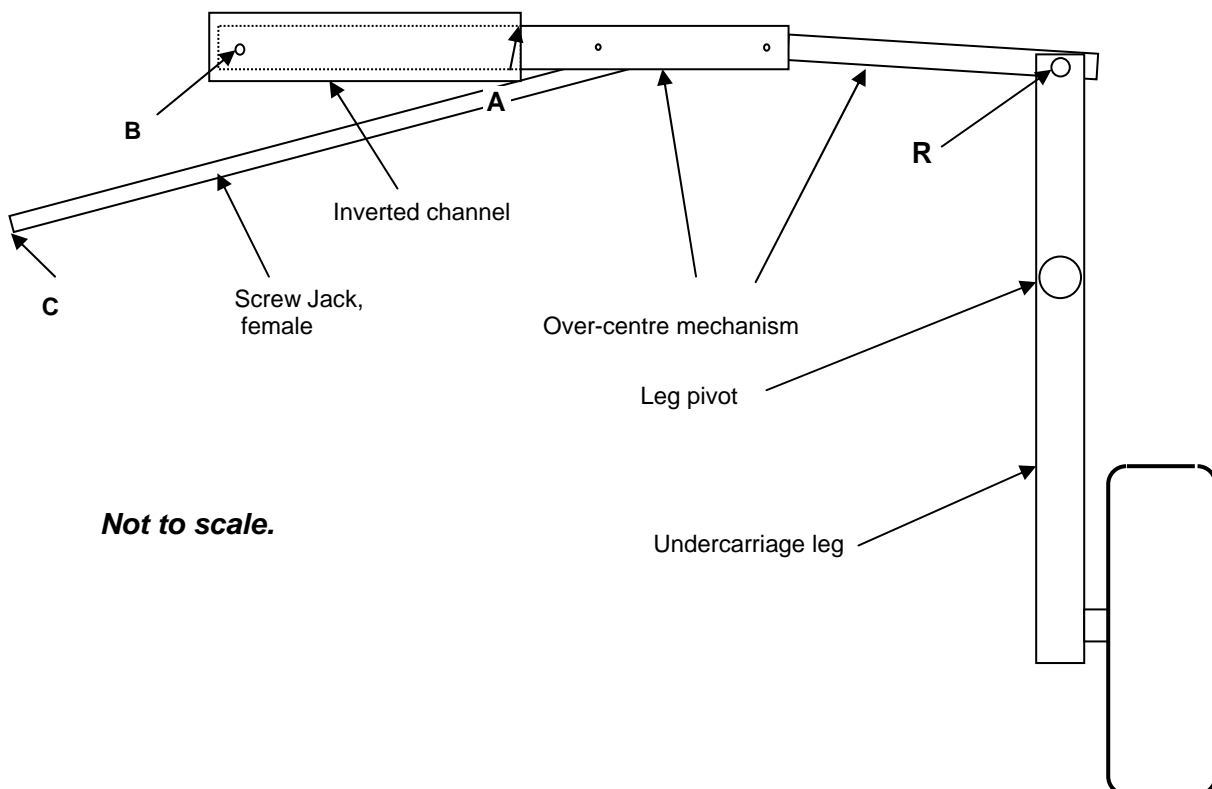
The geometry of the leg's mechanism is shown below; the right hand mechanism, looking from the rear, is shown. The screw jack thread has a pitch of 4mm. Only half-turn increments can be made to the jack's extension by turning the female part of the jack screw at its bolted connection with the arm, ie. the jack's length can be adjusted by a minimum of 2mm increments only.

The effect of a 2mm extension to the jack is critical. Due to the geometry of the mechanism, in particular the

angle which the screw jack makes with the over-centre arm, a 2mm change in the screw jack length results in a 3.5° change in the over-centre angle. Thus a correctly adjusted right hand undercarriage leg can result in a left leg which, in theory, cannot go over-centre.

Check adjustment of BOTH left and right legs with the undercarriage down and locked. They are properly adjusted when the top edges of the overcentre arms comes up firmly against the underside of the channel on both sides at the point the undercarriage motor stops. If this is not the case, then it is permissible to remove up to 3.0mm of material from the top of the first arm to contact the channel at **A** where it stops on the underside of the inverted channel's outboard end. (This arm comprises two parallel aluminium strips, both of which require the treatment). Proceed as follows:

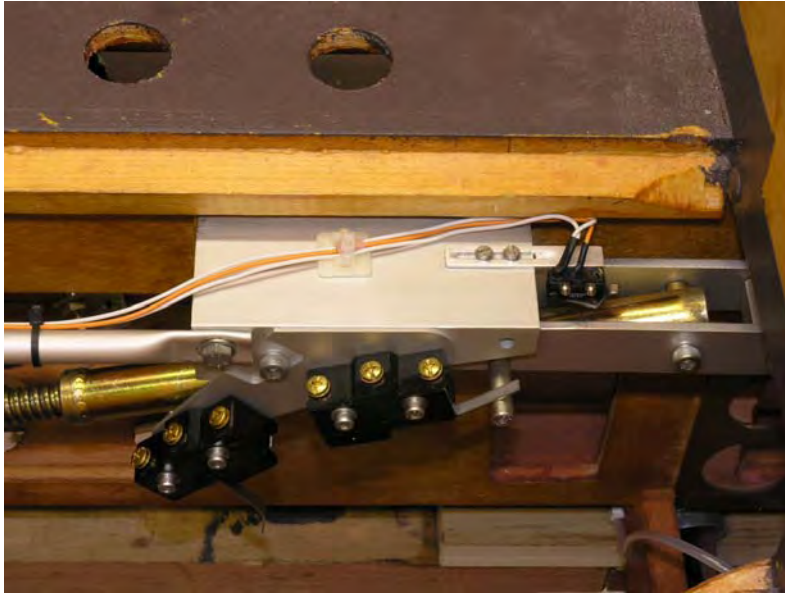
The microswitch is mounted on a carrier bracket cut from 10mm x 10mm x 1mm aluminium angle, and having a slot machined in its top surface. Two 3.0mm bolts secure this bracket and the microswitch to the top of the inverted channel.

By loosening the 3mm screws and adjusting the bracket laterally, the microswitch can be made to operate (close) just at the point at which the over-centre arm touches the underside of the channel ie. in its secure over-centre position.

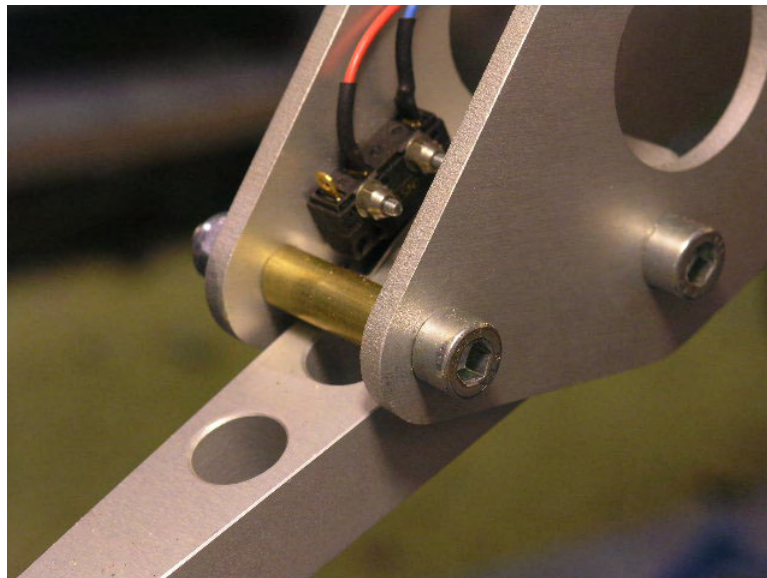
Nose Gear Microswitch Mounting

The front undercarriage microswitch is mounted at the forward end of the front undercarriage right hand plate (P/N 3AL685). Its lever bears on the top of the rear part of the forward over-centre arm as shown.

The microswitch is secured to the side plate by two 3mm bolts and lock nuts. Its lever is adjusted so that the switch operates (closes) just after the arm has moved over-centre and before it contacts the brass spacer stop. Ensure that the microswitch cannot restrict the movement of the arm.
