LAA/AWA/20/10  
29<sup>th</sup> April 2020

## Arplast PV-50 Propeller

### Establishment of Correct Mechanical Fine Pitch Stop Setting

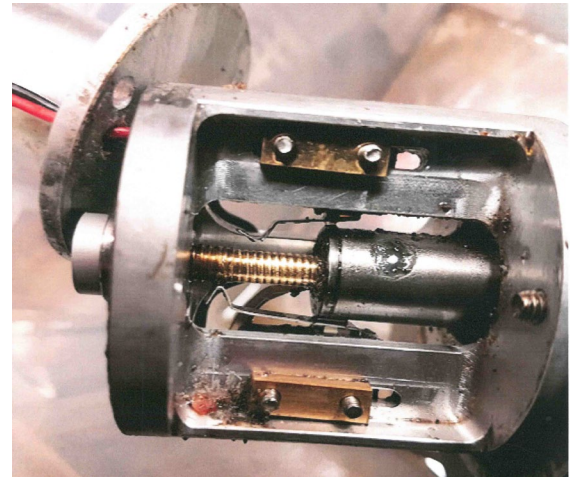
Fig 1. The driving force behind the pitch change mechanism on the Arplast PV-50 propeller is an electric motor driving a threaded lead screw which, in turn, moves a carriage (called a swashplate) which is connected mechanically to the blade's root. The normal range between maximum coarse and minimum fine is determined by the position of two microswitches – the absolute fine position is determined by a mechanical fine pitch stop.

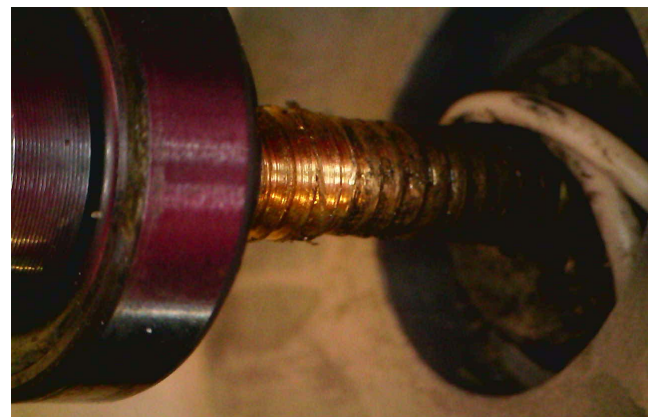
In 2007 the pilot of a Europa aircraft suffered a loss of propeller thrust shortly after take-off. Post incident investigation revealed that the primary cause of the propeller failure was an excessively worn lead screw (the threaded shaft that drives the pitch change mechanism) which had eventually failed. The cause of the excessive wear and the eventual thread failure was determined to be lack of lubrication.

In both the above incidents, though the initial cause of the failure of the propeller mechanism was due to the thread stripping on the lead screw, the reason for the loss of thrust was that the propeller's mechanical fine pitch stop had been incorrectly set.

Fig 2. The initiating cause of the two pitch change mechanism failures suffered by LAA members was the mechanical failure of the lead screw; this was considered due to lack of in-service lubrication. It is an LAA requirement that, in the event of a failure of any kind to a propeller pitch change mechanism, the aircraft remains safely flyable. Because, in both incidences, the propeller's fine pitch stops were not correctly set, this wasn't the case and both the aircraft involved were damaged during the subsequent forced landings.

This later issue reaffirms the importance of the 50 hour lead screw inspection/lubrication requirement, and introduces a one-time check to ensure that when the propeller is operating against the mechanical fine pitch stop, the resulting pitch angle is sufficient to hold the engine RPM within manufacturer's limits when at normal climb speed.
