LAA/AWA/19/05
21st February 2019

Rotorsport UK – Calidus Front Fork – Top Steering Plate Replacement and Rotorsport UK Gyroplanes (All Marks)

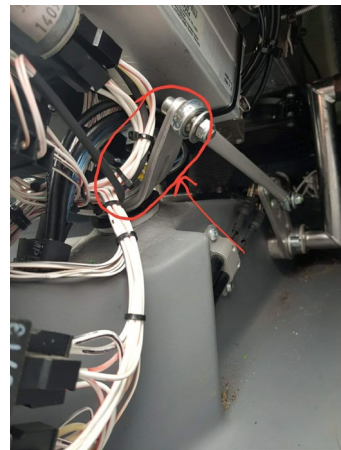
Fig 1. (Left) This picture shows the result of an overload to the top steering plate which has significantly bent; this was most probably caused because of an incorrect rudder application by a student being forcibly corrected by the instructor. Since this failure the steering brackets on aircraft equipped for training have been strengthened.

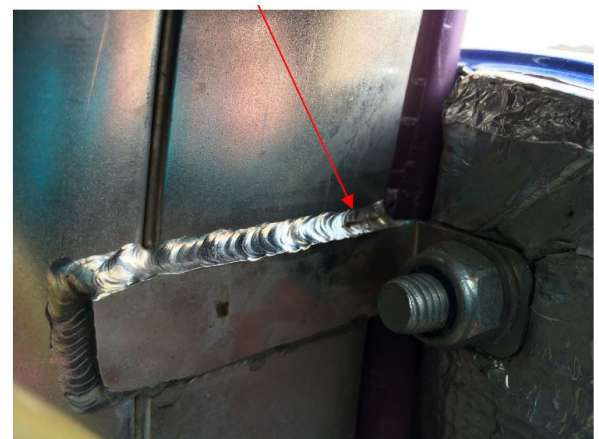
Fig 3. The recent Rotorsport SIL gives examples of cracks that engineers have spotted in welded joints in the structure; the crack shown was found in the right hand upper body bracket. Cracks like this, when spotted early, can be easily repaired, but if left can result in expensive structural repairs.
