LAA/AWA/20/11

## Aerotechnik EV-97 Eurostar (All Marks)

### Publication of Airworthiness Information Leaflet LAA/MOD/315/005 Issue 2 - Inspection of Fuel Filler Hose

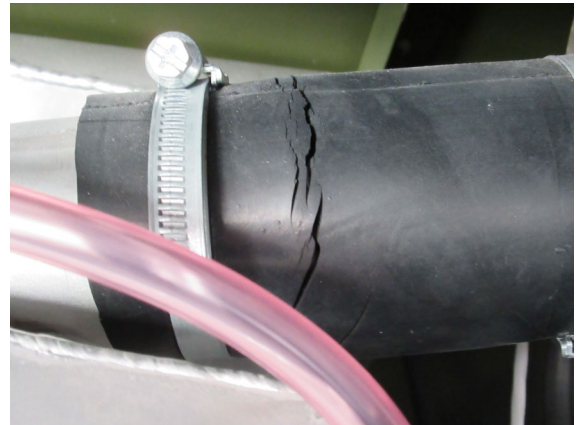
The aircraft involved in this event was assembled from a kit of parts which was originally delivered in 2009. When delivered, the kit included the flexible fuel filler hose. So, this part was possibly at least ten years old when it eventually succumbed to the natural ageing process, a process normal to all components manufactured from rubber.

Since the Leaflet was issued, feedback received from owners and LAA Inspectors suggests that the manufactured quality of filler hoses fitted to EV-97 aircraft varies considerably, and that the hose that suffered the failure was of an unusually low quality.

Fig. 1 This rubber fuel filler hose has failed such that fuel has leaked into the fuselage. Naturally, this fuel has the very real potential of causing an in-flight cockpit fire. Note though, this hose didn't degrade completely in one go, and that this materials failure is likely to affect both the external and internal structure. Material degradation inside the pipe will mean that there's a huge risk of a fuel blockage (and therefore engine failure) due to 'breakaway' rubber debris collecting in the fuel system.

Following the report of a recent in-flight incident, where a pilot became aware of a strong smell of fuel in the cockpit of an Aerotechnik EV-97 Eurostar aircraft, LAA Engineering issued an Airworthiness Information Leaflet (AIL) (LAA/MOD/315/005 Issue 1) mandating the manufacturer's annual inspection requirement to inspect fuel hoses, specifically, the fuel filler hose.

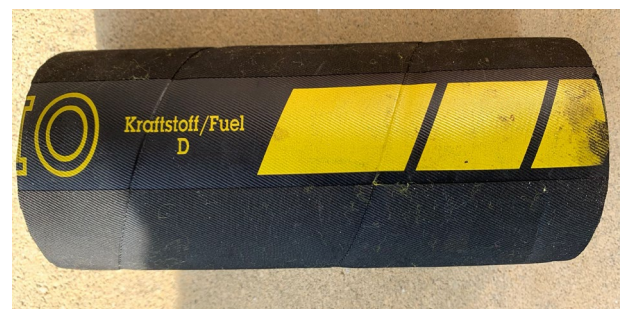
Fig. 2 This picture shows an example of a higher quality fuel hose which remains in perfect condition after many years' service. It can be seen that it is clearly marked as suitable for use with fuel. Should a pipe of this quality be fitted to an aircraft under inspection then, at the discretion of the LAA Inspector, the inspection frequency for this part may be reduced to every three years.

Taking this new information into consideration, the Leaflet has been raised to Issue 2 which, under some circumstances, allows a decrease in the inspection frequency from an annual inspection to an inspection every three years.
