LAA/AWA/20/21
17th November 2020

Aeroprakt A22, A22-L, A22-LS & A22-L2 Foxbat Aircraft

Inspection of the Attachment of the Nose Undercarriage Leg Support Block

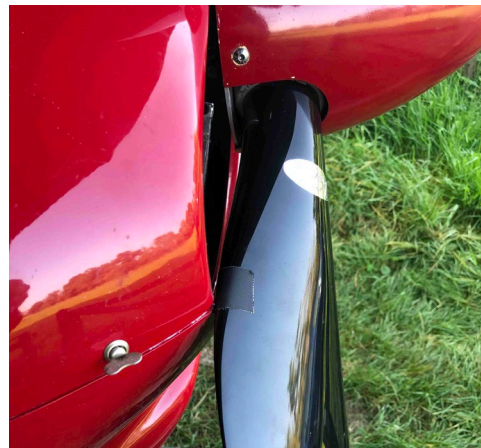
During the pre-flight inspection of an Aeroprakt A22 Foxbat, the pilot noticed that the propeller's trailing edge was nearly touching the lower engine cowl.

The owner of the Foxbat shown in the picture above noticed that the trailing edge of the propeller was very close indeed to the lower engine cowling, emphasising, perhaps, the great importance of a thorough pre-flight inspection.

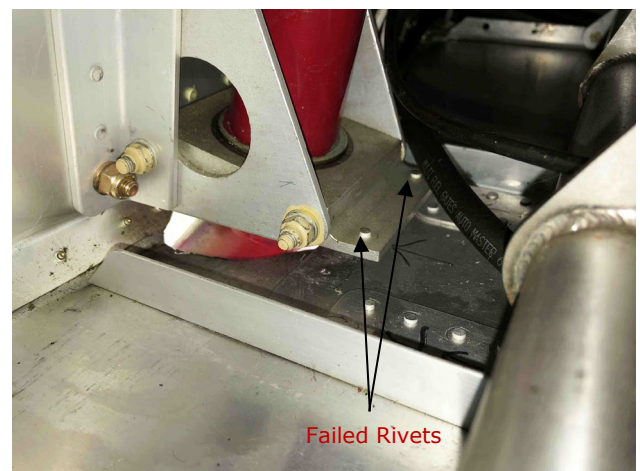
Further investigation revealed that the firewall had buckled at a point where the firewall meets the cockpit floor; this structural failure had allowed the engine mount frame to drop slightly.

One contributing factor in this failure event, was that the two rivets securing the nose undercarriage support block to the aircraft's floor, had failed.

It is thought that this part had been supplied as a replacement when carrying out a previous repair with only two of the four reference holes drilled, perhaps to allow the same part to be used for both riveted and bolted connections.

Further investigation revealed that the engine mount frame had moved because an essential structural element elsewhere had failed. Notice in the picture that both the rivets holding the nose undercarriage support block had broken. This block should have been held in place by four rivets and, because there were only two fitted, it failed under load far sooner than it was designed to.

LAA Engineering has issued an Airworthiness Information Leaflet (LAA/MOD/317/003 Issue 1) requiring owners to check their aircraft to ensure that either four rivets or three 3/16" (AN3-3A) bolts, nyloc nuts and washers attach the nose undercarriage support block to the fuselage floor.
