## Europa Classic, XL and NG Aircraft

### Fuel Filler Pipe Inspection

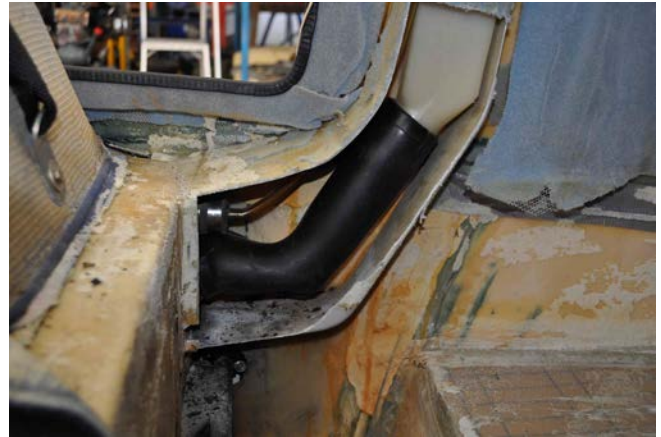
In this case the fuel filler pipe had been sealed off behind a fibreglass cover by the aircraft's original builder and had therefore not been inspected for many years.

Fig 1. Picture shows the fuel filler pipe *in situ*, note that in this example the pipe was completely hidden inside the fibreglass enclosure.

To ensure that there are no other Europa aircraft operating with potentially suspect fuel filler hoses LAA Engineering has published an Airworthiness Information Leaflet (LAA/MOD/247/011 issue 1); a copy of this Leaflet can be downloaded [HERE](#).

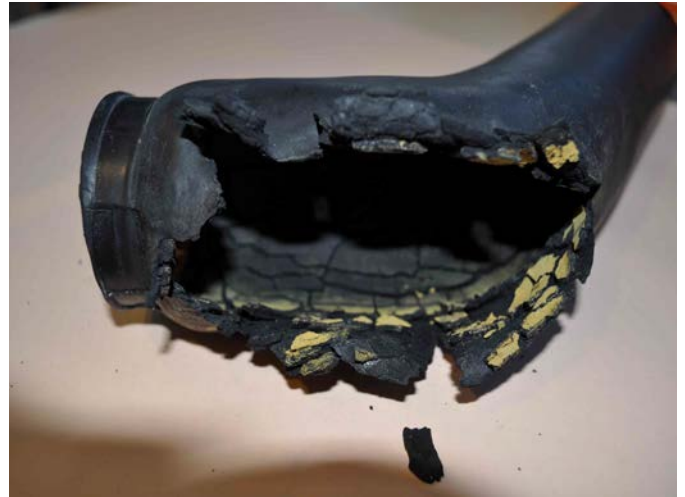
A recent incident, where fuel was seen leaking from a de-rigged Europa aircraft, led to the discovery that the rubber fuel filler pipe on the aircraft had structurally failed, become porous and was breaking up internally, releasing particles of rubber into the fuel system.

It is an annual requirement for aircraft operating under an LAA administered Permit to Fly that the fuel system is fully inspected. It is possible that the fuel filler pipe may look in good order during a cursory in-situ inspection, however, the lessons learnt from this recent incident is that, often despite its outward appearances, the inside of a pipe may be in poor condition.

Fig 2. When the 'hidden' fuel filler pipe was removed from the aircraft it effectively disintegrated; it should be noted that the pipe looked from the outside to be in good condition (except, in this example, it was leaking fuel)
