LAA/AWA/19/13  
2<sup>nd</sup> April 2019

## Rotax 912i & 915i A Series Engines

### Inspection and/or Replacement of Fuel Pump Assembly

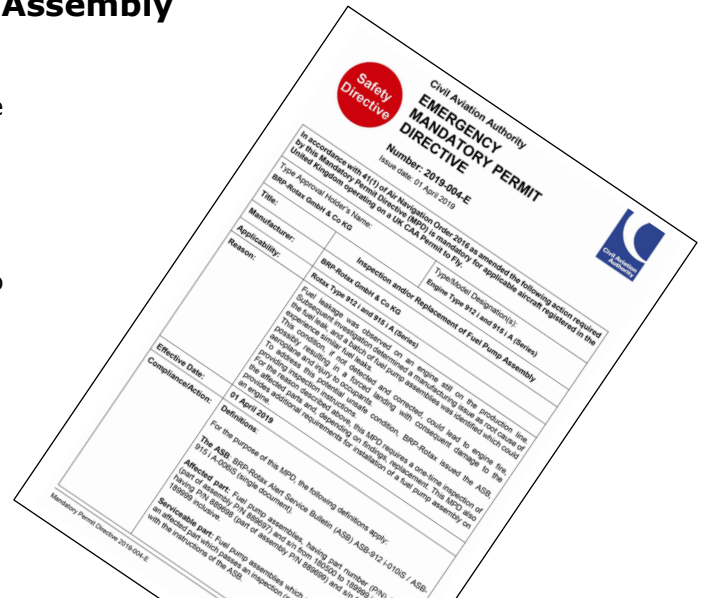
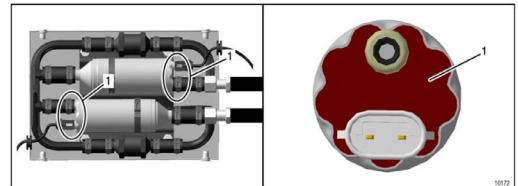
Fig.1 The Rotax 912i engine is not equipped with a mechanical fuel pump and therefore requires two high pressure rotary pumps to ensure appropriate redundancy; because of the very high flow rate, and unusually in aircraft systems, these pumps cannot be operated together. The two individual pumps are mounted in an assembly and operate in parallel. Whilst still at the manufacturer's an engine was found with a leaky pump which was later found to be caused by a manufacturing error (see 1 above for leakage point).

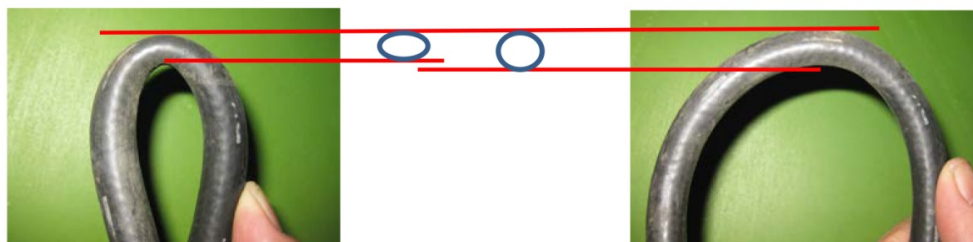
Fig. 2 An example of a pipe with not enough of a radius – note the reduction in the pipe's internal diameter (and therefore area).

This example shows the bare minimum radius necessary to ensure no kinking in this type of rubber fuel pipe – note, different pipes will require a different minimum bend radius.
