LAA/AWA/21/05  
5<sup>th</sup> February 2021

## Hoffmann HO-V 72 Propellers Hub Inspection

### EASA Emergency Airworthiness Directive 2020-0226-E

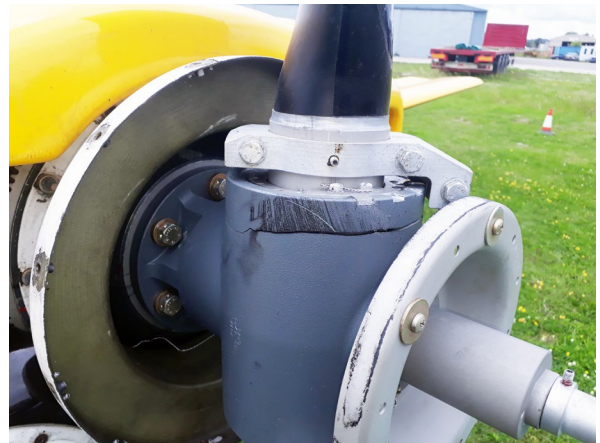
This circumferential hub crack created a noticeable in-flight vibration which led the pilot to abandon the flight.

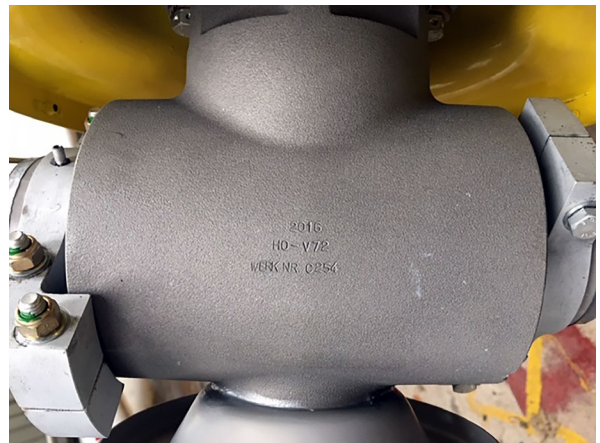
The EASA E-AD mandates a 30 year life for this hub model, the date of manufacture is stamped clearly on the hub.
