LAA/AWA/20/14
8th June 2020

Jabiru Engines – All Models

Service Letter – JSL 023-2

Jabiru Engine Overhauling – Important Build Issues

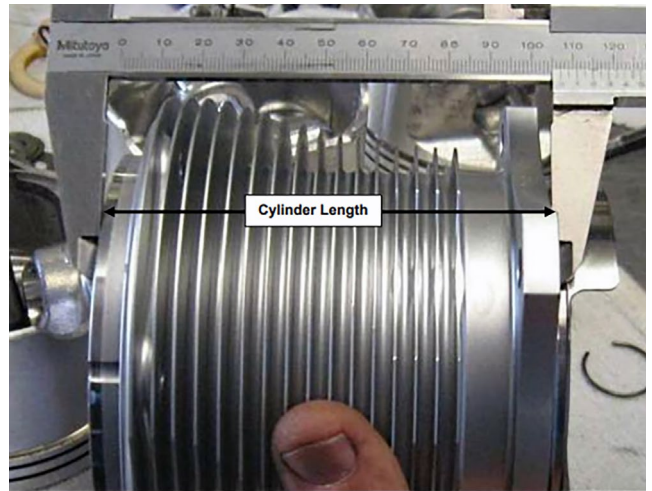
When carrying out a top-overhaul on a Jabiru engine, it is essential that close reference is made to the relevant and most up-to-date issue of the overhaul manual. Incorrect clearances may lead to premature wear or an unexpected engine stoppage.

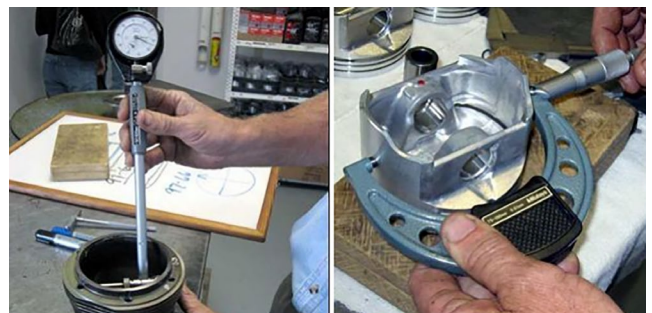
An engine overhaul will almost certainly require specialist measurement equipment. This picture shows the equipment required to ensure that the piston to bore clearance is within manufacturer's limits before final assembly.
