LAA/AWA/21/04
26th January 2021

Jabiru Aircraft (All Marks) Jabiru Service Bulletin JSB 044-1 Control Surface Hinge Inspection

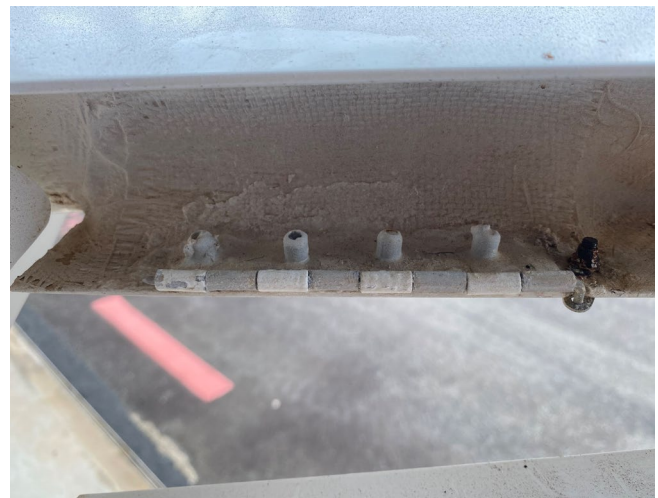
Evidence seen in the fracture face of the failed hinge shows that corrosion has played a major part in this hinge failure, primarily because corrosion products cause stiffness in the hinge which, in turn, leads to fatigue in the hinge's leaf.

This picture shows one half of the failed aileron piano hinge from a Jabiru SP4 aircraft. This hinge was found broken by the pilot during the pre-flight check, but it is likely that the hinge had been failing for some time.
