LAA/AWA/19/22  
27<sup>th</sup> November 2019

## Jodel DR100 (Series) Aircraft Inspection of the Tubular Frame of the Front Seats

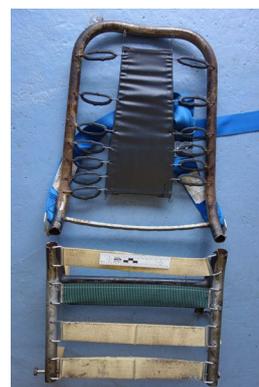
During the preparations for an instructional flight in a Jodel DR1050, the front/starboard seat's tubular structure failed in such a way that the seat's base separated from the seat's back. The tubular-framed front seats, used on the Jodel three and four seater aircraft, have a history of cracking at this point, though this is the first time LAA Engineering has seen a complete failure of the seat frame.

Fig 2. (Left) shows the seat as it was removed from a Jodel 4 seat aircraft (a DR1050).

Note that the seat has failed in a place described in the BV AD written over thirty years previously.

LAA Engineering has recently published Airworthiness Information Leaflets (AILs) affecting all DR100 types. The AILs remind both owners and LAA Inspectors of the importance of carrying out the requirements of AD 66-26-30 at the defined inspection points, and introduces a requirement to widen the inspection area to include the whole of the bend area which forms the transition between the seat's base and the seat's back.
