LAA/AWA/18/02
10th March 2018

Rotax 912 (Series) and 914 Engines

Valve Pushrod Assembly – Inspection/Replacement

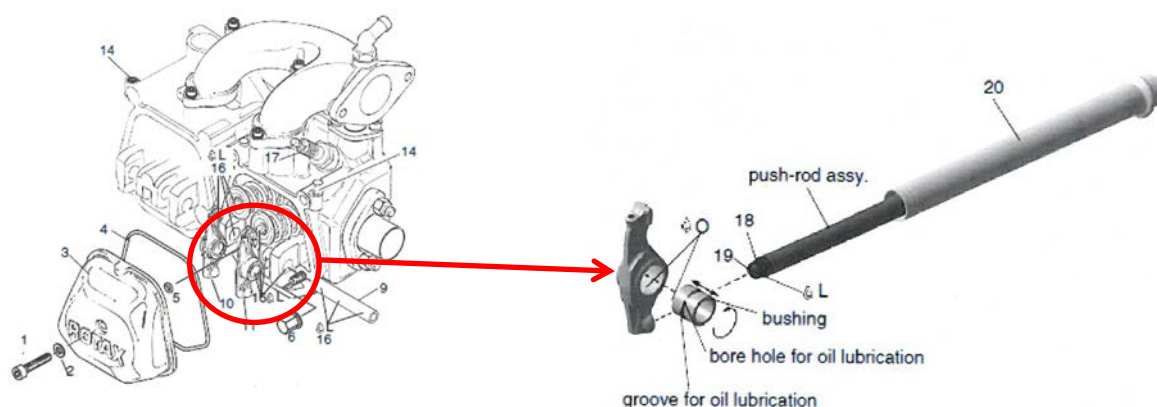
The issue stems from a batch of pushrods manufactured with an incorrect surface finish on the rocker-arm ball socket which, in service, could result in rapid wear. Wear in this area could lead to rocker arm damage and/or malfunction of the valve train, the possible effects of this include reduced power and a rough running engine.

Affected pushrods can easily be identified once the rocker covers have been removed. Pushrods with a silver finish conform to design standard, those with a black finish don't and must therefore be replaced.
