LAA/AWA/19/25
19th December 2019

Trio 'Gold Standard' Auto-Pilot Servo

Addition of Fail-Safe Washers and Cotter Pin to Prevent the Possibility of a Control Jam

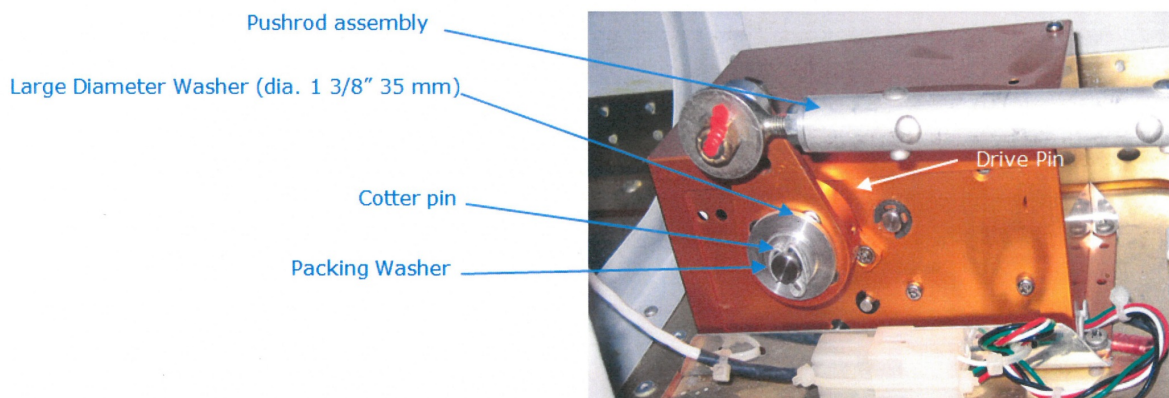
Fig 2. A Trio auto-pilot servo as fitted to a Van's RV-10

The initial 2012 Leaflet required the fitment of a cotter pin and packing washers because, during an annual inspection of a Vans RV10 aircraft, the owner noticed significant movement in the connection between the output drive shaft and the drive arm; after further investigation, it was discovered that the drive pin itself was loose and was in danger of falling out. The loss of the drive pin would mean that the drive arm would be free to move on the drive shaft which, in addition to the loss of auto-pilot function, the drive arm could become detached from the shaft completely, with a consequential risk of a control jam. The addition of the cotter pin and washers would prevent this.

This later requirement (to fit the large diameter washer) has been added to prevent the egress of the four screws attaching the drive arm to the shaft attachment from coming loose.

LAA has recently re-issued a 2012 Airworthiness Information Leaflet (AIL) (LAA/MOD/EQUIP/002 Issue 1). Issue 2 of this Leaflet has been created to introduce a requirement to fit a large diameter washer on the output drive shaft between the cotter pin, packing washer(s), and the drive arm.

After fitment of the washers inspectors must check controls for full range of movement, ensure that the servo operates normally throughout its full range, and that there is no possibility that the linkage could lock over-centre.
