LAA/AWA/19/15
29th May 2019

RotorSport MT-03 & MTOsport Gyroplanes

SB-123 Issue 1 – Pitch Control Rod

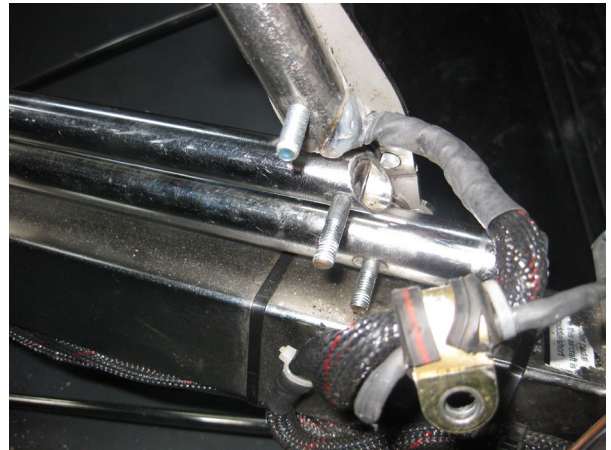
Fig. 1 This picture shows the base of the forward control stick with the starboard connection plate removed (for clarity). The stick itself pivots fore and aft, around the bottom bolt in the system and controls pitch; the bottom tube in the assembly has a bearing at each end which allows for side to side movement of the stick (roll).

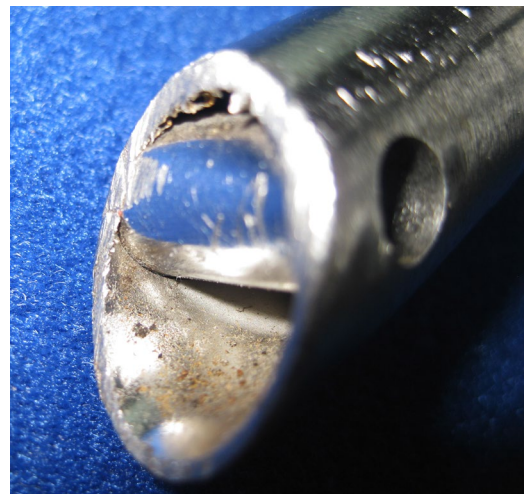
The issue relates to a manufacturing error affecting the pitch change rod at its connection with the front control stick where, during the part's manufacture, too much material had been removed between the welded bush (through which the stick is attached to the tube) and the forward end of the tube. It was also noted that the weld securing the bush in place and the ends of the bush itself had been removed during final finishing though, during a close inspection after removal, the bush remained firmly in place in the tube: the gap left between the side plates because of the removal of the weld material being taken up by multiple washers.

Fig 2. A 'close-in' picture showing the worrisome pitch control tube's end. As you can see, there's very little land between the through-bush and the end of the tube itself; there should be a minimum of 3 mm land here according to drawings of the part.

Some time ago, the original manufacturer of the MT-03, Auto-Gyro, became aware of this issue after an in-service failure of a control assembly at this point on an aircraft that had been involved in an accident. In May 2017, Auto-Gyro issued a Category B Service Bulletin asking owners to check their pitch control rods to ensure that at least 3 mm of material remained between the edge of the weld and the tube's end. During the previous annual inspection this Bulletin had not been seen by either the owner or the inspector. In our letter, we pointed out the importance of taking note of all manufacturer's Service Bulletins and inspection points within the aircraft's Tailored Maintenance Schedule (or approved manufacturer's schedule where appropriate).
