LAA/AWA19/04
21th February 2019

Slick Magneto (4-Cyl. Type)

Potential Decrease in Service Life

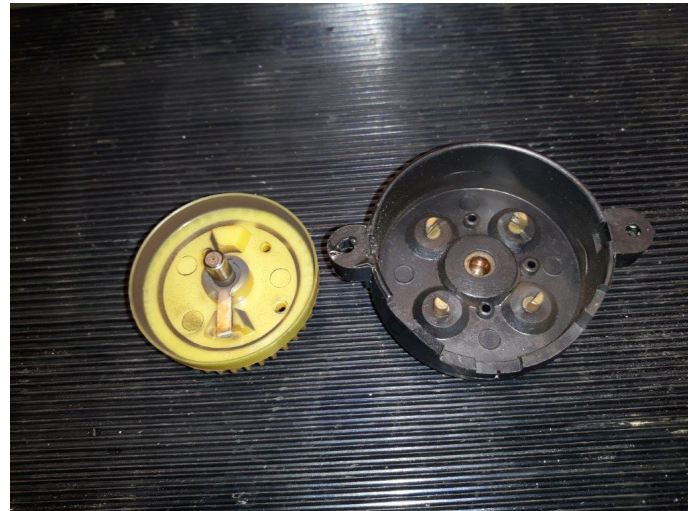
Slick magnetos are common in the GA fleet and only rarely cause trouble, though one issue that was once considered quite rare, but recently appears to be a more common failure mode, is slippage of the distributor gear's 'finger' electrode.

One LAA member, who was suffering rough running on one fairly recently overhauled magneto, ended up unnecessarily replacing all the spark plugs and the ignition leads before returning the magneto to the repair shop where a loose finger electrode was found to be the problem.

Fig 1. The 'finger' electrode directs the high-tension electrical charge to the correct plug at the correct time. Looseness in the electrode will affect the quality of the spark and may cause rough running. As the gap between the finger electrode and the contact in the distribution cap naturally increases with age, increased sparking will decrease the efficiency of the ignition system and may lead to a failure of one or more cylinders.

Champion have recently replaced the troublesome copper electrode with one made from Monel (a nickel-copper alloy) which is stronger and has a better resistance to corrosion.

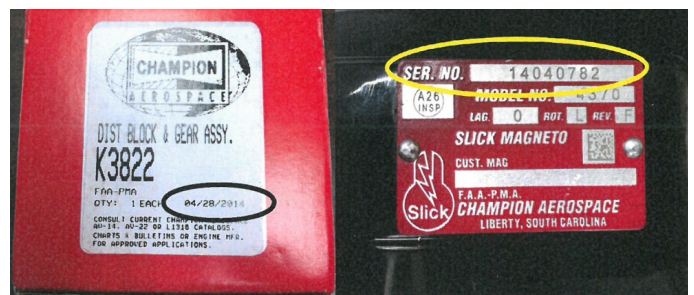
Fig 2. Distributor gears manufactured between 2008 and 2016 may contain suspect finger electrodes. The serial number, on the magneto's data plate, also contains the date of manufacture.

The example shown above gives the date first (2014/April) followed by the actual serial number (0782).

Champion Aerospace, the manufacturer of the 'Slick' range of magnetos, recently revised a Service Bulletin (SB1-15A) suggesting that some magnetos designed for 4-cylinder engines may suffer a decrease in service life because of this issue; they'll replace the potentially defective part free of charge, but of course this will mean removing and dismantling the magneto.
