LAA/AWA/19/02
11th January 2019

Jabiru Aircraft (All Marks)

The Use of Solid Tyres

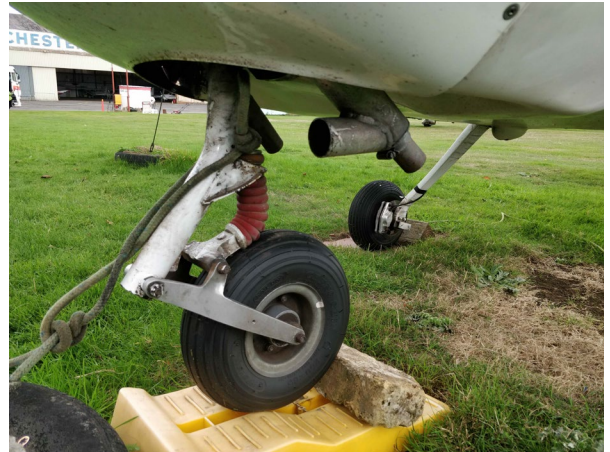
We became aware that some Jabiru aircraft may be fitted with solid tyres after an incident that occurred in October 2018 where a nose undercarriage failed after a rather heavy landing; it was noted by the pilot, who was not the owner of the aircraft, that a solid tyre had been fitted after the incident and that the resulting reduction in suspension in the undercarriage system may have contributed to the undercarriage's failure.

Fig. 1 The picture above shows the failed nose-undercarriage shock strut assembly; this strut has failed as a result of overload because of a heavy landing.

This Alert serves to let owners of Jabiru aircraft know that these solid tyres are not approved for use on Jabiru aircraft for two principal reasons. Firstly, they offer no suspension whatsoever within the normal impact ranges expected during landing and therefore the undercarriage, as a system, becomes much less able to absorb the energy imparted during a heavier than normal landing.

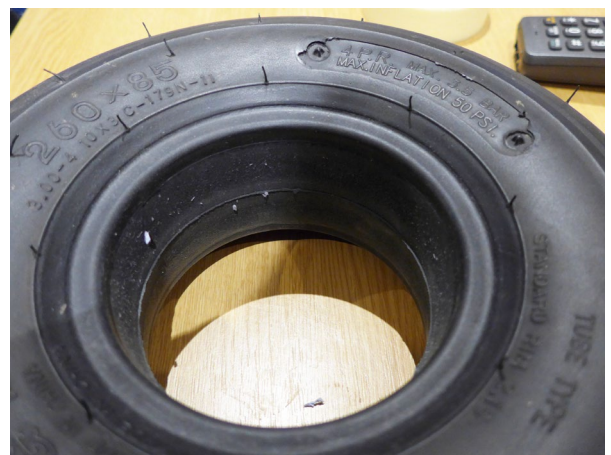
Follow-up investigation has revealed that these solid tyres have been modified by a specialist after-market manufacturer for use on mobility scooters and are fitted to avoid the complications of a disabled user suffering a puncture. It was this attribute that persuaded the owner of the aircraft to fit them after discussions with a microlight instructor who had suffered similar problems.

Fig. 2 This picture shows how the tyre looks when removed from the wheel assembly, note the very professional look to the inner infill core – and the fact that the tyre gives a maximum inflation pressure though, naturally, an inspector wouldn't find an inflation valve.
