LAA/AWA/19/08  
4<sup>th</sup> March 2019

## **CZAW SportCruiser Nose Undercarriage Spindle Inspection**

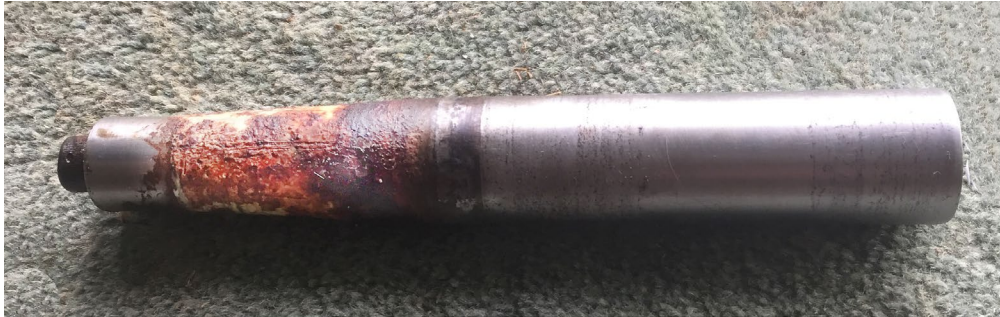
Fig 1. This picture shows the corrosion damage that has occurred unseen in a CZAW SportCruiser noseleg spindle after five years in service. Corrosion like this is extremely dangerous because surface corrosion pitting in high-strength steel is a common cause of cracking and component failure.

The reason for this new requirement is that there have been a number of field reports suggesting problems with corrosion on the mating face of the spindle, normally having been found during annual maintenance. The spindle is a highly stressed component which is manufactured from extremely strong steel. This type of steel is known to be seriously weakened by local corrosion pits or stress corrosion cracking and to avoid this, during initial assembly, a jointing compound (JC5a or equivalent) is used. It has become clear that, over time, the protection afforded by the jointing compound diminishes and the corrosion process begins.

LAA Engineering have recently published an Airworthiness Information Leaflet (AIL) (MOD/338/019 Issue 1) which introduces a requirement to physically remove the spindle from its housing for inspection and servicing at each annual inspection. It is strongly suggested that this spindle removal/inspection be completed alongside other annually required checks of the nose undercarriage assembly.

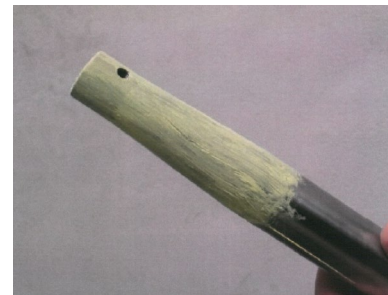
Fig 2. To act as a barrier between the mating surfaces a jointing compound is applied before assembly. When 'wet assembled', this has the added benefit of filling any voids which may allow water ingress into the assembly.

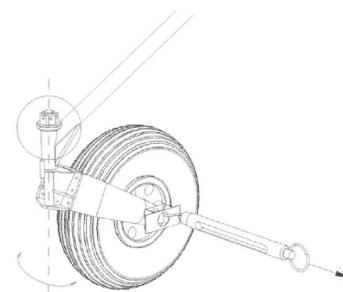
Fig 3. As a by-product of their design, most noselegs can suffer from shimmy if not set up correctly. Important factors in the prevention of shimmy include ensuring that the correct friction is maintained between the spindle block and, naturally, correctly inflated tyres.
