LAA/AWA/21/03
25th January 2021

Stampe SV 4 DGAC Airworthiness Directive F-2020-006 Tightening of the Propeller

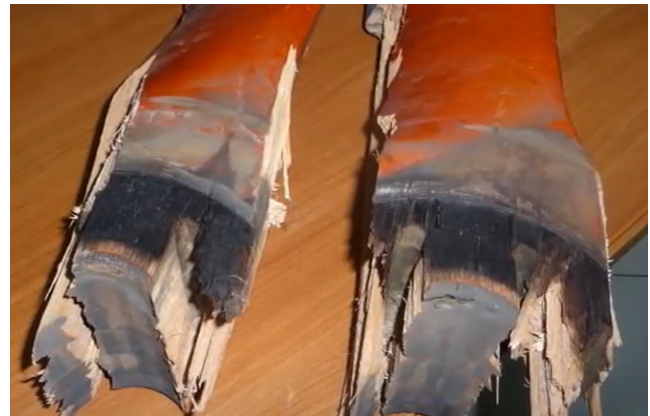
We believe that this AD has been issued as a response to an incident in 2009 where, after the propeller departed the aircraft, the pilot was forced to ditch in the Mediterranean Sea; the reason for the propeller's failure was not definitively established, though loosening of the propeller clearly led to friction-heating of the wood.

Wood swells and shrinks as its percentage water content rises and falls; during a period of very dry weather, the wood will lose water and shrink. Though the amount of this shrinkage is small, it's enough to reduce the securing bolt's tension. When this happens, the consequential reduction in grip may allow a propeller to move back and forth as the propeller rotates, generating heat and, as can be seen in the picture above, carbonise the wood. When this starts to happen, a propeller loss is inevitable.

The importance of ensuring that all wooden propellers remain correctly tightened cannot be over-emphasised, this is especially true after an extended period where the aircraft hasn't been operated.

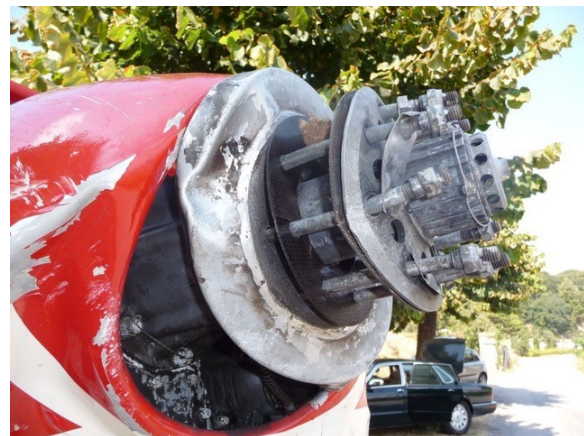
Another possible reason for this propeller loss may have been that the attachment bolts had worked loose. This may have happened because locking 'tab' washer had failed in service. The AD reminds owners that locking 'tab' washers' must only be used once as, during the bending/unbending process, the tab will become work-hardened and prone to failure in service.
